Contract #: 04-0120F4Cty: SF/ALA Rte: 80 PM: 13.2/13.9File #: 1.28**WELDING INSPECTION REPORT****Resident Engineer:** Pursell, Gary**Address:** 333 Burma Road**City:** Oakland, CA 94607**Report No:** WIR-012995**Date Inspected:** 07-Apr-2010**Project Name:** SAS Superstructure**OSM Arrival Time:** 630**Prime Contractor:** American Bridge/Fluor Enterprises, a JV**OSM Departure Time:** 1500**Contractor:** American Bridge/Fluor Enterprises, a JV**Location:** Job Site**CWI Name:** See Below**CWI Present:** Yes No**Inspected CWI report:** Yes No N/A**Rod Oven in Use:** Yes No N/A**Electrode to specification:** Yes No N/A**Weld Procedures Followed:** Yes No N/A**Qualified Welders:** Yes No N/A**Verified Joint Fit-up:** Yes No N/A**Approved Drawings:** Yes No N/A**Approved WPS:** Yes No N/A**Delayed / Cancelled:** Yes No N/A**Bridge No:** 34-0006**Component:** Orthotropic Box Girders (OBG)**Summary of Items Observed:**

Field Splice 2E/3E Face E-1 (First side-inside)

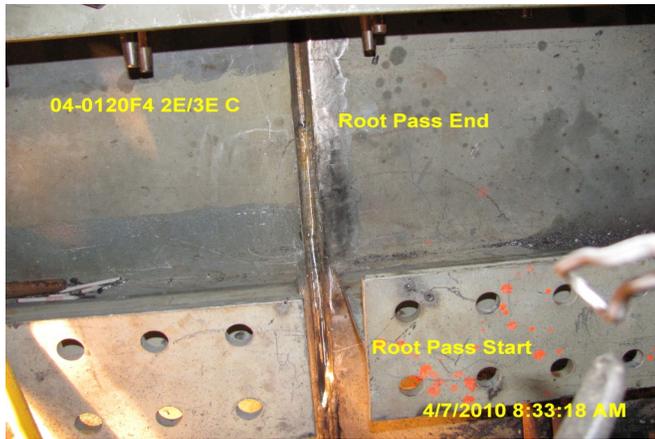
The QA inspector noted ABF welding personnel Chun Fai Tsui setting up to perform Flux Cored Arc Welding (FCAW) at weld number designated D2 for approximately 600mm in close proximity to the longitudinal diaphragm. Upon initial review by the QA inspector it was verified no pre heat or interpass temperature was present. The temperature was verified by temperature indicating markers and noted to be less than 38° C and utilizing the QC inspector's temperature gun it was noted to be 20° C. This information was brought to the attention of the QC inspector as this weld joint requires an elevated preheat of 93° C due to the thickness of the weld joint and which filler metal the contractor utilizes. QC inspector Bernard Docena agreed that the pre heat was nonexistent and relayed to the QA inspector it was up to production to remedy the situation. The QA inspector inquired when the root pass was performed in this area as it was ground to bright metal and the QC inspector relayed it was welded the previous day late in the shift and the QA inspector inquired again about holding the pre heat once the welding was initiated. After approximately 10 minutes with no further action performed by the QC inspector the QA inspector informed welding foreman Dan Ieraci of the issue in which Mr. Ieraci requested the QA inspector review the drawings for the thickness of this plate together in which it was confirmed that the elevated pre heat requirements would be necessary for this location. Mr. Ieraci relayed to the QA inspector he would relocate the welder and once additional heating coils became available he would attach them to this location and then proceed further. This information was relayed to lead QA inspector Bill Levell by phone and the QA inspector attempted to relay this issue to lead QC inspector Leonard Cross via phone and a voice message was left. After an hour elapsed, the QA inspector had not received a call from the QC lead and informed WQCM Jim Bowers of the issue and he relayed he would look into the situation.

QC inspector Mike Johnson confronted the QA inspector and insisted the weld in this location was completed the previous day. The QA inspector inquired from the QC inspector if he was trying to discuss the same area and the QA inspector suggested both individuals should review the area together in which Mr. Johnson agreed. Upon arrival at the location the QC inspector again insisted it was completed the previous day and the post weld heat was completed for this area. The QA inspector inquired if the QC inspector was speaking about the first 200mm (approximately) which was adjacent to the longitudinal diaphragm which was completed in lieu of the 400mm (approximate) area which had a root pass. See digital photo below for clarification.

The QC inspector responded with "I don't consider that a root pass" and the QA inspector inquired if both sides of the bevel was tied into a weld pass and the QC inspector confirmed it was. The QC inspector asked the QA inspector if informing the foreman and the welding quality control manager was QA's normal procedure. The QA inspector relayed to Mr. Johnson the scenario which took place, the attempt by QA to inform the QC inspector assigned to this area and after no remedial action relayed the issue to the aforementioned individuals. At this time the QC and QA inspectors returned to their normal duty areas. Later in the shift lead QC inspector Leonard Cross

returned the QA inspectors phone call and the QA inspector relayed this information and Mr. Cross informed the QA inspector he would look into the issue and discuss it with Mr. Bowers. An incident report will be generated for this item for this date after discussion with the lead QA inspector.
