**DEPARTMENT OF TRANSPORTATION**

Contract #: 04-0120F4Cty: SF/ALA Rte: 80 PM: 13.2/13.9File #: 1.28**WELDING INSPECTION REPORT****Resident Engineer:** Pursell, Gary**Address:** 333 Burma Road**City:** Oakland, CA 94607**Report No:** WIR-012997**Date Inspected:** 13-Apr-2010**Project Name:** SAS Superstructure**OSM Arrival Time:** 630**Prime Contractor:** American Bridge/Fluor Enterprises, a JV**OSM Departure Time:** 1500**Contractor:** American Bridge/Fluor Enterprises, a JV**Location:** Job Site

## WELDING INSPECTION REPORT

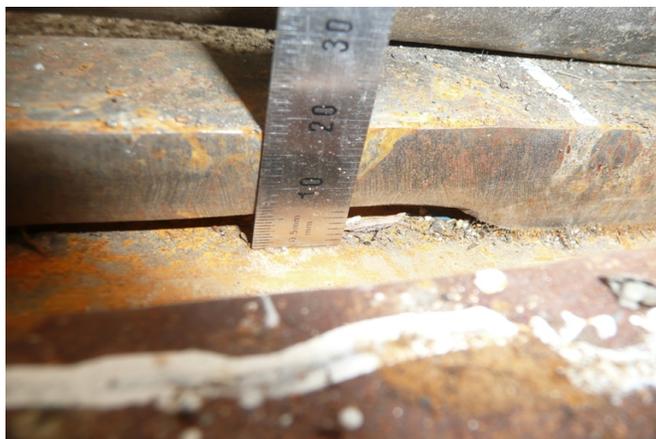
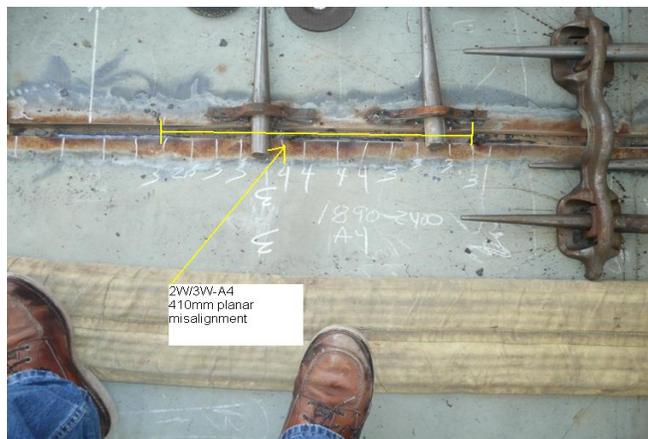
Upon the arrival of the QA Inspector at the above identified location, the QA Inspector randomly observed the ABF welders James Zhen, Mitch Sittinger and Chun Fai Tsui performing SMAW tack welding of the steel backing. The QA Inspector noted the ABF welders were utilizing 5/32" E7018 low hydrogen electrodes with approximately 157 Amps for all three welders. The QA Inspector noted the SMAW parameters appeared to be in general compliance with ABF-WPS-D1.5-F1200A. The QA Inspector performed random visual and dimensional testing of the fit up prior to and during the SMAW tack welding. The QA Inspector noted several areas of planar misalignment that exceeds that allowed by AWS D1.5-02 section 3.3.3 In addition the QA Inspector noted several areas where the gap at the steel backing and the bevel exceed 2mm which exceeded the maximum allowable by AWS D1.5-02 section 3.3.1.1. The following locations of the above identified issues are as described below:

The unacceptable planar misalignment was located at the following locations:

A1-y=0mm-130mm 8mm-3mm misalignment (130mm in length)

A1-y=3770mm-3945mm 3-5mm misalignment (205mm in length)

A4-y=1890mm-2400mm 3-4mm misalignment (410mm in length)

The gaps exceeding 2mm between the steel backing and the bevel were located at the following locations:

A1-y=2015mm-2125mm, gap at steel backing 7mm-3mm (length 110mm) 2W side of groove

A1-y=1970mm-2130mm, gap at steel backing 9mm-3mm (length 160mm) 3W side of groove

The QA Inspector noted the two members' identified as 2W/3W-A were joined by welding on both sides of the steel backing bar. It was noted no additional fit up tasks would be performed after the members were joined by welding. The QA Inspector wrote and submitted Incident Reports for the unacceptable fit up issues described above. The pictures below represent examples of the planar misalignment and gaps at the steel backing.
