DEPARTMENT OF TRANSPORTATION

Contract #: 04-0120F4Cty: SF/ALA Rte: 80 PM: 13.2/13.9File #: 1.28**WELDING INSPECTION REPORT****Resident Engineer:** Pursell, Gary**Address:** 333 Burma Road**City:** Oakland, CA 94607**Report No:** WIR-013058**Date Inspected:** 15-Apr-2010**Project Name:** SAS Superstructure**OSM Arrival Time:** 630**Prime Contractor:** American Bridge/Fluor Enterprises, a JV**OSM Departure Time:** 1500**Contractor:** American Bridge/Fluor Enterprises, a JV**Location:** Job Site

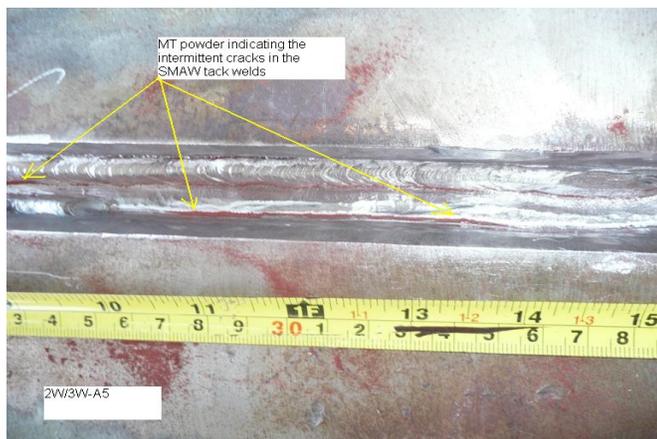
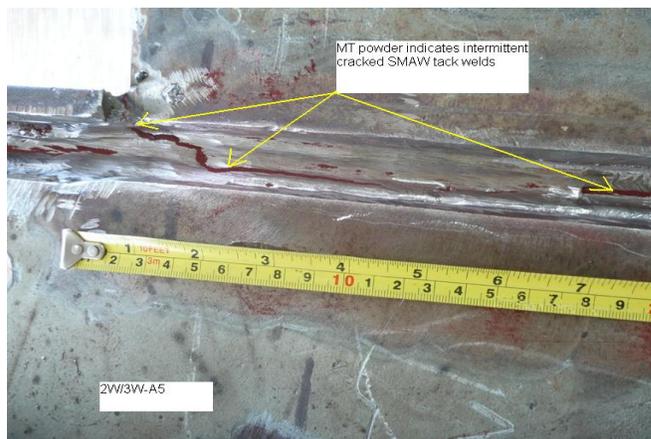
The QA Inspector randomly discovered and noted a crack at the end of the above identified weld joint in section 2W/3W-A5. The QA Inspector observed the crack to start at the beginning of the weld tab and propagate approximately 450mm intermittently down the edge of the bevel on both sides of the weld joint. The QA Inspector noted the crack was located by the QA Inspector Rick Bettencourt. The QA Inspector noted the ABF welding operator nor the SE QC Inspector Bnifacio Daquinag were aware of the cracked area of tack weld. The QA Inspector informed them of the cracked area just prior to the ABF welding operator performing the SAW root pass.

After the extent of the cracks length was determined by the QC Inspector utilizing the MT method, the ABF representative Dan Ieraci utilized a burr bit grinder to excavate the area where the crack was present. The QA Inspector randomly observed the QC Lead Inspector Mike Johnson inform the ABF representative Dan Ieraci

engineering approval was required prior to any weld repairs being made (see summary of conversations). The QA Inspector noted no welding repairs were made prior to the end of the QA Inspectors shift on the job site on today's date.

The QA Inspector asked the QC Inspector Bnifacio Daquinag what he intended to do in regards to repairing the cracked tack weld. The QC Inspector informed the QA Inspector he would do as directed by the QC Lead Inspector Mike Johnson. Mr. Johnson informed the QA Inspector he would present the pictures and dimensions of the cracked area the ABF Welding Quality Control Manager (WQCM) Jim Bowers. Mr. Johnson went on to inform the QA Inspector a repair procedure would be written and submitted to the department for engineering approval prior to performing any weld repairs.
