DEPARTMENT OF TRANSPORTATION

Contract #: 04-0120F4Cty: SF/ALA Rte: 80 PM: 13.2/13.9File #: 69.28**WELDING INSPECTION REPORT****Resident Engineer:** Pursell, Gary**Address:** 333 Burma Road**City:** Oakland, CA 94607**Report No:** WIR-013078**Date Inspected:** 28-Mar-2010**Project Name:** SAS Superstructure**OSM Arrival Time:** 700**Prime Contractor:** American Bridge/Fluor Enterprises, a JV**OSM Departure Time:** 1900**Contractor:** Zhenhua Port Machinery Company, Ltd (ZPMC), Changxing Island **Location:** Shanghai, China**CWI Name:** Mr. Li Yang**CWI Present:** Yes No**Inspected CWI report:** Yes No N/A**Rod Oven in Use:** Yes No N/A**Electrode to specification:** Yes No N/A**Weld Procedures Followed:** Yes No N/A**Qualified Welders:** Yes No N/A**Verified Joint Fit-up:** Yes No N/A**Approved Drawings:** Yes No N/A**Approved WPS:** Yes No N/A**Delayed / Cancelled:** Yes No N/A**Bridge No:** 34-0006**Component:** Orthotropic Box Girder (OBG)**Summary of Items Observed:**

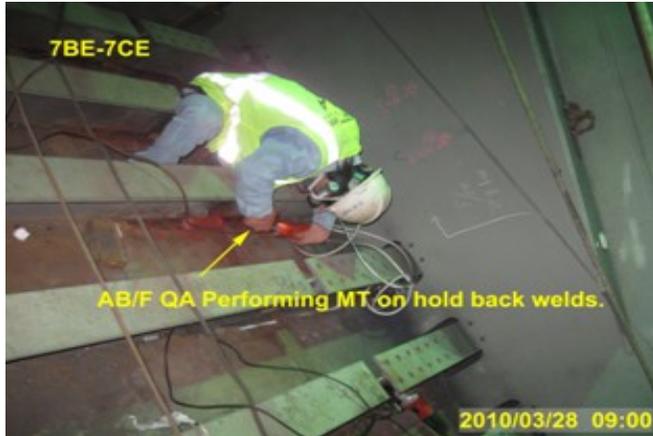
This QA Inspector observed American Bridge/Fluor (AB/F) QA Inspector Mr.Tao Linying was performing Magnetic Particle Testing (MT) for Side panel ‘T’ Rib Holdback fillet welds at SEGMENT: 7BE-7CE, PP#52-53, Side panel, CB side.

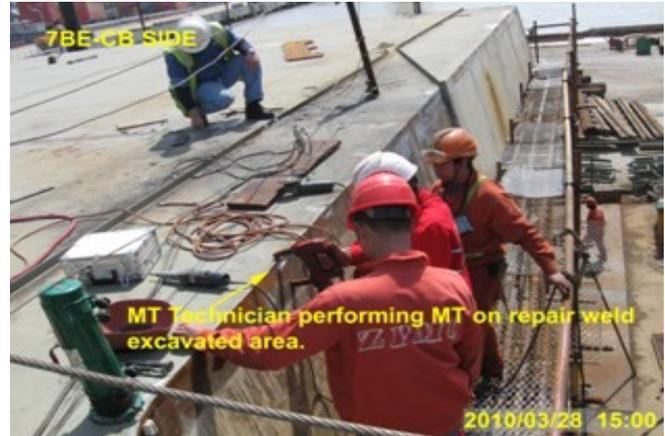
This QA Inspector observed ZPMC MT Technician Mr.Liu Zhang Min was performing Magnetic Particle Testing (MT) for Deck panel to Edge panel Repair weld excavated area.
