**DEPARTMENT OF TRANSPORTATION**

Contract #: 04-0120F4Cty: SF/ALA Rte: 80 PM: 13.2/13.9File #: 69.28**WELDING INSPECTION REPORT****Resident Engineer:** Pursell, Gary**Address:** 333 Burma Road**City:** Oakland, CA 94607**Report No:** WIR-013079**Date Inspected:** 23-Mar-2010**Project Name:** SAS Superstructure**OSM Arrival Time:** 700**Prime Contractor:** American Bridge/Fluor Enterprises, a JV**OSM Departure Time:** 1900**Contractor:** Zhenhua Port Machinery Company, Ltd (ZPMC), Changxing Island **Location:** Shanghai, China**CWI Name:** Mr. Wuzhi Cheng**CWI Present:** Yes No**Inspected CWI report:** Yes No N/A**Rod Oven in Use:** Yes No N/A**Electrode to specification:** Yes No N/A**Weld Procedures Followed:** Yes No N/A**Qualified Welders:** Yes No N/A**Verified Joint Fit-up:** Yes No N/A**Approved Drawings:** Yes No N/A**Approved WPS:** Yes No N/A**Delayed / Cancelled:** Yes No N/A**Bridge No:** 34-0006**Component:** Orthotropic Box Girder (OBG)**Summary of Items Observed:**

SEGMENT: 7AW-Panel Point (PP) # 47.5~48-Counter weight (CW) side.

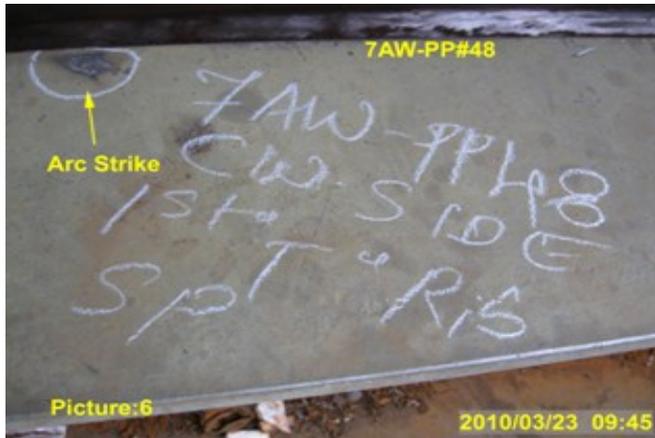
- One (1) Arc Strike on Segment 7AW -1st “T”Rib flange base metal. (See attached Picture: 6.)
- Two (2) Arc Strikes on Segment 7AW -2nd “T”Rib flange base metal. (See attached Picture: 5.)
- Nine (9) Arc Strikes on Segment 7AW –Longitudinal Diaphragm (LD 11B) base metal. (See attached Picture: 2, 3&4.)
- Two (2) Arc Strikes on Segment 7AW –floor beam web base metal (West side). (See attached Picture: 1.)
- SEGMENT: 7AW is located near the OBG TRIAL ASSEMBLY AREA.

“The surface defects such as pitting, arc strikes and compress marks shall be repaired by grinding and arc gouge excavation if necessary. The ground surface shall be transitioned smoothly. If the thickness after grinding is within the allowance shall have no need for repairing weld. Magnet Particle test shall be performed for the arc strike area after grinding for verifying no more defects.”
