DEPARTMENT OF TRANSPORTATION

Contract #: 04-0120F4Cty: SF/ALA Rte: 80 PM: 13.2/13.9File #: 69.28**WELDING INSPECTION REPORT****Resident Engineer:** Pursell, Gary**Address:** 333 Burma Road**City:** Oakland, CA 94607**Report No:** WIR-013087**Date Inspected:** 15-Mar-2010**Project Name:** SAS Superstructure**OSM Arrival Time:** 700**Prime Contractor:** American Bridge/Fluor Enterprises, a JV**OSM Departure Time:** 1900**Contractor:** Zhenhua Port Machinery Company, Ltd (ZPMC), Changxing Island **Location:** Shanghai, China

LAY DOWN YARD (North side of Bay#18&19).

SEGMENT: 9AW -Panel Point (PP) #72 &73.

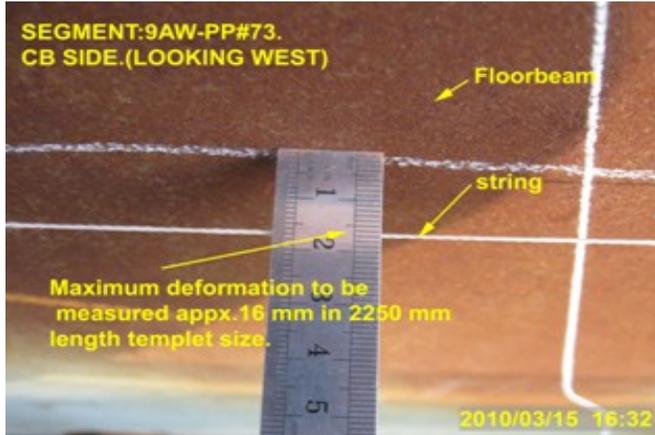
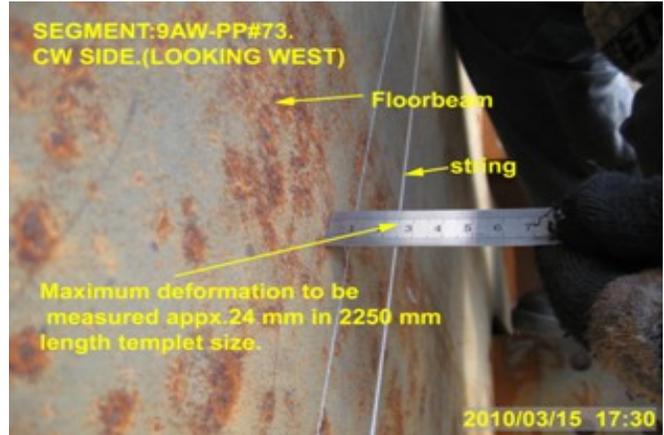
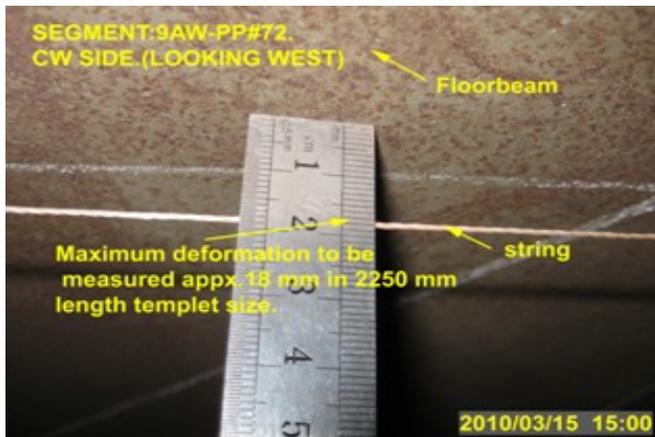
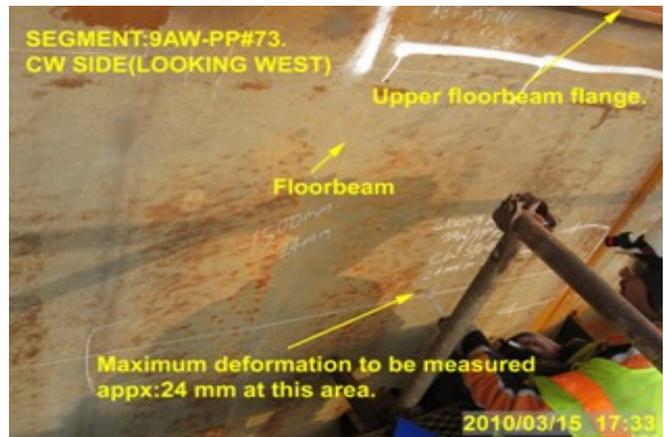
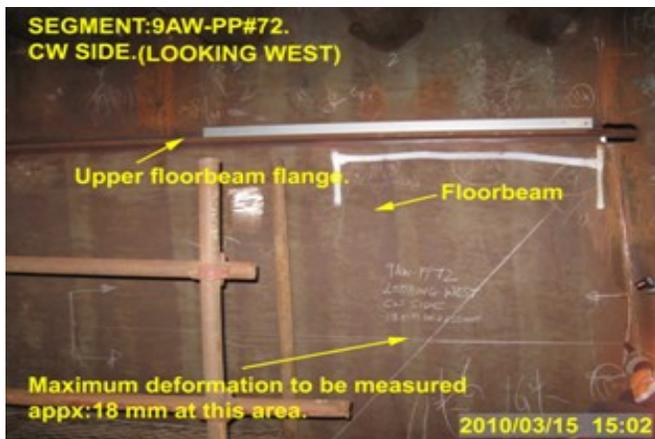
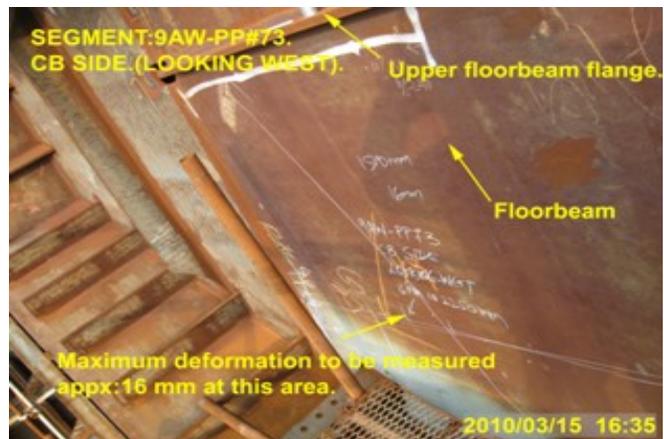
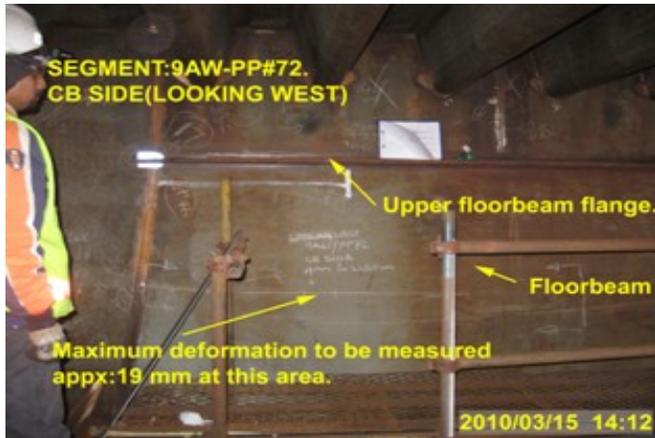
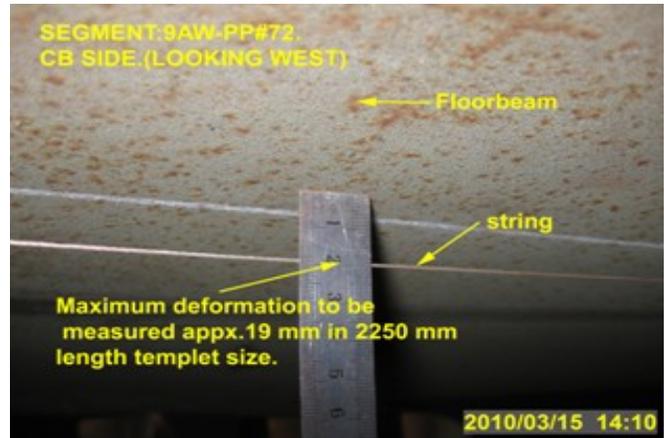
- The Deformation was measured to be approximately 19 mm in 2250 mm Maximum template size.
- The Segment and Panel Point no is 9AW-PP#72 Looking West at Crossbeam (CB) Side.
- The Deformation was measured to be approximately 18 mm in 2250 mm Maximum template size.
- The Segment and Panel Point no is 9AW-PP#72 Looking West at Counter Weight (CW) Side.

- The Deformation was measured to be approximately 24 mm in 2250 mm Maximum template size.
- The Segment and Panel Point no is 9AW-PP#73 Looking West at CW Side.

- The Deformation was measured to be approximately 16 mm in 2250 mm Maximum template size.
- The Segment and Panel Point no is 9AW-PP#73 Looking West at CB Side.

This QA generated a report on this date for the above issues and submitted to the Task Leader for further action. The attached photographs provide additional detail.
