Contract #: 04-0120F4Cty: SF/ALA Rte: 80 PM: 13.2/13.9File #: 69.28**WELDING INSPECTION REPORT****Resident Engineer:** Pursell, Gary**Address:** 333 Burma Road**City:** Oakland, CA 94607**Report No:** WIR-013088**Date Inspected:** 08-Mar-2010**Project Name:** SAS Superstructure**OSM Arrival Time:** 700**Prime Contractor:** American Bridge/Fluor Enterprises, a JV**OSM Departure Time:** 1900**Contractor:** Zhenhua Port Machinery Company, Ltd (ZPMC), Changxing Island **Location:** Shanghai, China**CWI Name:** Mr. Li Yang**CWI Present:** Yes No**Inspected CWI report:** Yes No N/A**Rod Oven in Use:** Yes No N/A**Electrode to specification:** Yes No N/A**Weld Procedures Followed:** Yes No N/A**Qualified Welders:** Yes No N/A**Verified Joint Fit-up:** Yes No N/A**Approved Drawings:** Yes No N/A**Approved WPS:** Yes No N/A**Delayed / Cancelled:** Yes No N/A**Bridge No:** 34-0006**Component:** Orthotropic Box Girder (OBG)**Summary of Items Observed:**

OBG TRIAL ASSEMBLY

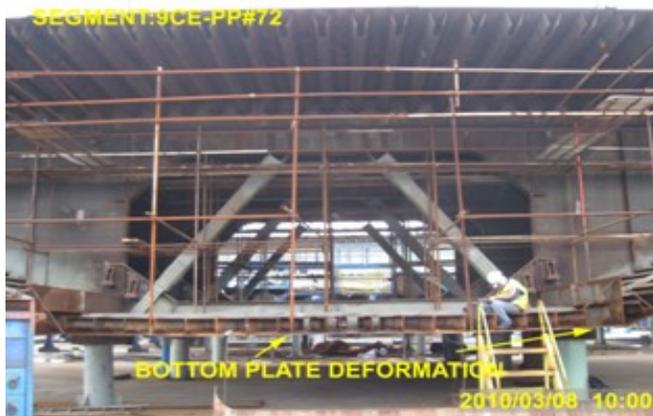
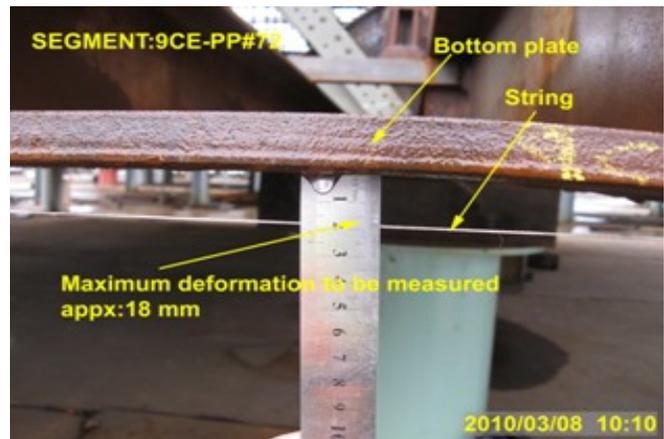
SEGMENT: 9CE -Panel Point (PP) #72.

This QA Inspector Randomly performed joint Inspection along with Caltrans QA Inspector Mr. Manoj Prabhune for the Skin flatness at Segment: 9CE - PP#72(Bottom plate). The following location is not comply with the contract document.

- The Deformation was measured to be approximately 18 mm Maximum.

This QA generated a report on this date for the above issue and submitted to the Task Leader for further action. The attached photographs provide additional detail.
