DEPARTMENT OF TRANSPORTATION

Contract #: 04-0120F4Cty: SF/ALA Rte: 80 PM: 13.2/13.9File #: 69.28**WELDING INSPECTION REPORT****Resident Engineer:** Pursell, Gary**Address:** 333 Burma Road**City:** Oakland, CA 94607**Report No:** WIR-013109**Date Inspected:** 16-Apr-2010**Project Name:** SAS Superstructure**OSM Arrival Time:** 700**Prime Contractor:** American Bridge/Fluor Enterprises, a JV**OSM Departure Time:** 1900**Contractor:** Zhenhua Port Machinery Company, Ltd (ZPMC), Changxing Island **Location:** Shanghai, China**CWI Name:** Li Yang**CWI Present:** Yes No**Inspected CWI report:** Yes No N/A**Rod Oven in Use:** Yes No N/A**Electrode to specification:** Yes No N/A**Weld Procedures Followed:** Yes No N/A**Qualified Welders:** Yes No N/A**Verified Joint Fit-up:** Yes No N/A**Approved Drawings:** Yes No N/A**Approved WPS:** Yes No N/A**Delayed / Cancelled:** Yes No N/A**Bridge No:** 34-0006**Component:** OBG**Summary of Items Observed:**

TRIAL ASSEMBLY YARD

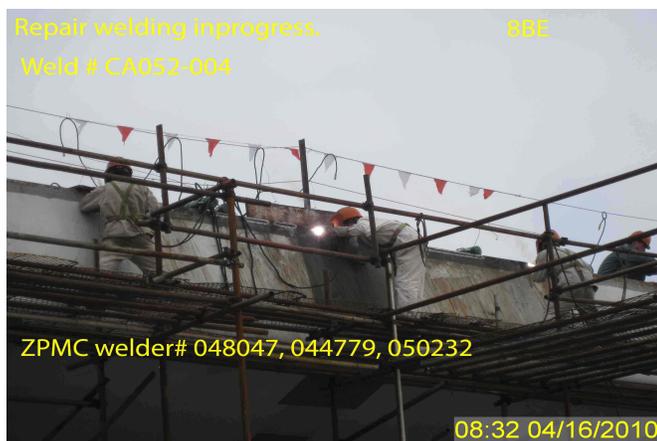
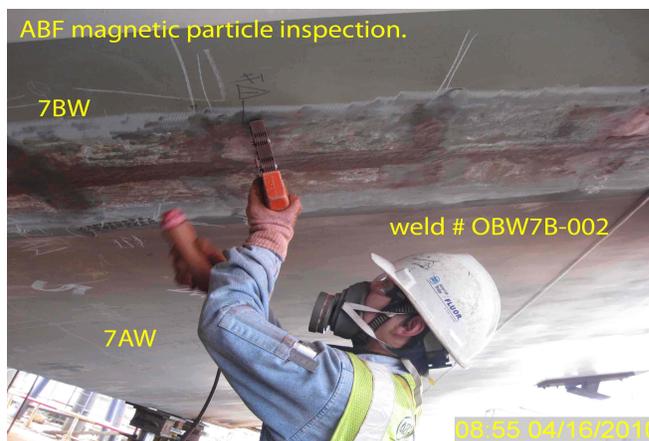
This QA Inspector Witnessed ABF personal performing Magnetic particle Testing (MT) on weld between deck panel and edge panel (bike path side) of OBG segment 7DE. Weld are identified as

CA042-004 (7DE- DP to EP, BP side)
