DEPARTMENT OF TRANSPORTATION

Contract #: 04-0120F4Cty: SF/ALA Rte: 80 PM: 13.2/13.9File #: 69.28**WELDING INSPECTION REPORT****Resident Engineer:** Pursell, Gary**Address:** 333 Burma Road**City:** Oakland, CA 94607**Report No:** WIR-013139**Date Inspected:** 23-Mar-2010**Project Name:** SAS Superstructure**OSM Arrival Time:** 700**Prime Contractor:** American Bridge/Fluor Enterprises, a JV**OSM Departure Time:** 1900**Contractor:** Zhenhua Port Machinery Company, Ltd (ZPMC), Changxing Island **Location:** Shanghai, China**CWI Name:****CWI Present:**

Bridge No: 34-0006**Component:** OBG Trial Assembly**Summary of Items Observed:**

Orthotropic Box Girder (OBG) Trial Assembly Areas

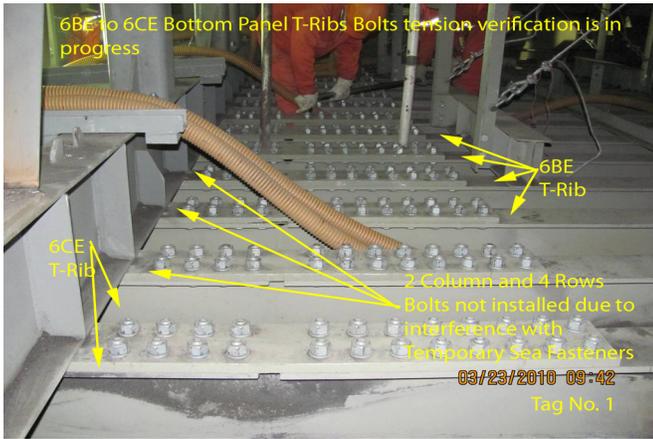
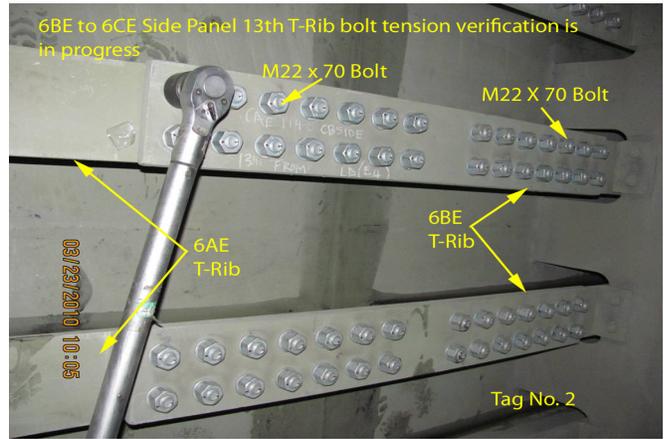
Note: Bottom Panel T-Ribs bolts at Segment 6BE Panel Point (PP) 43 (2 Columns and 4 Rows) bolts not installed and not offered for tension verification due the temporary sea fasteners interfering at that location. Please refer the pictures attached with Tag No. 1 below for more comprehensive detail.
