**DEPARTMENT OF TRANSPORTATION**

Contract #: 04-0120F4Cty: SF/ALA Rte: 80 PM: 13.2/13.9File #: 69.28**WELDING INSPECTION REPORT****Resident Engineer:** Pursell, Gary**Address:** 333 Burma Road**City:** Oakland, CA 94607**Report No:** WIR-013141**Date Inspected:** 21-Mar-2010**Project Name:** SAS Superstructure**OSM Arrival Time:** 700**Prime Contractor:** American Bridge/Fluor Enterprises, a JV**OSM Departure Time:** 1900**Contractor:** Zhenhua Port Machinery Company, Ltd (ZPMC), Changxing Island **Location:** Shanghai, China

<b>CWI Name:</b>	Li Yang and Wu Zhi Cheng	<b>CWI Present:</b>	Yes	No
<b>Inspected CWI report:</b>	Yes No N/A	<b>Rod Oven in Use:</b>	Yes	No N/A
<b>Electrode to specification:</b>	Yes No N/A	<b>Weld Procedures Followed:</b>	Yes	No N/A
<b>Qualified Welders:</b>	Yes No N/A	<b>Verified Joint Fit-up:</b>	Yes	No N/A
<b>Approved Drawings:</b>	Yes No N/A	<b>Approved WPS:</b>	Yes	No N/A
		<b>Delayed / Cancelled:</b>	Yes	No N/A
<b>Bridge No:</b>	34-0006	<b>Component:</b>	OBG Trial Assembly

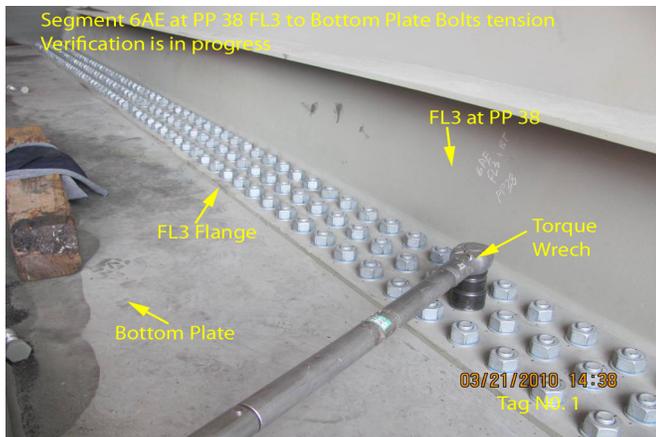
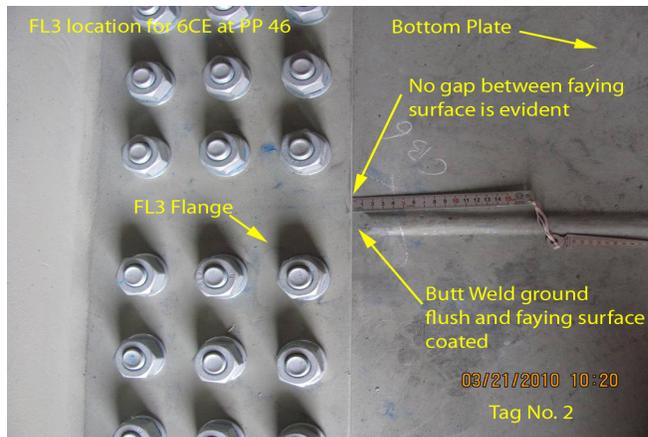
This Quality Assurance (QA) Inspector witnessed final tension verification for Bolts connecting FL3 flange to the Bottom Plate at Panel Point (PP) 38, PP 39 and PP 40 for Segment 6AE. Inspected bolts tension on a random basis and found the tension to be in general compliance. Inspection was performed against the Notification No. 00294 Dated March 21, 2010.

Note: 2 Column and 4 rows bolts not installed at FL3 flange to Bottom Panel next to Cross Beam 5 faying surface

at PP 38, PP 39 and PP 40 due to transportation purpose.

Please refer the attached pictures with Tag No. 1 for more comprehensive details.

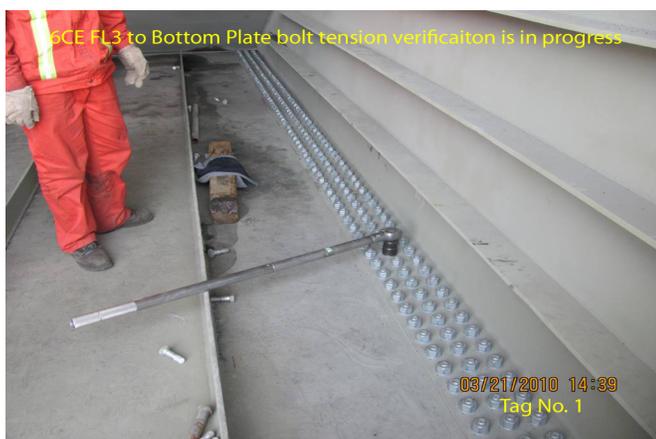
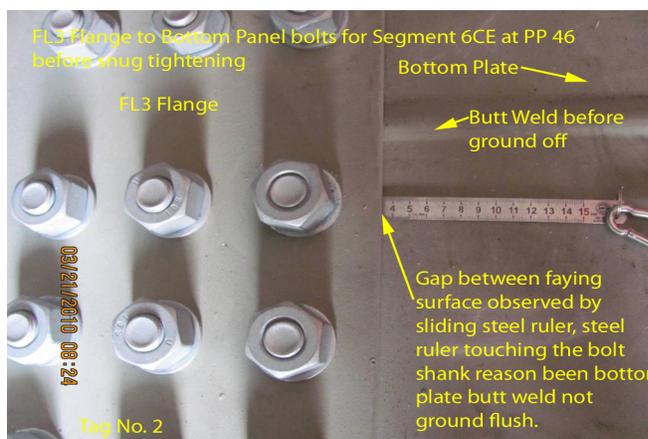
This Quality Assurance (QA) Inspector witnessed final tension verification for Bolts connecting FL3 flange to the Bottom Plate at Panel Point (PP) 44, PP 45 and PP 46 for Segment 6CE. ZPMC called for Snug Tight inspection during the Inspection it was observed gap between the Faying surface of Bottom Plate to the FL3 Flange reason been butt weld of the Bottom Panel which is not ground flush asked the ZPMC QC and ABF QC to ground flush the weld as done at PP 44 and PP 45 and then install bolt and snug tight. Inspection was carried out at that location and no gap was observed.

Please refer the attached pictures with Tag No. 2 for more comprehensive details.
