DEPARTMENT OF TRANSPORTATION

Quality Assurance and Source Inspection

Contract #: 04-0120F4Cty: SF/ALA Rte: 80 PM: 13.2/13.9File #: 69.28**WELDING INSPECTION REPORT****Resident Engineer:** Pursell, Gary**Address:** 333 Burma Road**City:** Oakland, CA 94607**Report No:** WIR-013154**Date Inspected:** 24-Mar-2010**Project Name:** SAS Superstructure**OSM Arrival Time:** 700**Prime Contractor:** American Bridge/Fluor Enterprises, a JV**OSM Departure Time:** 1900**Contractor:** Zhenhua Port Machinery Company, Ltd (ZPMC), Changxing Island **Location:** Shanghai, China**CWI Name:** Li Yang**CWI Present:** Yes No**Inspected CWI report:** Yes No N/A**Rod Oven in Use:** Yes No N/A**Electrode to specification:** Yes No N/A**Weld Procedures Followed:** Yes No N/A**Qualified Welders:** Yes No N/A**Verified Joint Fit-up:** Yes No N/A**Approved Drawings:** Yes No N/A**Approved WPS:** Yes No N/A**Delayed / Cancelled:** Yes No N/A**Bridge No:** 34-0006**Component:** OBG Segment**Summary of Items Observed:**

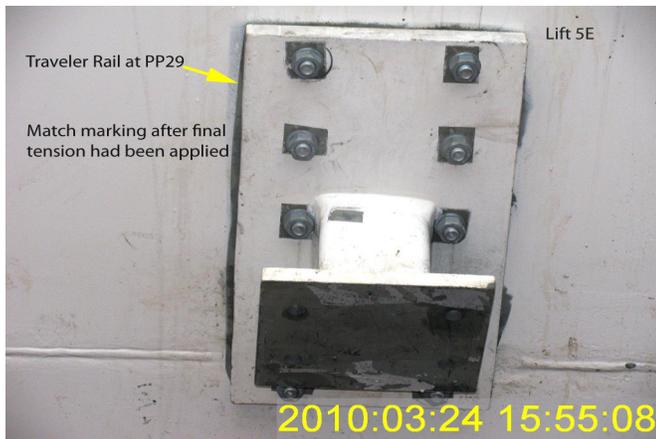
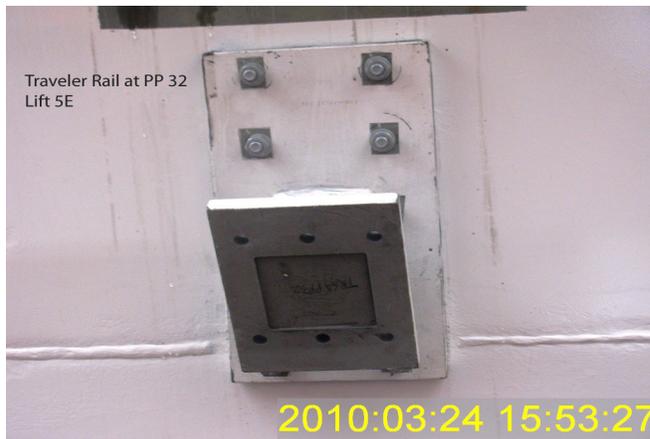
The Caltrans Quality Assurance (QA) Inspector observed that the tightening of the bolts were not performed per the approved procedure.

- Marking bolts after final tension had been applied at Traveler Rail located at PP 29.
- ZPMC workers were performing final bolt tightening of ASTM A325 bolts by turn-of-nut specification of 180° to 210°.
- This issue is located at Lift 5E Traveler Rail at PP 29 to PP 36 (Bike path side)

The incident report is issued for the above mentioned discrepancy observed in Lift 5E. And prior to issue it was informed to ZPMC QC and ABF QA.
