**DEPARTMENT OF TRANSPORTATION**

Contract #: 04-0120F4Cty: SF/ALA Rte: 80 PM: 13.2/13.9File #: 69.28**WELDING INSPECTION REPORT****Resident Engineer:** Pursell, Gary**Address:** 333 Burma Road**City:** Oakland, CA 94607**Report No:** WIR-013175**Date Inspected:** 14-Apr-2010**Project Name:** SAS Superstructure**OSM Arrival Time:** 700**Prime Contractor:** American Bridge/Fluor Enterprises, a JV**OSM Departure Time:** 1900**Contractor:** Zhenhua Port Machinery Company, Ltd (ZPMC), Changxing Island **Location:** Shanghai, China**CWI Name:** Li Yang**CWI Present:** Yes No**Inspected CWI report:** Yes No N/A**Rod Oven in Use:** Yes No N/A**Electrode to specification:** Yes No N/A**Weld Procedures Followed:** Yes No N/A**Qualified Welders:** Yes No N/A**Verified Joint Fit-up:** Yes No N/A**Approved Drawings:** Yes No N/A**Approved WPS:** Yes No N/A**Delayed / Cancelled:** Yes No N/A**Bridge No:** 34-0006**Component:** OBG**Summary of Items Observed:**

## WELDING INSPECTION REPORT

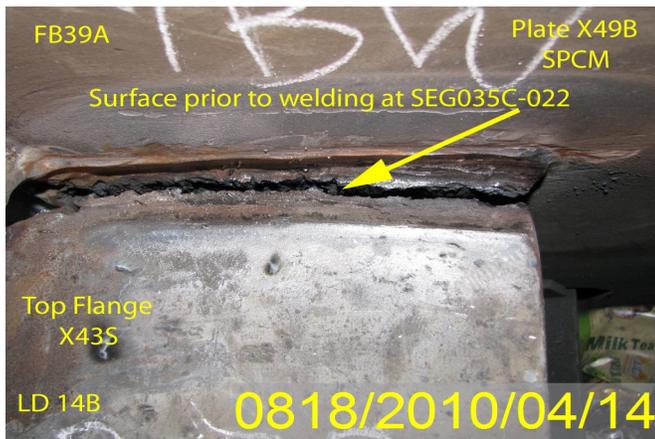
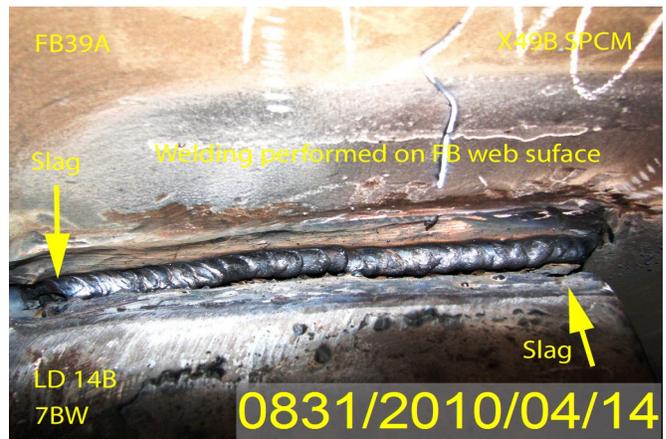
This QA Inspector observed ZPMC welding personnel had commenced a Critical Weld Repair (CWR) on Seismic Performance Critical Material (SPCM) without an approved Critical Weld Repair procedure and prior to properly preparing the joint. The following information of incident is as followed: Weld joint is identified as SEG035C-022 which is joining the top flange (X43S) of longitudinal diaphragm identified as LD14B to floor beam web (X49B SPCM) identified as FB39A. This location is at panel point 50 cross beam side of segment. This QA Inspector issued an incident for today's work shift.
