DEPARTMENT OF TRANSPORTATION

Contract #: 04-0120F4Cty: SF/ALA Rte: 80 PM: 13.2/13.9File #: 69.28**WELDING INSPECTION REPORT****Resident Engineer:** Pursell, Gary**Address:** 333 Burma Road**City:** Oakland, CA 94607**Report No:** WIR-013183**Date Inspected:** 27-Mar-2010**Project Name:** SAS Superstructure**OSM Arrival Time:** 700**Prime Contractor:** American Bridge/Fluor Enterprises, a JV**OSM Departure Time:** 1900**Contractor:** Zhenhua Port Machinery Company, Ltd (ZPMC), Changxing Island **Location:** Shanghai, China**CWI Name:** Li Yang**CWI Present:** Yes No**Inspected CWI report:** Yes No N/A**Rod Oven in Use:** Yes No N/A**Electrode to specification:** Yes No N/A**Weld Procedures Followed:** Yes No N/A**Qualified Welders:** Yes No N/A**Verified Joint Fit-up:** Yes No N/A**Approved Drawings:** Yes No N/A**Approved WPS:** Yes No N/A**Delayed / Cancelled:** Yes No N/A**Bridge No:** 34-0006**Component:** OBG**Summary of Items Observed:**

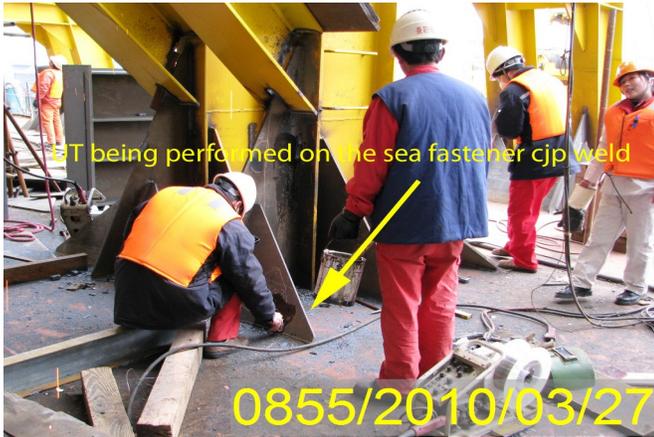
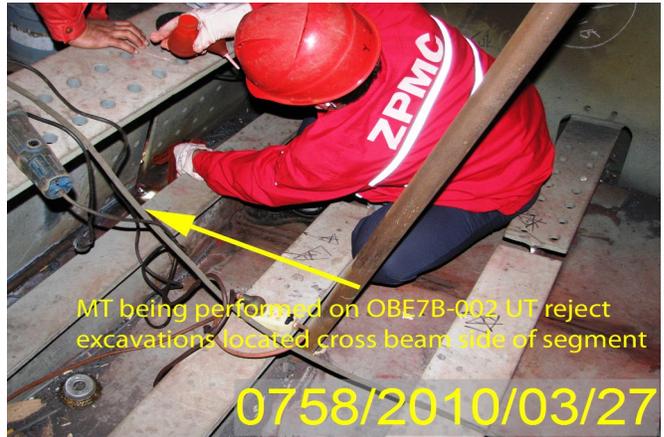
Shield Metal Arc Welding (SMAW) repair welding was performed on deck plate weld joint 003 located at OBE7 bike path of segment. Welder is identified as Mr. Li Zhengxu (066361). ZPMC QC is identified as Li Yang. The welding variables monitored and recorded by the QC appeared to comply with WPS-345-SMAW-4G (4F)-FCM-Repair-1 and WR1345 repair procedure.

Shield Metal Arc Welding (SMAW) repair welding was performed on weld joint 001 located at OBE7 cross beam side of segment. Welder is identified as Mr. Han Xiaofeng (054467). ZPMC QC is identified as Li Yang. The welding variables monitored and recorded by the QC appeared to comply with WPS-345-SMAW-3G (3F)-FCM-Repair-1 and WR1345 repair procedure.

Shield Metal Arc Welding (SMAW) repair welding was performed on weld joint 003 located at OBE7B bike path side of segment. Welder is identified as Mr. Han Xiaofeng (054467). ZPMC QC is identified as Li Yang. The welding variables monitored and recorded by the QC appeared to comply with WPS-345-SMAW-1G (1F)-FCM-Repair-1 and WR1345 repair procedure.

Shield Metal Arc Welding (SMAW) repair welding was performed on weld joint 003 located at OBE7B bike path side of segment. Welder is identified as Mr. Li Zhengxu (066179). ZPMC QC is identified as Li Yang. The welding variables monitored and recorded by the QC appeared to comply with WPS-345-SMAW-1G (1F)-FCM-Repair-1 and WR1345 repair procedure.
