DEPARTMENT OF TRANSPORTATION

Contract #: 04-0120F4Cty: SF/ALA Rte: 80 PM: 13.2/13.9File #: 69.28**WELDING INSPECTION REPORT****Resident Engineer:** Pursell, Gary**Address:** 333 Burma Road**City:** Oakland, CA 94607**Report No:** WIR-013185**Date Inspected:** 05-Apr-2010**Project Name:** SAS Superstructure**OSM Arrival Time:** 700**Prime Contractor:** American Bridge/Fluor Enterprises, a JV**OSM Departure Time:** 1900**Contractor:** Zhenhua Port Machinery Company, Ltd (ZPMC), Changxing Island **Location:** Shanghai, China**CWI Name:** Li Yang**CWI Present:** Yes No**Inspected CWI report:** Yes No N/A**Rod Oven in Use:** Yes No N/A**Electrode to specification:** Yes No N/A**Weld Procedures Followed:** Yes No N/A**Qualified Welders:** Yes No N/A**Verified Joint Fit-up:** Yes No N/A**Approved Drawings:** Yes No N/A**Approved WPS:** Yes No N/A**Delayed / Cancelled:** Yes No N/A**Bridge No:** 34-0006**Component:** OBG**Summary of Items Observed:**

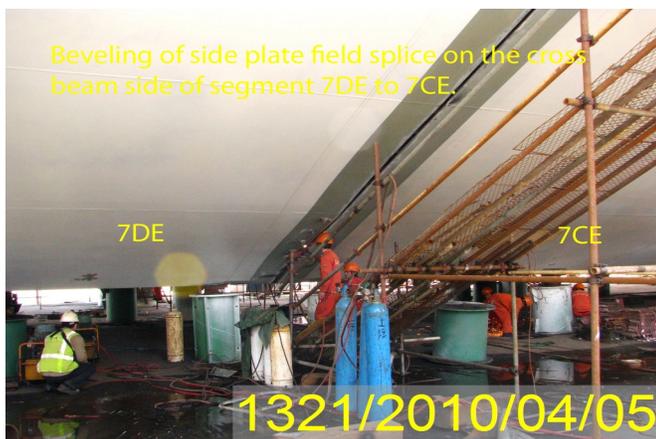
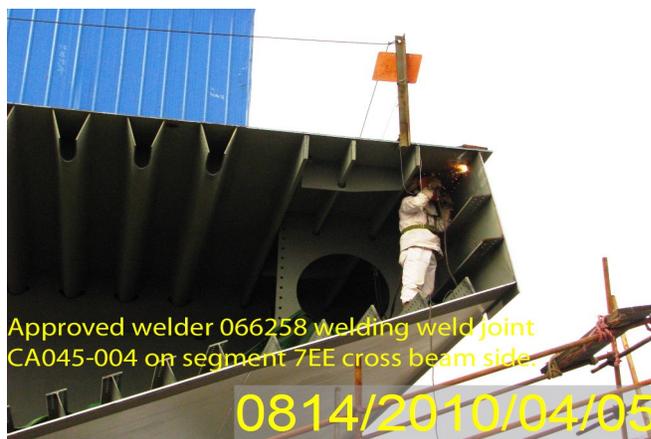
QA Inspector observed ZPMC's personnel performing various job functions at Trail Assembly yard. Locations and description of work are as followed:

1. Observed heat straightening in progress at various side plate t stiffeners per HSR1 (B)-8235 procedure.

1. Observed beveling of the deck plate, side plate (crossbeam & bike path side) and bottom plate for welding.
