DEPARTMENT OF TRANSPORTATION

Contract #: 04-0120F4Cty: SF/ALA Rte: 80 PM: 13.2/13.9File #: 13.28**WELDING INSPECTION REPORT****Resident Engineer:** Pursell, Gary**Address:** 333 Burma Road**City:** Oakland, CA 94607**Report No:** WIR-013192**Date Inspected:** 15-Apr-2010**Project Name:** SAS Superstructure**OSM Arrival Time:** 1000**Prime Contractor:** American Bridge/Fluor Enterprises, a JV**OSM Departure Time:** 1830**Contractor:** Oregon Iron Works Clackamas, Or.**Location:** Clackamas, OR

CWI Name:	M. Gregson, J. Salazar, G. Mundt	CWI Present:	Yes	No			
Inspected CWI report:	Yes	No	N/A	Rod Oven in Use:	Yes	No	N/A
Electrode to specification:	Yes	No	N/A	Weld Procedures Followed:	Yes	No	N/A
Qualified Welders:	Yes	No	N/A	Verified Joint Fit-up:	Yes	No	N/A
Approved Drawings:	Yes	No	N/A	Approved WPS:	Yes	No	N/A
				Delayed / Cancelled:	Yes	No	N/A
Bridge No:	34-0006	Component:	Hinge K Pipe Beams

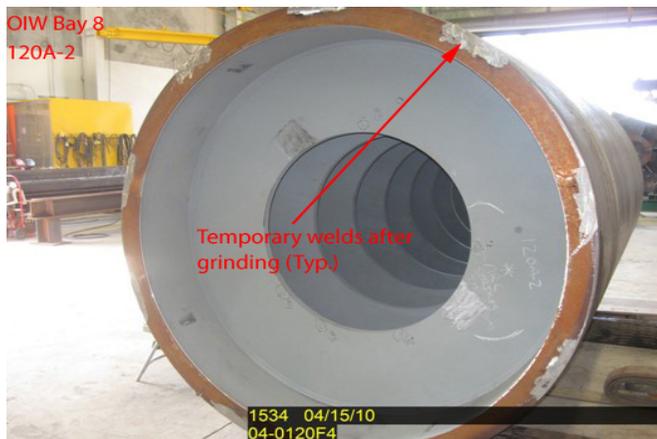
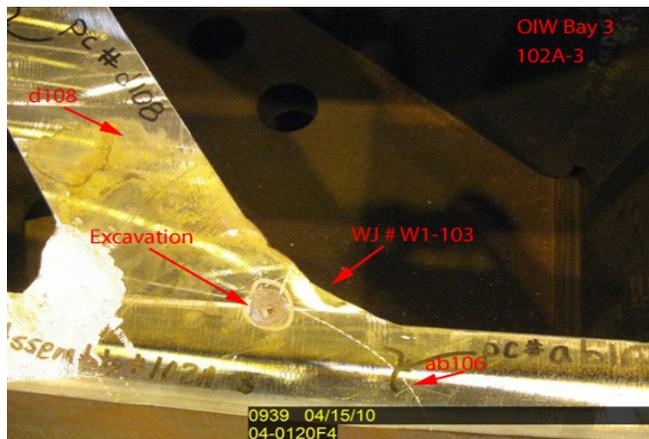
Hinge-K Pipe Beam Assembly 120A-2:

The QA Inspector witnessed WID #F17 (Igor Frolov), removing the temporary ring, on the end of the Fuse 120A-2. The QA Inspector noted that OIW had previously tack welded this ring to the end of the Fuse, to accommodate a fit on the mechanical rollers, during the Electroslag Welding (ESW) and overlay repairs. The QA Inspector noted that WID #F17 was utilizing a hand held oxygen acetylene cutting torch, to cut the temporary tack welds. WID #F17 explained to the QA Inspector that he was currently removing the last two tacks and he will then grind the areas flush, to the adjacent base metal. The QA Inspector later witnessed WID #F17 grinding the areas flush, utilizing a hand held mechanical grinder, with an attached 9" disc. WID #F17 explained that he will continue to perform the grinding on the tack welds and then will grind on the arc strikes which are present on the a125 ring stiffener. The QA Inspector noted that the arc strikes were due to improper placement of the welding ground clamp, during the previous overlay repairs at AG Machine Works. The QA Inspector noted that there were a total of 8 arc strike areas on the stiffener and that once ground to sound metal, 100 % Visual and Magnetic Particle (VT/MT) will be performed by OIW QC personell. The QA Inspector noted that per AWS D1.5, that a Brinell hardness test will also be performed. The QA Inspector noted that this Fuse will eventually be transferred to AG Machine Works, for final machining of the overlay and final facing of the end, in which the temporary ring was removed. See attached pictures below.
