**DEPARTMENT OF TRANSPORTATION**

Contract #: 04-0120F4Cty: SF/ALA Rte: 80 PM: 13.2/13.9File #: 13.28**WELDING INSPECTION REPORT****Resident Engineer:** Pursell, Gary**Address:** 333 Burma Road**City:** Oakland, CA 94607**Report No:** WIR-013193**Date Inspected:** 16-Apr-2010**Project Name:** SAS Superstructure**OSM Arrival Time:** 1000**Prime Contractor:** American Bridge/Fluor Enterprises, a JV**OSM Departure Time:** 1830**Contractor:** Oregon Iron Works Clackamas, Or.**Location:** Clackamas, OR

**Bridge No:** 34-0006**Component:** Hinge K Pipe Beams**Summary of Items Observed:**

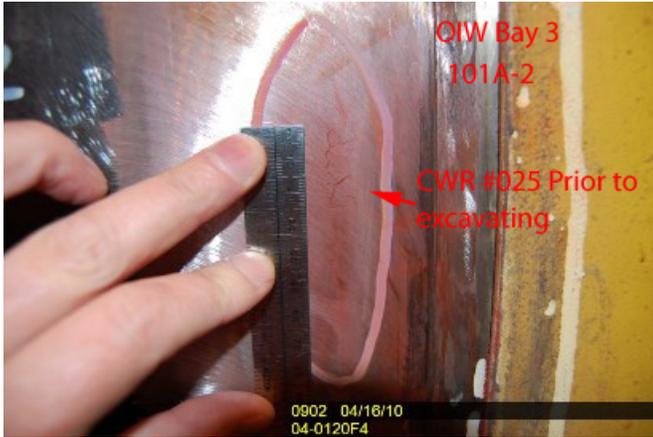
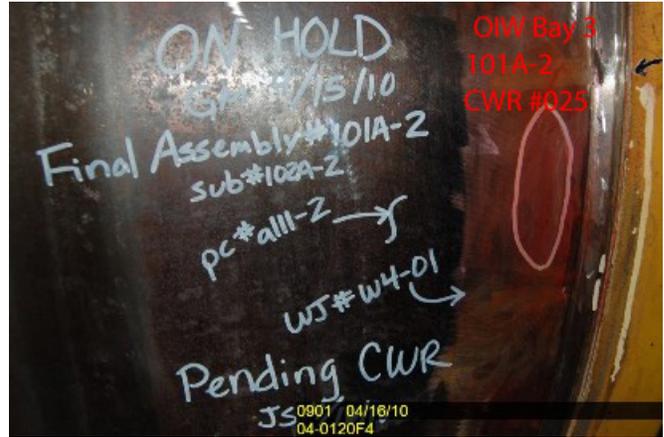
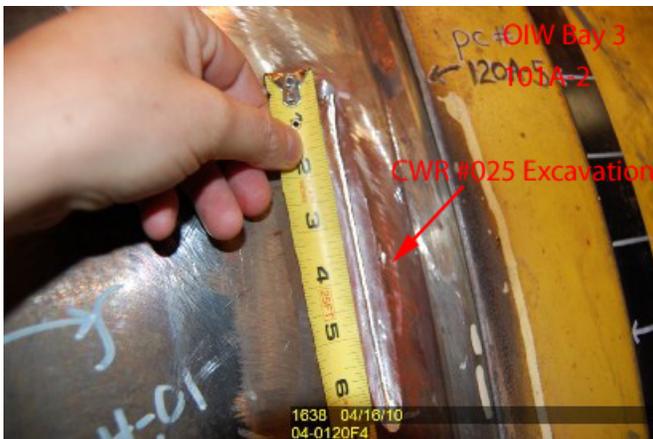
The QA Inspector was present to witness WID #V7 (Vincent Vue) setting up to perform the excavation, on the CWR #2244-025. The QA Inspector noted that this was the Complete Joint Penetration, AWS D1.5 B-U7-S 120A-5 Fuse to 102A-2 Forging, Weld Joint #WM4-1. The QA Inspector witnessed WID #V7 applying pre-heat, utilizing a hand held torch and witnessed QC Inspector Gary Mundt performing a pre-heat check, prior to carbon arcing. QC Inspector Mundt explained that the pre-heat was at the minimum of 150 degrees Fahrenheit and the QA Inspector verified this. The QA Inspector then witnessed WID #V7 perform the carbon arc and then grinding the excavated area to sound base metal. The QA Inspector then witnessed QC Inspector Mundt measuring the completed backgouge and perform Visual and Magnetic Particle Testing (VT/MT) on the completed backgouged area. QC Inspector Mundt explained that no rejectable indications were found. The QA Inspector then performed VT/MT on the backgouge and found no rejectable indications. The QA Inspector measured the area to be as follows: 171 long x 10 mm wide x 11 mm deep. The QA Inspector noted that WID #V7 had performed the excavation on the crack and continued the excavation 60 mm on each side of the crack. The QA Inspector noted that per AWS D1.5 Sect. 3.7.2.4, "The metal shall be removed for the full length of the crack plus 50 mm each end of the crack and rewelded". The QA Inspector was then informed by QC Inspector Mundt that WID #V7, will be setting up to perform the Flux Core Arc Welding (FCAW), on the repair. QC Inspector Mundt explained that Welding Procedure Specification (WPS) 3048, will be utilized for the repair and he will be present the entire shift, to monitor the welding parameters and pre/post-heat, during and after the FCAW. See attached pictures below.

The QA Inspector spoke with Swing Shift QC Inspector Gary Mundt and he explained that WID #V7 (Vincent Vue) had visually discovered the crack, on the previous swing shift, during the grinding flush of the exterior weld joint cap, #WM4-1. QC Inspector Mundt explained that WID #V7 had notified him of the crack and QC Inspector Mundt then performed Magnetic Particle Testing (MT) on the area and the testing clearly revealed the crack. QC Inspector Mundt explained that he then marked on the part as "QC Hold" and then performed additional informal MT on the remaining cap and found no additional indications.

The QA Inspector was informed by Lead QA Inspector Joe Adame that Lead QC Inspector Mike Gregson had informed him, of the crack discovered in the weld Joint #WM4-1, on assembly 101A-2. QA Inspector Adame explained that OIW production is requesting to proceed with the Critical Weld Repair (CWR) 32244-025. QA Inspector Adame explained that he had spoke with Robert Mertz and Mr. Mertz explained that OIW may start the

repair after a preliminary submittal of the CWR report, which will include a Description of Condition, Cause and Disposition to correct the issue from re-occurrence, etc. QA Inspector Adame explained that Lead QC Inspector Mike Gregson had provided a preliminary copy of the CWR report and after corrections were made, a verbal to proceed with the repair was granted, per Robert Mertz. QA Inspector Adame explained that OIW has agreed to formally submit the CWR, which will include pictures and drawings, on 4/19/10.
