DEPARTMENT OF TRANSPORTATION

Contract #: 04-0120F4Cty: SF/ALA Rte: 80 PM: 13.2/13.9File #: 69.28**WELDING INSPECTION REPORT****Resident Engineer:** Pursell, Gary**Address:** 333 Burma Road**City:** Oakland, CA 94607**Report No:** WIR-013201**Date Inspected:** 07-Feb-2010**Project Name:** SAS Superstructure**OSM Arrival Time:** 7000**Prime Contractor:** American Bridge/Fluor Enterprises, a JV**OSM Departure Time:** 1900**Contractor:** Zhenhua Port Machinery Company, Ltd (ZPMC), Changxing Island **Location:** Shanghai, China

Segment 9CE

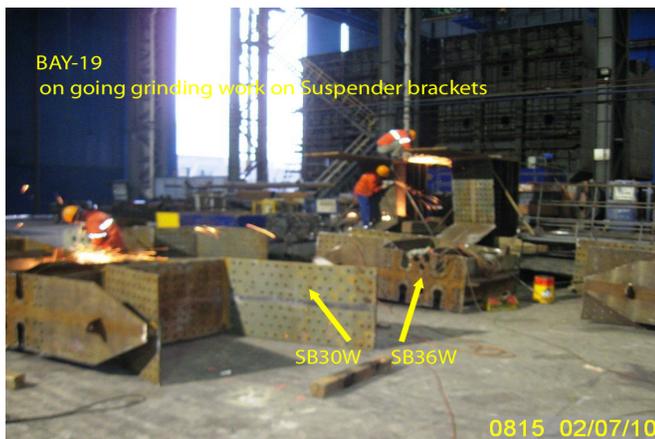
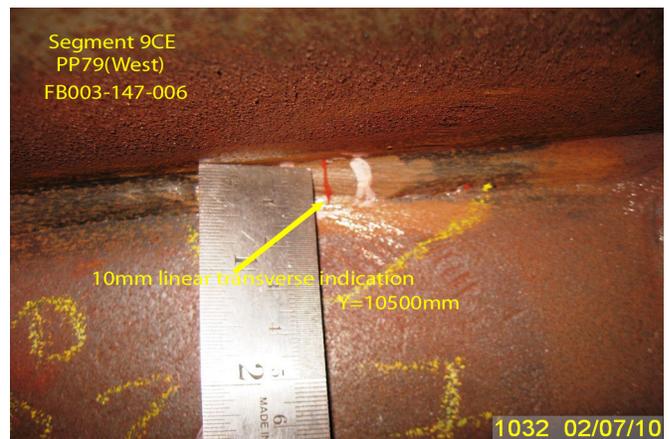
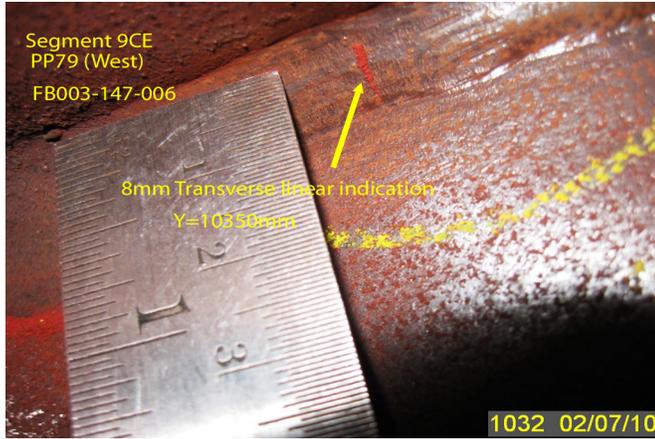
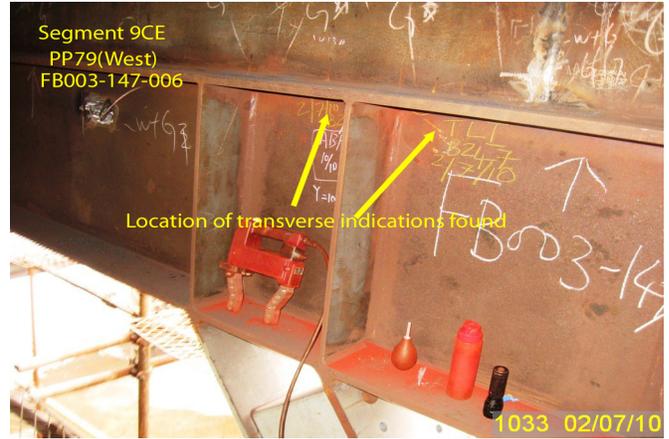
1)PP75-FB003-147 – 006.

-During in process visual inspection of the above mentioned weld, this QA observed Two (2) transverse indications.

-This was confirmed with MT wherein, One (1) transverse crack measuring approximately 10 mm length. Second (1) transverse crack measuring approximately 8mm length respectively were observed.

-The above mentioned welds were previously Magnetic Particle Testing (MT) tested and accepted by ZPMC Quality Control (QC) personnel.

-The member(s) are identified as OBG components – Floor Beam & Floor Beam Flange on PP79 west side.

During the Quality Assurance Magnetic particle Testing (MT) review of welds located on OBG Segment 9CE, this Quality Assurance Inspector (QA) discovered the following issue:

-Two (2) linear transverse indication that measured approximately 10mm and 08mm in length.
