DEPARTMENT OF TRANSPORTATION

Contract #: 04-0120F4Cty: SF/ALA Rte: 80 PM: 13.2/13.9File #: 69.28**WELDING INSPECTION REPORT****Resident Engineer:** Pursell, Gary**Address:** 333 Burma Road**City:** Oakland, CA 94607**Report No:** WIR-013257**Date Inspected:** 03-Apr-2010**Project Name:** SAS Superstructure**OSM Arrival Time:** 700**Prime Contractor:** American Bridge/Fluor Enterprises, a JV**OSM Departure Time:** 1900**Contractor:** Zhenhua Port Machinery Company, Ltd (ZPMC), Changxing Island **Location:** Shanghai, China

WELDING INSPECTION REPORT

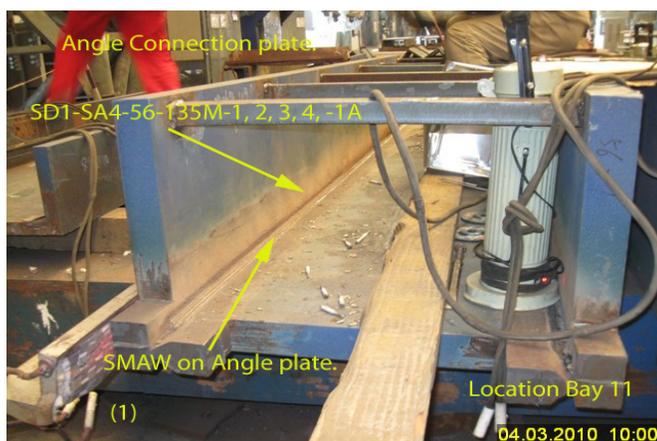
This QA Inspector observed ZPMC qualified welding personnel identified as 040614, 040667. Perform Shielded Metal Arc Welding (SMAW) on lift 4 Angle connection plate. Joint identified as SD1-SA4-56-135M-1, 2, 3, 4-1A. ZPMC CWI Identified as An Qing Xiang, The welding parameters as measured using QC's calibrated instrument appeared to be in general compliance with WPS-B-T-3211-Tc-U5b-1. For more information see below attached photo No-1.

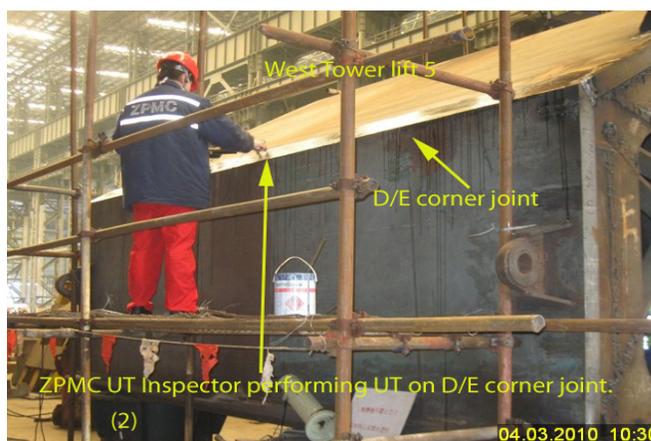
This QA Inspector observed during random Visual inspection ZPMC Ultrasonic Testing (UT) inspector performing UT on West Tower lift 5 D/E corner joint. For more information see below attached photo No-2.
