DEPARTMENT OF TRANSPORTATION

Contract #: 04-0120F4Cty: SF/ALA Rte: 80 PM: 13.2/13.9File #: 69.28**WELDING INSPECTION REPORT****Resident Engineer:** Pursell, Gary**Address:** 333 Burma Road**City:** Oakland, CA 94607**Report No:** WIR-013294**Date Inspected:** 17-Mar-2010**Project Name:** SAS Superstructure**OSM Arrival Time:** 700**Prime Contractor:** American Bridge/Fluor Enterprises, a JV**OSM Departure Time:** 1900**Contractor:** Zhenhua Port Machinery Company, Ltd (ZPMC), Changxing Island **Location:** Shanghai, China**CWI Name:** Yu Dong Ping, Tu Jun**CWI Present:** Yes No**Inspected CWI report:** Yes No N/A**Rod Oven in Use:** Yes No N/A**Electrode to specification:** Yes No N/A**Weld Procedures Followed:** Yes No N/A**Qualified Welders:** Yes No N/A**Verified Joint Fit-up:** Yes No N/A**Approved Drawings:** Yes No N/A**Approved WPS:** Yes No N/A**Delayed / Cancelled:** Yes No N/A**Bridge No:** 34-0006**Component:** Tower**Summary of Items Observed:**

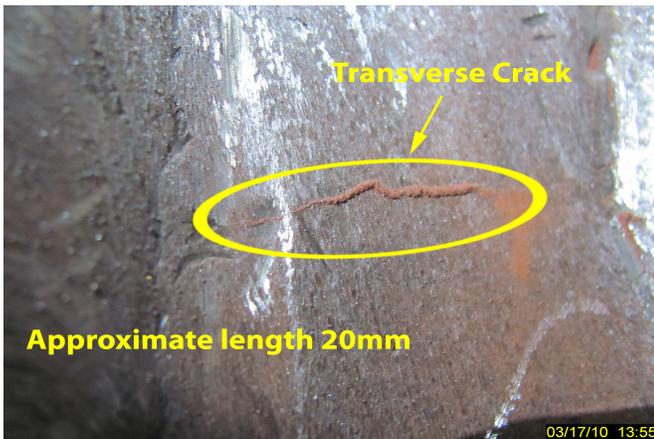
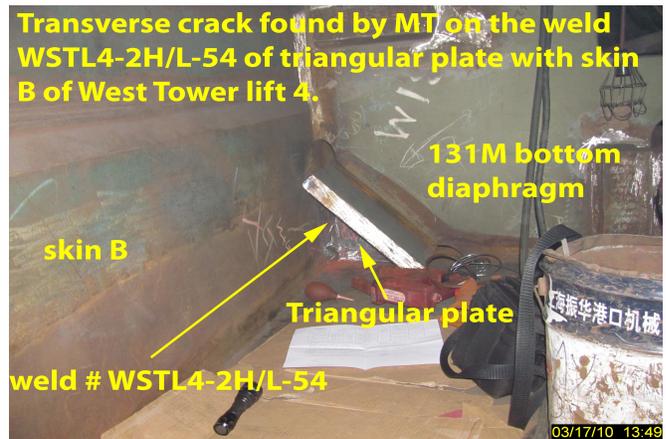
During the Quality Assurance Magnetic Particle Testing (MT) review of welds located on West Tower Lift 4, weld number WSTL4-2H/L-54, this Quality Assurance (QA) Inspector discovered one (1) transverse crack found on the weld measuring approximately 20mm in length. The weld is identified as: WSTL4-2H/L-54. The Weld is a fillet weld joining the triangular plate with skin B. The member is located in Bay 11

The Notice of Witness Inspection Number (NWIT) is 005362. The indication is located outside the area that has been previously tested and accepted by ZPMC Quality Control (QC) personnel. The attached photographs provide additional detail. This issue has an incident report.
