DEPARTMENT OF TRANSPORTATION

Quality Assurance and Source Inspection

Contract #: 04-0120F4Cty: SF/ALA Rte: 80 PM: 13.2/13.9File #: 69.28**WELDING INSPECTION REPORT****Resident Engineer:** Pursell, Gary**Address:** 333 Burma Road**City:** Oakland, CA 94607**Report No:** WIR-013301**Date Inspected:** 06-Apr-2010**Project Name:** SAS Superstructure**OSM Arrival Time:** 700**Prime Contractor:** American Bridge/Fluor Enterprises, a JV**OSM Departure Time:** 1900**Contractor:** Zhenhua Port Machinery Company, Ltd (ZPMC), Changxing Island **Location:** Shanghai, China**CWI Name:** An Qing Xiang, Tu Jun**CWI Present:** Yes No**Inspected CWI report:** Yes No N/A**Rod Oven in Use:** Yes No N/A**Electrode to specification:** Yes No N/A**Weld Procedures Followed:** Yes No N/A**Qualified Welders:** Yes No N/A**Verified Joint Fit-up:** Yes No N/A**Approved Drawings:** Yes No N/A**Approved WPS:** Yes No N/A**Delayed / Cancelled:** Yes No N/A**Bridge No:** 34-0006**Component:** Tower**Summary of Items Observed:**

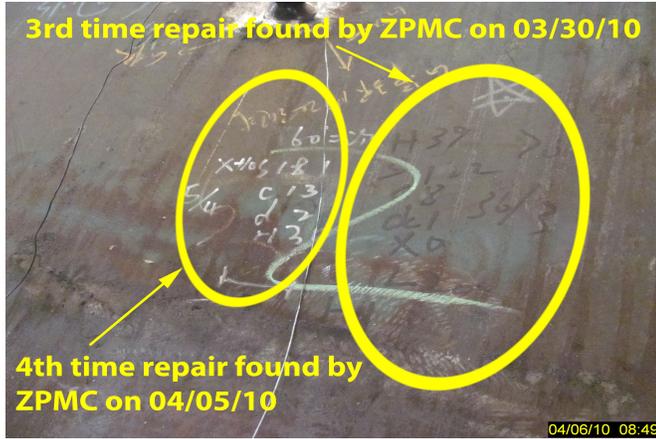
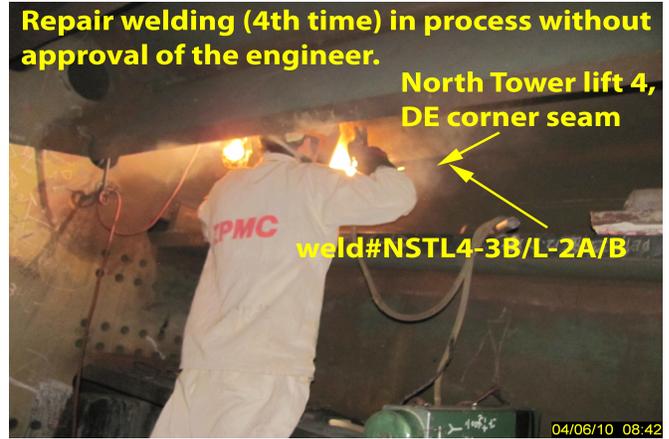
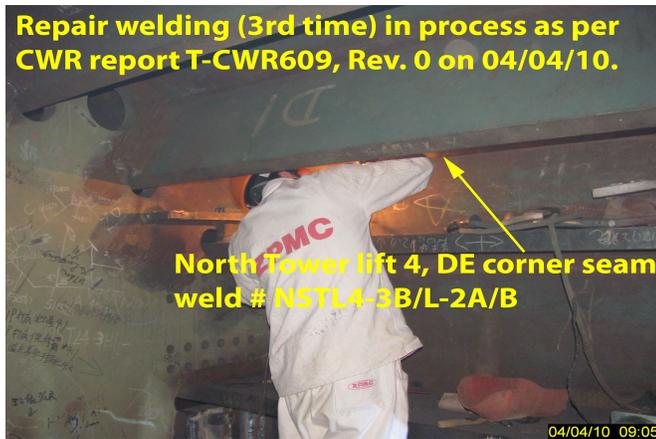
During random in-process verification of D/E corner seam of North Tower lift 4, this QA Inspector observed Shielded Metal Arc Welding (SMAW) for repair on D/E corner seam of North Tower lift 4. This repair welding (4th time) has been performed without prior approval of the engineer. This repair was previously (3rd time) performed on the same location as per CWR report T-CWR609, Rev. 0 on dated 04th April 2009. ZPMC NDT personnel rejected the 3rd time repair by Ultrasonic Testing (UT) at this same location. The weld number is identified as NSTL4-3B/L-2A/B. The Y location of the repair is identified as 1630. The welder is identified as #052493. The member is located in Bay 10. This issue has an incident report.

The attached photographs provide additional detail.
