DEPARTMENT OF TRANSPORTATION

Quality Assurance and Source Inspection

Contract #: 04-0120F4Cty: SF/ALA Rte: 80 PM: 13.2/13.9File #: 1x.28**WELDING INSPECTION REPORT****Resident Engineer:** Pursell, Gary**Address:** 333 Burma Road**City:** Oakland, CA 94607**Report No:** WIR-013404**Date Inspected:** 22-Apr-2010**Project Name:** SAS Superstructure**OSM Arrival Time:** 1100**Prime Contractor:** American Bridge/Fluor Enterprises, a JV**OSM Departure Time:** 1930**Contractor:** American Bridge/Fluor Enterprises, a JV**Location:** Job Site

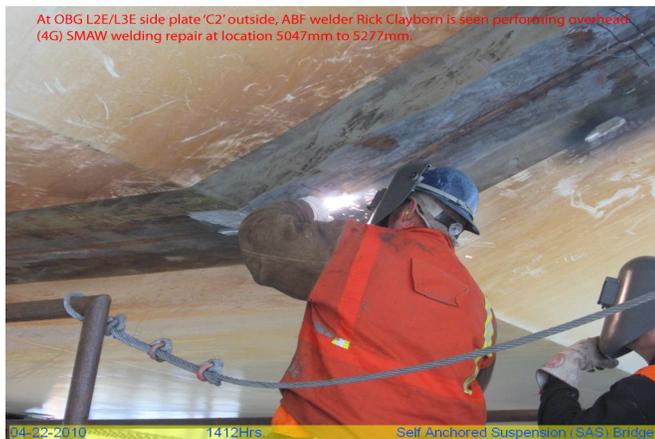
04-22-2010 1412Hrs Self Anchored Suspension (SAS) Bridge

At OBG L2E/L3E side plate 'C2' outside, ABF welder Rick Clayborn is seen performing overhead (4G) SMAW welding repair at location 5047mm to 5277mm.

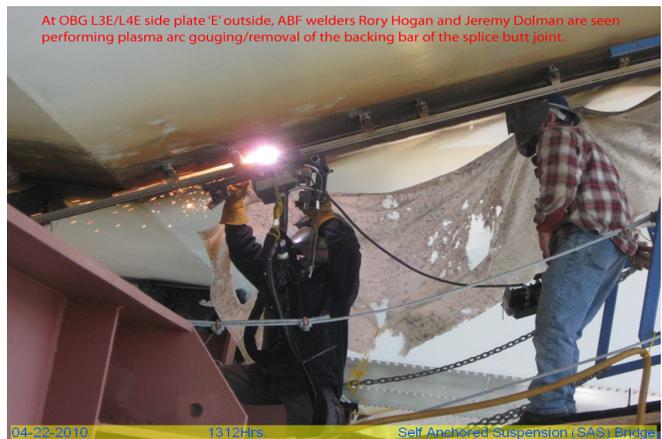
04-22-2010 1312Hrs Self Anchored Suspension (SAS) Bridge

At OBG L3E/L4E side plate 'E' outside, ABF welders Rory Hogan and Jeremy Dolman are seen performing plasma arc gouging/removal of the backing bar of the splice butt joint.

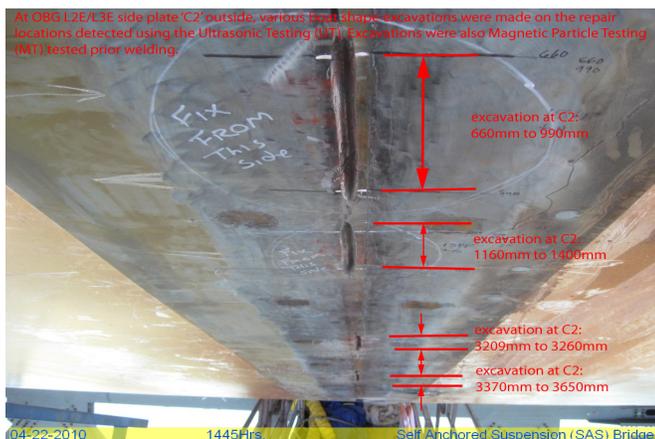
04-22-2010 1445Hrs Self Anchored Suspension (SAS) Bridge

At OBG L2E/L3E side plate 'C2' outside, various boat shape excavations were made on the repair locations detected using the Ultrasonic Testing (UT). Excavations were also Magnetic Particle Testing (MT) tested prior welding.

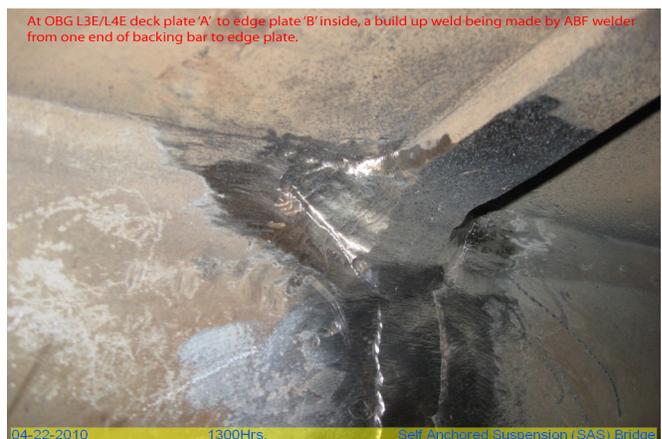
04-22-2010 1300Hrs Self Anchored Suspension (SAS) Bridge

At OBG L3E/L4E deck plate 'A' to edge plate 'B' inside, a build up weld being made by ABF welder from one end of backing bar to edge plate.
