**DEPARTMENT OF TRANSPORTATION**

Contract #: 04-0120F4Cty: SF/ALA Rte: 80 PM: 13.2/13.9File #: 1.28**WELDING INSPECTION REPORT****Resident Engineer:** Pursell, Gary**Address:** 333 Burma Road**City:** Oakland, CA 94607**Report No:** WIR-013432**Date Inspected:** 20-Apr-2010**Project Name:** SAS Superstructure**OSM Arrival Time:** 630**Prime Contractor:** American Bridge/Fluor Enterprises, a JV**OSM Departure Time:** 1500**Contractor:** American Bridge/Fluor Enterprises, a JV**Location:** Job Site**CWI Name:** See Below**CWI Present:** Yes No**Inspected CWI report:** Yes No N/A**Rod Oven in Use:** Yes No N/A**Electrode to specification:** Yes No N/A**Weld Procedures Followed:** Yes No N/A**Qualified Welders:** Yes No N/A**Verified Joint Fit-up:** Yes No N/A**Approved Drawings:** Yes No N/A**Approved WPS:** Yes No N/A**Delayed / Cancelled:** Yes No N/A**Bridge No:** 34-0006**Component:** Orthotropic Box Girders (OBG)**Summary of Items Observed:**

# WELDING INSPECTION REPORT

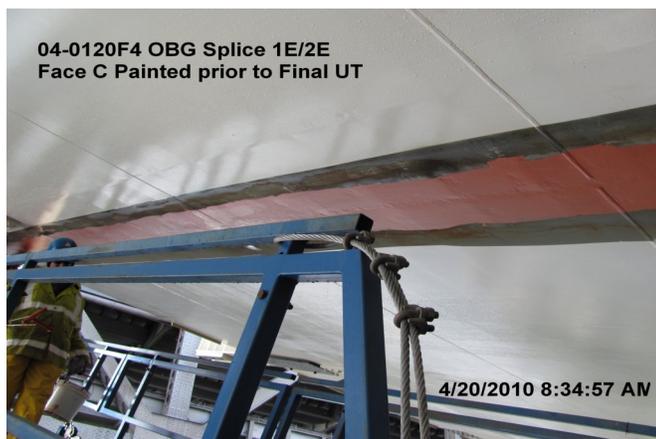
**Field Splice 1E/2E Face C (Second side-Outside)**

Upon a general review of the progression of the work at the beginning of the shift it was noted the contractor was in the process of applying the coating to the entire length of weld at this location. The QA inspector spoke with ABF field Engineer John Callaghan and relayed this weld had rejectable indications discovered during ultrasonic testing (UT) which were repaired the previous day late in the shift and inquired about the contract 24 hour hold time for the final UT of the repairs. Mr. Callaghan relayed they would examine the repair areas from the inside as he was not aware of any areas which would require scanning from the outside. The QA inspector spoke with QC inspector Jessie Cayabyab and Mr. Cayabyab relayed he had performed a preliminary scan of the repair areas from the outside with no rejectable indications noted at the time of review and would be performing the final scan from the inside once the contract hold time was satisfied. The QA inspector reviewed the inside weld surface and confirmed several repair locations passed through the longitudinal stiffeners and required the scan from the outside

in order to obtain full coverage of the weld. See digital photos in the body of this report for clarification. This information was discussed with the QC inspector again in which the QC inspector relayed no indications were observed in these particular locations from the outside preliminary scan. The QA inspector relayed this issue to second shift QA inspector Dan Reyes for tracking observation purposes.

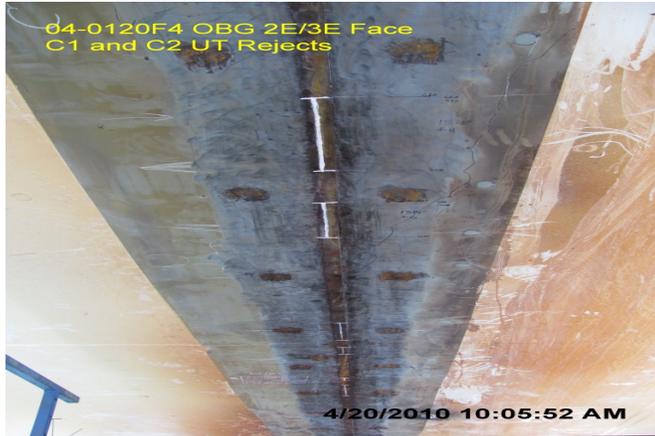
The QA inspector periodically observed ABF welding personnel Bryce Howell performing backgouging operations and the removal of the backing bar utilizing the plasma process. QC inspector Jim Cunningham was noted to be in the general vicinity in addition to Jessie Cayabyab periodically to observe the progress of the work. The work progressed throughout the QA inspector shift, was not completed and appeared to be progressing in general conformance with the contract documents.
