**DEPARTMENT OF TRANSPORTATION**

Contract #: 04-0120F4Cty: SF/ALA Rte: 80 PM: 13.2/13.9File #: 1.28**WELDING INSPECTION REPORT****Resident Engineer:** Pursell, Gary**Address:** 333 Burma Road**City:** Oakland, CA 94607**Report No:** WIR-013437**Date Inspected:** 26-Apr-2010**Project Name:** SAS Superstructure**OSM Arrival Time:** 700**Prime Contractor:** American Bridge/Fluor Enterprises, a JV**OSM Departure Time:** 1530**Contractor:** American Bridge/Fluor Enterprises, a JV**Location:** Job Site**CWI Name:** See Below**CWI Present:** Yes No**Inspected CWI report:** Yes No N/A**Rod Oven in Use:** Yes No N/A**Electrode to specification:** Yes No N/A**Weld Procedures Followed:** Yes No N/A**Qualified Welders:** Yes No N/A**Verified Joint Fit-up:** Yes No N/A**Approved Drawings:** Yes No N/A**Approved WPS:** Yes No N/A**Delayed / Cancelled:** Yes No N/A**Bridge No:** 34-0006**Component:** Orthotropic Box Girders (OBG)**Summary of Items Observed:**

1. OBG Field Splice 2E/3E C2 Repairs (First Side-Inside)
2. OBG Field Splice 2E/3E Face B/C Transition Areas (First Side-Inside)
3. OBG Field Splice 2E/3E Face E (Second Side-Outside)
4. OBG Field Splice 3E/4E Face E (Second Side-Outside)

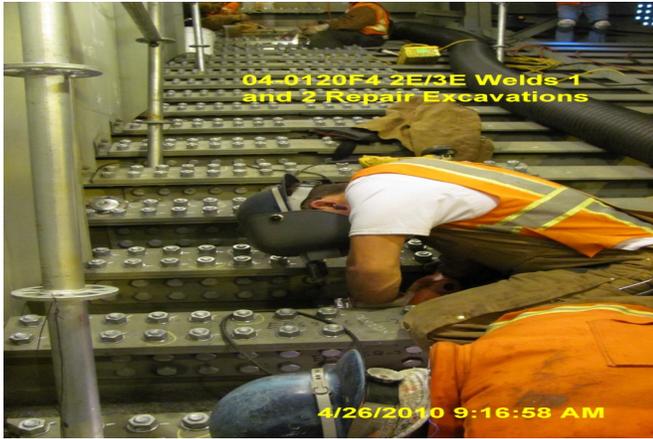
The QA inspector was informed the contractor had completed the weld repairs for the top deck field splice identified as A1-A5. The QA inspector spoke with QC inspector Steve McConnell in which Mr. McConnell relayed he was in the process of performing the UT for the repairs on this date in order to satisfy the contract required hold time after completion of the repairs. The QC inspector was responsible for the review of several areas including the UT and welding locations and as such was unable to complete the UT review for the repaired areas on at this time due to issues discovered in another area. The QA inspector performed a UT review of the non-repair areas on this date with the understanding another UT review for a portion of the repair welds will be performed at a later time. The QA inspector performed the UT review utilizing a zero degree transducer in order to check for laminar reflectors and a 70 degree transducer and wedge combination for the shear wave examination. The areas reviewed were located in welds designated A1, A3, A4 and A5 with Y locations designated 0-200, 15, 200-18,000 and 24,500-26,000mm respectively with no rejectable indications discovered at the time of review for A1, A4 or A5. The QA inspector discovered an indication with no appreciable length which exhibited a db rating just inside of a class A indication. The QA inspector reviewed this area with QC inspector Steve McConnell in which Mr. McConnell verified the indication; however there was a 2 db difference between the inspectors UT equipment and calibration variables and the area was classified as acceptable. This information was relayed to lead QA inspector Bill Levell and a TL-6027 will be generated for this item for this date.
