DEPARTMENT OF TRANSPORTATION

Contract #: 04-0120F4Cty: SF/ALA Rte: 80 PM: 13.2/13.9File #: 1.28**WELDING INSPECTION REPORT****Resident Engineer:** Pursell, Gary**Address:** 333 Burma Road**City:** Oakland, CA 94607**Report No:** WIR-013438**Date Inspected:** 26-Apr-2010**Project Name:** SAS Superstructure**OSM Arrival Time:** 630**Prime Contractor:** American Bridge/Fluor Enterprises, a JV**OSM Departure Time:** 1500**Contractor:** American Bridge/Fluor Enterprises, a JV**Location:** Job Site

CWI Name:	Tom Pasqualone, Steve McConnell, Wilfredo Daquinag			CWI Present:	Yes	No	
Inspected CWI report:	Yes	No	N/A	Rod Oven in Use:	Yes	No	N/A
Electrode to specification:	Yes	No	N/A	Weld Procedures Followed:	Yes	No	N/A
Qualified Welders:	Yes	No	N/A	Verified Joint Fit-up:	Yes	No	N/A
Approved Drawings:	Yes	No	N/A	Approved WPS:	Yes	No	N/A
				Delayed / Cancelled:	Yes	No	N/A
Bridge No:	34-0006			Component:	SAS OBG 3W/4W-A, 1W/2W-E,

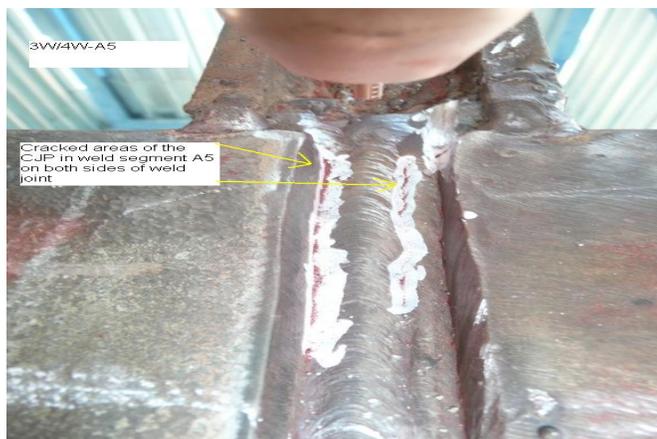
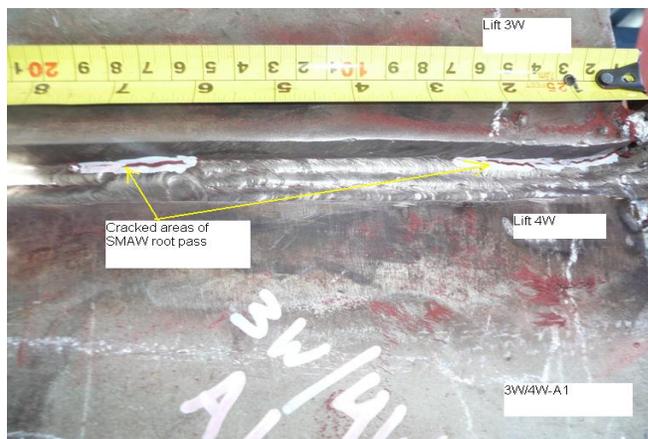
The QA Inspector randomly discovered and noted a crack at the end of the above identified weld joint in section 3W/4W-A5. The QA Inspector observed the crack to start at the beginning of the weld tab and propagate approximately 55mm and stop and cracked again between Y=155mm-180mm. The QA Inspector noted the crack was located by the QA Inspector Rick Bettencourt. The QA Inspector noted the ABF welding operator nor the SE QC Inspector Steve McConnell were aware of the cracked area of the shielded metal arc welding (SMAW) root pass. The QA Inspector noted the SMAW root pass was previously welded on Friday 4/ 23/10 approximately 200mm long, in an attempt to eliminate any cracking. The QA Inspector informed them of the cracked area just prior to the ABF welding operator performing the SAW root pass. After the extent of the cracks length was determined by the QC Inspector utilizing the MT method, the ABF representative Jordan Hazelaar utilized a burr bit grinder to excavate the area where the crack was present. The QA Inspector randomly observed the QC Inspector Steve McConnell inform the ABF representative Dan Ieraci engineering approval was required prior to any weld repairs being made (see summary of conversations). The QA Inspector noted no welding repairs were made prior to the end of the QA Inspectors shift on the job site on today's date.

Upon discovery of the cracked root pass identified above in A1, the SE QC Inspector Dan McConnell discovered two cracks in the same location as A1 on both sides of the root pass. The QA Inspector noted the same SMAW root pass described above was performed at the end of A5 to eliminate the cracking issue. After the extent of the cracks length was determined by the QC Inspector utilizing the MT method, the ABF representative Jordan Hazelaar utilized a burr bit grinder to excavate the area where the crack was present. The QA Inspector randomly observed the QC Inspector Steve McConnell inform the ABF representative Dan Ieraci engineering approval was required prior to any weld repairs being made (see summary of conversations). The QA Inspector observed the crack to start at the beginning of the weld tab and propagate approximately 55mm from the end of the joint on the 3W side and 60mm from the end on the 4W side. After a short time the QA Inspector returned to the A5 weld segment where the cracked areas were previously discovered and excavated. The QA Inspector observed the area had been repaired by welding prior to any engineering approval to do so. The QA Inspector informed the QC Inspector Steve McConnell of the repaired area, the QA Inspector noted the QC Inspector was not aware the ABF welding operator had welded over the area (see summary of conversations)

The QA Inspector informed the QC Inspector Steve McConnell of the crack discovered at the end of weld segment A1. The QC Inspector observed the crack and acknowledged the cracked area. A short time later the QC Inspector informed the QA Inspector of two cracks at the opposite end of the weld joint in weld segment A5. Mr. McConnell informed the QA Inspector he was taking pictures and reporting the cracks to his supervisor Leonard Cross to submit for engineering approval of the repairs. The QA Inspector observed the cracked areas at the end of A5 had been excavated and repaired by welding with out approval. The QA Inspector asked the QC Inspector if he was aware the area had been repaired by welding without approval. The QC Inspector informed the QA Inspector he was not aware. After the QC Inspector observed the area had been repaired the QC Inspector informed the QA Inspector he could not stop the welder rather just report it and document it. The QA Inspector informed the QC Inspector an incident report would be written for repairing a crack by welding with out engineering approval.
