DEPARTMENT OF TRANSPORTATION

Contract #: 04-0120F4Cty: SF/ALA Rte: 80 PM: 13.2/13.9File #: 69.28**WELDING INSPECTION REPORT****Resident Engineer:** Pursell, Gary**Address:** 333 Burma Road**City:** Oakland, CA 94607**Report No:** WIR-013459**Date Inspected:** 20-Feb-2010**Project Name:** SAS Superstructure**OSM Arrival Time:** 7000**Prime Contractor:** American Bridge/Fluor Enterprises, a JV**OSM Departure Time:** 1900**Contractor:** Zhenhua Port Machinery Company, Ltd (ZPMC), Changxing Island **Location:** Shanghai, China

Segment 9EE

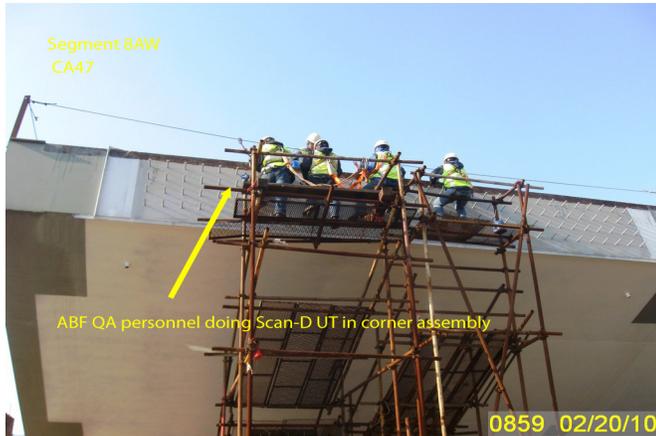
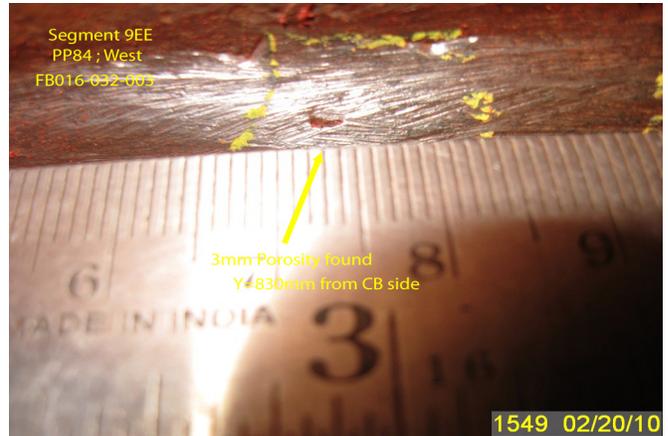
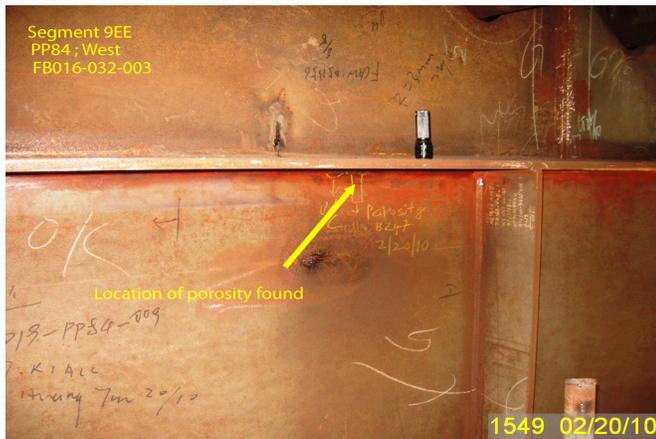
1. PP83(East)- FB016-033-004
2. PP84(West)- FB016-032-003 - one porosity of 3mm dia found.
3. PP84(West)- FB003-145-004

During visual inspection of segment 10BE this QA inspector observed that PP84 (West) FB016-032-003, 3mm diameter Porosity from Y=830mm from CB side. This is marked on that location for future ZPMC reference

and rectification. For more information please see the attached photos.
