DEPARTMENT OF TRANSPORTATION

Contract #: 04-0120F4Cty: SF/ALA Rte: 80 PM: 13.2/13.9File #: 13.28**WELDING INSPECTION REPORT****Resident Engineer:** Pursell, Gary**Address:** 333 Burma Road**City:** Oakland, CA 94607**Report No:** WIR-013461**Date Inspected:** 23-Apr-2010**Project Name:** SAS Superstructure**OSM Arrival Time:** 1000**Prime Contractor:** American Bridge/Fluor Enterprises, a JV**OSM Departure Time:** 1830**Contractor:** Oregon Iron Works Clackamas, Or.**Location:** Clackamas, OR

CWI Name:	M. Gregson, J. Salazar, G. Mundt	CWI Present:	Yes	No			
Inspected CWI report:	Yes	No	N/A	Rod Oven in Use:	Yes	No	N/A
Electrode to specification:	Yes	No	N/A	Weld Procedures Followed:	Yes	No	N/A
Qualified Welders:	Yes	No	N/A	Verified Joint Fit-up:	Yes	No	N/A
Approved Drawings:	Yes	No	N/A	Approved WPS:	Yes	No	N/A
				Delayed / Cancelled:	Yes	No	N/A
Bridge No:	34-0006	Component:	Hinge K Pipe Beams

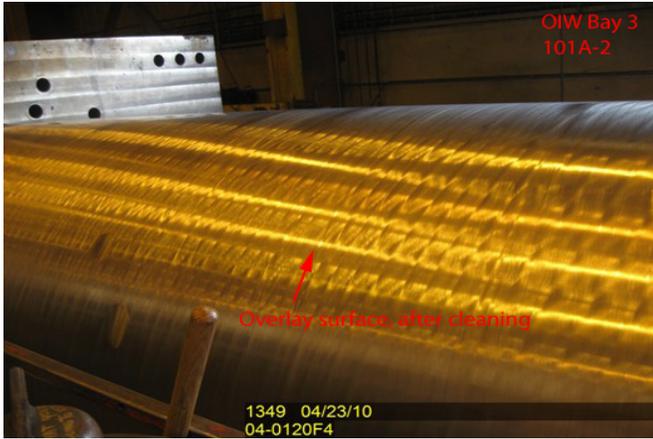
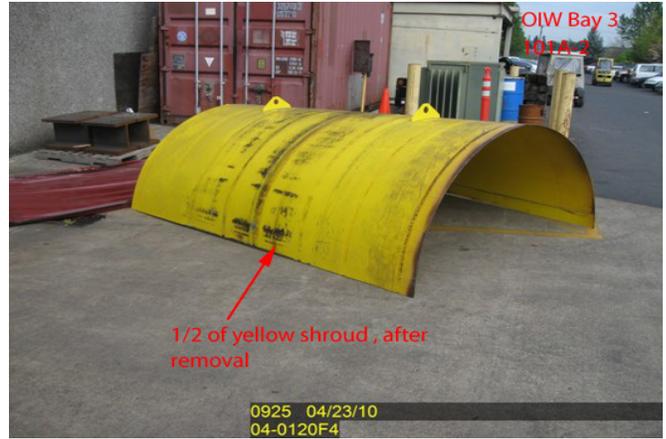
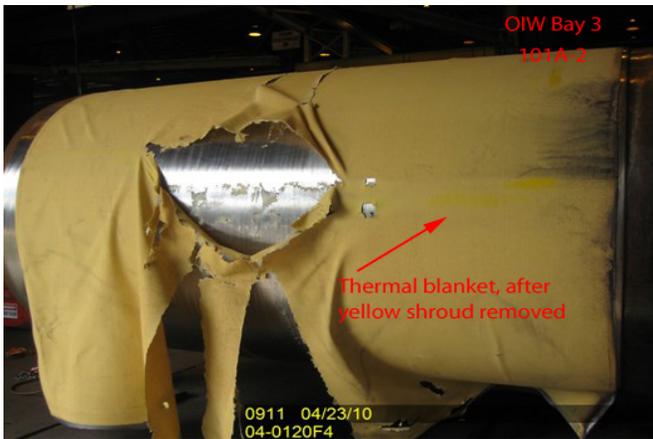
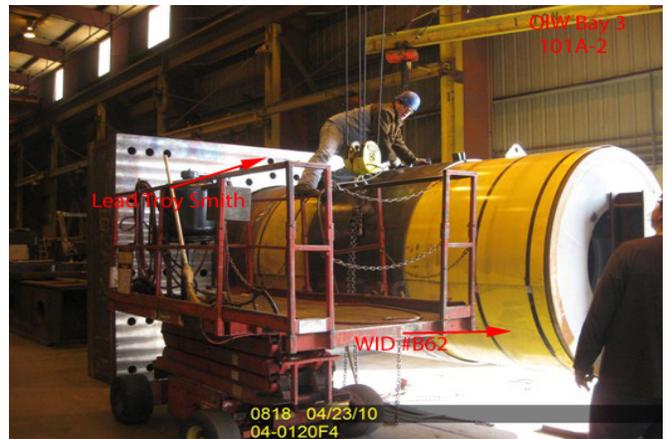
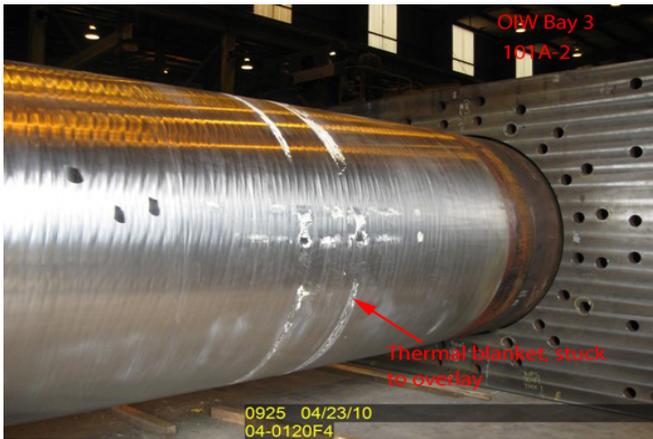
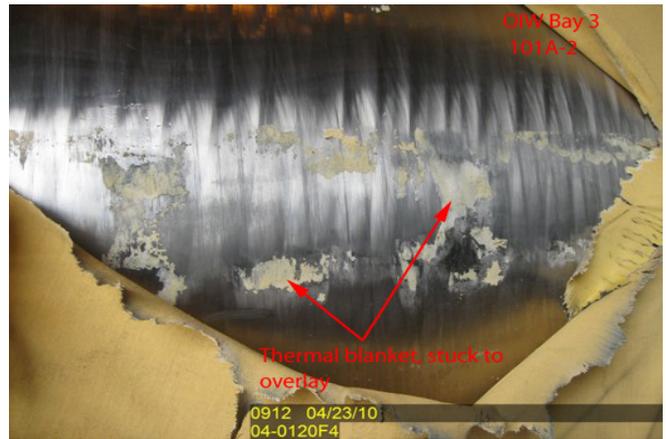
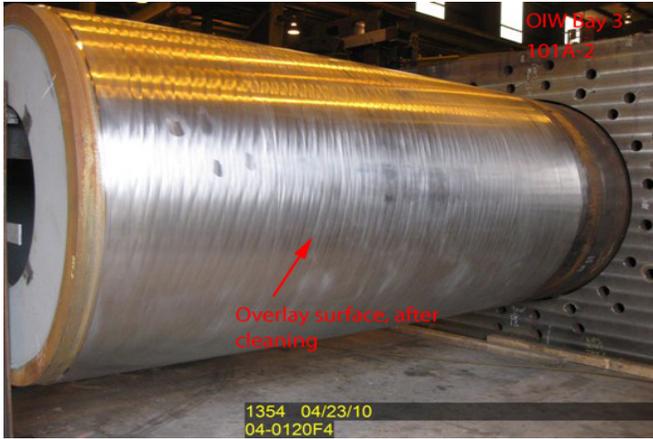
Hinge-K Pipe Beam Assembly 101A-2:

The QA Inspector witnessed Production Lead Troy Smith and WID #B62 (Marcus Belgarde), removing 2 sets of protective shrouding. One set of yellow painted shrouds, to protect the stainless steel overlay during transport/future storage and a second set, to prevent damage to the yellow painted shrouds and stainless steel overlay, during the rotation of the Fuse on automatic rollers, for the welding of the CJP weld joint #W4-01. The QA Inspector witnessed OIW first removing the set, which had been used to sit on the automatic rollers, utilizing an air ratchet gun, with an attached socket. The QA Inspector then witnessed OIW utilizing the overhead Bay 3 crane, to lift the shrouds off of the Fuse and place on the Bay 3 shop floor. The QA Inspector then witnessed OIW production removing the 2 piece yellow painted protective shrouds. Lead Troy Smith explained that these shrouds were being removed to check the condition of the stainless steel overlay and to replace the thermal blanket, if needed. The QA Inspector witnessed OIW cut the banding, which tightened the shrouds to the Fuse and then utilizing the overhead Bay 3 crane to lift the shrouds off the Fuse and then placing on the Bay 3 shop floor. After removal of the shrouds, the QA Inspector noted that the thermal blanket had stuck to the overlay in multiple areas on the overlay and was torn in various areas. Lead Troy Smith explained that this was caused by back and forth movement of the Fuse, between the shrouds, during welding of the CJP. The QA Inspector then witnessed OIW Production personell removing the torn thermal blanket and then scraping the stuck blanket off of the overlay. The QA Inspector noted

that the scrapers being utilized were the plastic type, used for removal of snow and ice from windshields. The QA Inspector noted that OIW production personell were also utilizing clear plastic type scrapers, used for placement into welding helmets, for eye protection during grinding. The QA Inspector noted that no scratching or damage was apparent at this time, caused by the plastic type scrapers.

The QA Inspector was later informed by OIW QC Inspector Jose' Salazar that OIW Production personell had scraped off the areas of stuck thermal blanket and had cleaned the entire surface with acetone. QC Inspector Salazar explained that he had visually inspected the surface and found no scratches or gauges and explained that the surface was acceptable. The QA Inspector then performed visual inspection on the overlay surface and found no apparent scratches or gouges on the overlay.

Lead Troy Smith then explained that swing shift will cut new thermal blanket and place around the Fuse and then the 2 protective yellow shrouds will then be placed and banded together and that OIW will transfer this Fuse to OIW Vancouver facility on 4/26/10. The QA Inspector noted that the assembly will eventually be primed and painted at the facility. See attached pictures below.
