**DEPARTMENT OF TRANSPORTATION**

Contract #: 04-0120F4Cty: SF/ALA Rte: 80 PM: 13.2/13.9File #: 1.28**WELDING INSPECTION REPORT****Resident Engineer:** Pursell, Gary**Address:** 333 Burma Road**City:** Oakland, CA 94607**Report No:** WIR-013467**Date Inspected:** 27-Apr-2010**Project Name:** SAS Superstructure**OSM Arrival Time:** 700**Prime Contractor:** American Bridge/Fluor Enterprises, a JV**OSM Departure Time:** 1530**Contractor:** American Bridge/Fluor Enterprises, a JV**Location:** Job Site**CWI Name:** See Below**CWI Present:** Yes No**Inspected CWI report:** Yes No N/A**Rod Oven in Use:** Yes No N/A**Electrode to specification:** Yes No N/A**Weld Procedures Followed:** Yes No N/A**Qualified Welders:** Yes No N/A**Verified Joint Fit-up:** Yes No N/A**Approved Drawings:** Yes No N/A**Approved WPS:** Yes No N/A**Delayed / Cancelled:** Yes No N/A**Bridge No:** 34-0006**Component:** Orthotropic Box Girders (OBG)**Summary of Items Observed:**

# WELDING INSPECTION REPORT

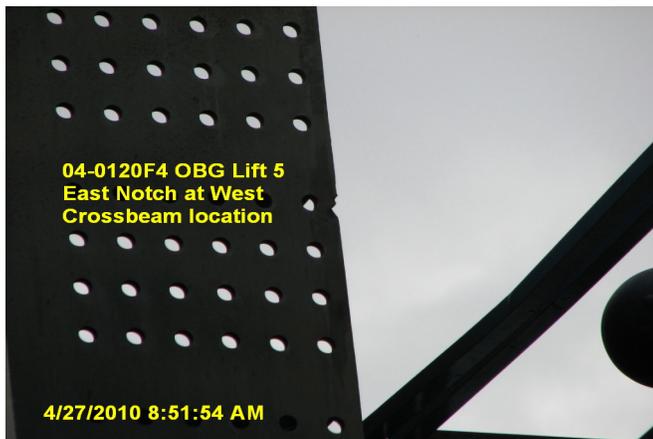
Minor Coating abrasions and surface discolorations were noted at support locations. A notch approximately 1500mm from the top of the West side of the crossbeam connection was damaged during removal from the vessel. Further information is provided in ABF Submittal 1503 Revision 15 along with a digital photo included in the

body of this report for general information. No other issues were observed.
