DEPARTMENT OF TRANSPORTATION

Quality Assurance and Source Inspection

Contract #: 04-0120F4Cty: SF/ALA Rte: 80 PM: 13.2/13.9File #: 1.28**WELDING INSPECTION REPORT****Resident Engineer:** Pursell, Gary**Address:** 333 Burma Road**City:** Oakland, CA 94607**Report No:** WIR-013469**Date Inspected:** 27-Apr-2010**Project Name:** SAS Superstructure**OSM Arrival Time:** 700**Prime Contractor:** American Bridge/Fluor Enterprises, a JV**OSM Departure Time:** 1530**Contractor:** American Bridge/Fluor Enterprises, a JV**Location:** Job Site**CWI Name:** Jim Bowers**CWI Present:** Yes No**Inspected CWI report:** Yes No N/A**Rod Oven in Use:** Yes No N/A**Electrode to specification:** Yes No N/A**Weld Procedures Followed:** Yes No N/A**Qualified Welders:** Yes No N/A**Verified Joint Fit-up:** Yes No N/A**Approved Drawings:** Yes No N/A**Approved WPS:** Yes No N/A**Delayed / Cancelled:** Yes No N/A**Bridge No:** 34-0006**Component:** Orthotropic Box Girders (OBG)**Summary of Items Observed:**

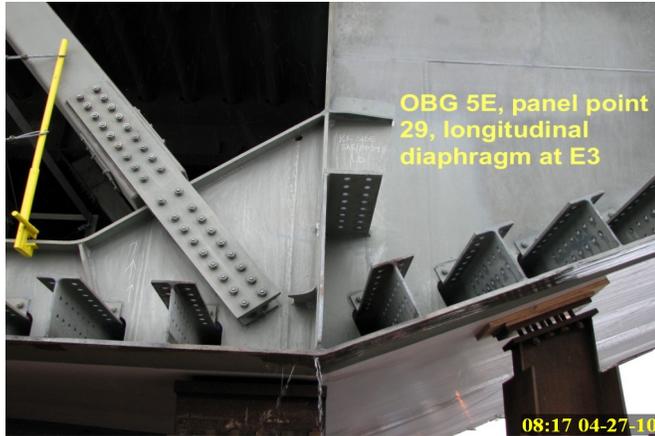
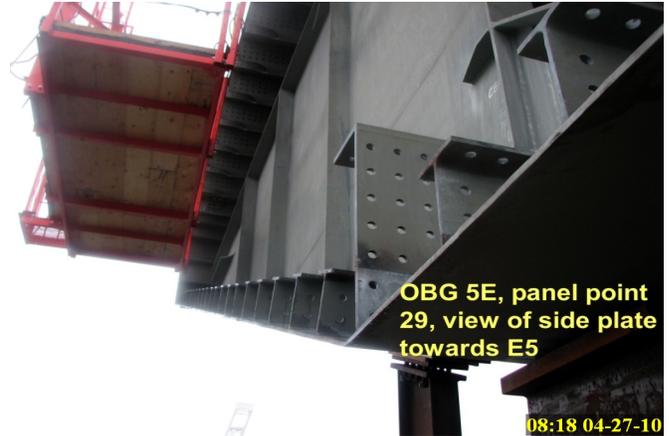
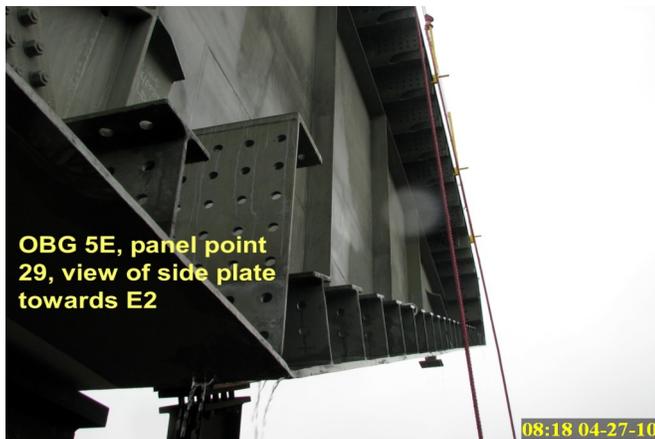
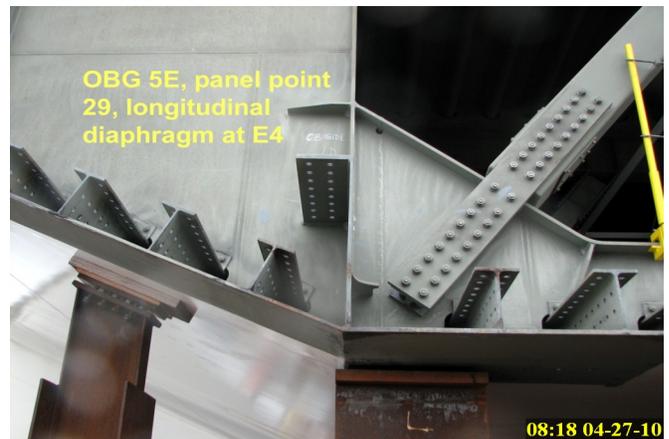
The QAI accompanied the Caltrans Construction group and assisted in performing the post arrival inspection of the Orthotropic Box Girder (OBG) segment 5E. At the beginning of the inspection, the QAI was informed that due to the inclement weather, the deck and upper connection areas will not be accessible. The QAI made observations of the lower exterior contact points between the OBG and the sea fasteners along lines E3 and E4. The QAI reviewed the shipping / fastening plan and noted where the shoring, longitudinal sea fasteners and lateral sea fasteners made contact with the bottom and side plates of the OBG. The QAI observed general marring to the finish of the final coating of paint at these locations. The QAI also observed where the longitudinal diaphragms connected to the sea fasteners. The QAI noted that there did not appear to be damage to the OBG from the sea fasteners. See the attached photos. The QAI relayed this information to the QAI Lead Bill Levell and the Associate Steel Inspector Jason Gramlick. See the attached photos.
