**DEPARTMENT OF TRANSPORTATION**

Contract #: 04-0120F4Cty: SF/ALA Rte: 80 PM: 13.2/13.9File #: 69.28**WELDING INSPECTION REPORT****Resident Engineer:** Pursell, Gary**Address:** 333 Burma Road**City:** Oakland, CA 94607**Report No:** WIR-013553**Date Inspected:** 01-May-2010**Project Name:** SAS Superstructure**OSM Arrival Time:** 700**Prime Contractor:** American Bridge/Fluor Enterprises, a JV**OSM Departure Time:** 1900**Contractor:** Zhenhua Port Machinery Company, Ltd (ZPMC), Changxing Island **Location:** Shanghai, China**CWI Name:** An Qing Xiang, Tu Jun**CWI Present:** Yes No**Inspected CWI report:** Yes No N/A**Rod Oven in Use:** Yes No N/A**Electrode to specification:** Yes No N/A**Weld Procedures Followed:** Yes No N/A**Qualified Welders:** Yes No N/A**Verified Joint Fit-up:** Yes No N/A**Approved Drawings:** Yes No N/A**Approved WPS:** Yes No N/A**Delayed / Cancelled:** Yes No N/A**Bridge No:** 34-0006**Component:** Tower**Summary of Items Observed:**

Bay 11, East Tower Lift 4 DE Corner Backfill Plate

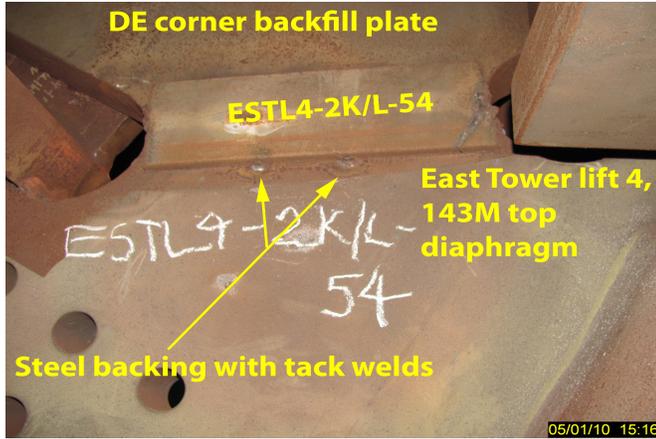
During random verification Visual Testing (VT) of D/E corner backfill plate of East Tower Lift 4, this Quality Assurance (QA) Inspector observed the following issues:

- Tack welds has been used to attach the steel backing on weld joint ESTL4-2K/L-54 at 143M (top) diaphragm.
- These tack welds placed external to the weld joint and was not made continuous by fillet welding for the full length of the backing.
- As per AWS D1.5, section 3.3.7.6; it supposed to be continuous by fillet welding for the full length of the backing.
- This weld joining the backfill plate and double diaphragm plate of East Tower lift 4 at DE corner.
- The members are located in Tower Bay 11.

The Notice of Witness Inspection Number (NWIT) is 005644. This weld has been previously tested and accepted by ZPMC Quality Control (QC) personnel. This issue has an incident report. The attached photograph provides additional detail.
