Contract #: 04-0120F4Cty: SF/ALA Rte: 80 PM: 13.2/13.9File #: 1.28**WELDING INSPECTION REPORT****Resident Engineer:** Pursell, Gary**Address:** 333 Burma Road**City:** Oakland, CA 94607**Report No:** WIR-013567**Date Inspected:** 29-Apr-2010**Project Name:** SAS Superstructure**OSM Arrival Time:** 700**Prime Contractor:** American Bridge/Fluor Enterprises, a JV**OSM Departure Time:** 1530**Contractor:** American Bridge/Fluor Enterprises, a JV**Location:** Job Site

Bridge No: 34-0006**Component:** Orthotropic Box Girders**Summary of Items Observed:**

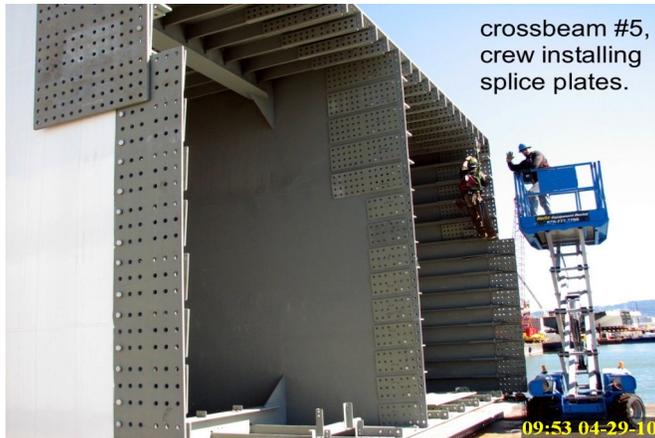
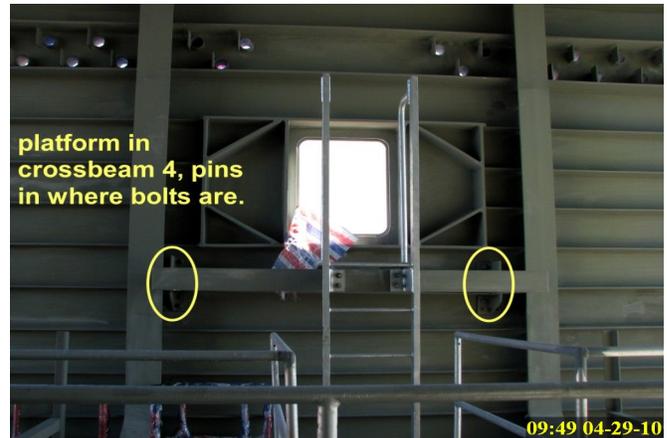
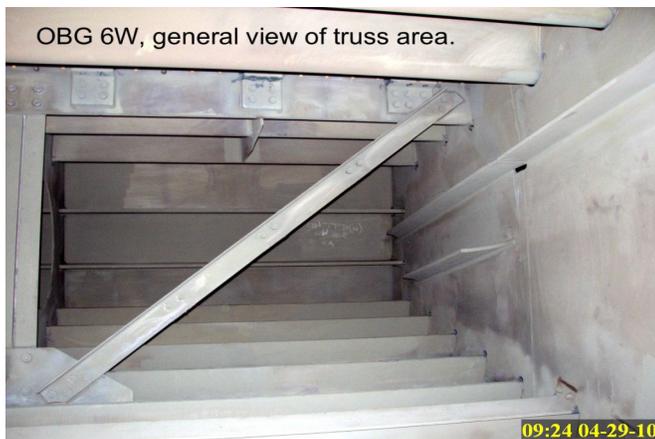
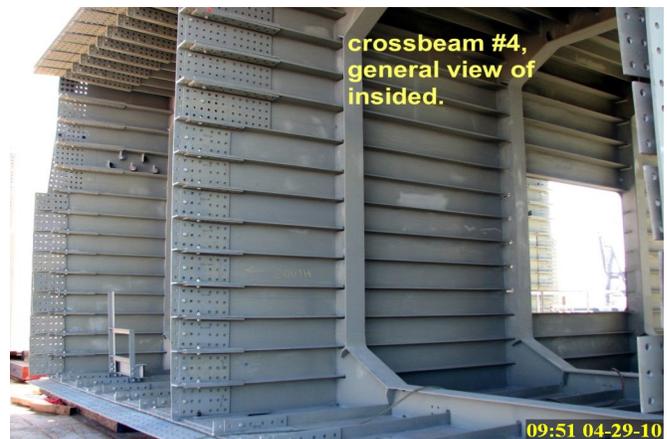
The QAI accompanied the Caltrans Structures Construction group and assisted in performing the post arrival inspection of the Orthotropic Box Girder (OBG) segments 6E, 5W and crossbeams #4, #5 and #6. The QAI made observations of the interior panel points from 37 to 42 on OBG segment 6E and of the interior panel points from 29 to 33 on OBG segment 5W. The QAI also made observations of all accessible surfaces of the crossbeams. The QAI reviewed the shipping / fastening plan and noted where the shoring, longitudinal sea fasteners and lateral sea fasteners made contact with the bottom and side plates of the OBG segments and crossbeams. The QAI noted the presence of water in the OBG segments and general marring of the finish coat paint on all observed components. The QAI noted that there did not appear to be shipping related damage to the OBG segments or the crossbeams. See the attached photos. The QAI relayed this information to the QAI Lead Bill Levell and the Associate Steel Inspector Jason Gramlick.
