DEPARTMENT OF TRANSPORTATION

Contract #: 04-0120F4Cty: SF/ALA Rte: 80 PM: 13.2/13.9File #: 69.28**WELDING INSPECTION REPORT****Resident Engineer:** Pursell, Gary**Address:** 333 Burma Road**City:** Oakland, CA 94607**Report No:** WIR-013658**Date Inspected:** 07-Feb-2010**Project Name:** SAS Superstructure**OSM Arrival Time:** 700**Prime Contractor:** American Bridge/Fluor Enterprises, a JV**OSM Departure Time:** 1900**Contractor:** Zhenhua Port Machinery Company, Ltd (ZPMC), Changxing Island **Location:** Shanghai, China**CWI Name:** ZPMC and ABF**CWI Present:** Yes No**Inspected CWI report:** Yes No N/A**Rod Oven in Use:** Yes No N/A**Electrode to specification:** Yes No N/A**Weld Procedures Followed:** Yes No N/A**Qualified Welders:** Yes No N/A**Verified Joint Fit-up:** Yes No N/A**Approved Drawings:** Yes No N/A**Approved WPS:** Yes No N/A**Delayed / Cancelled:** Yes No N/A**Bridge No:** 34-0006**Component:** Tower**Summary of Items Observed:**

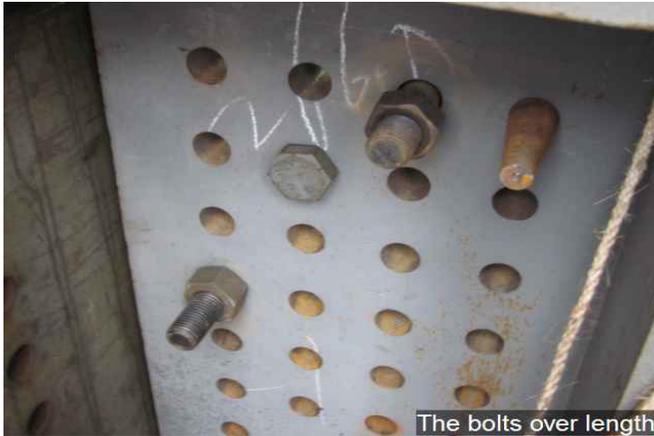
The bolts over length

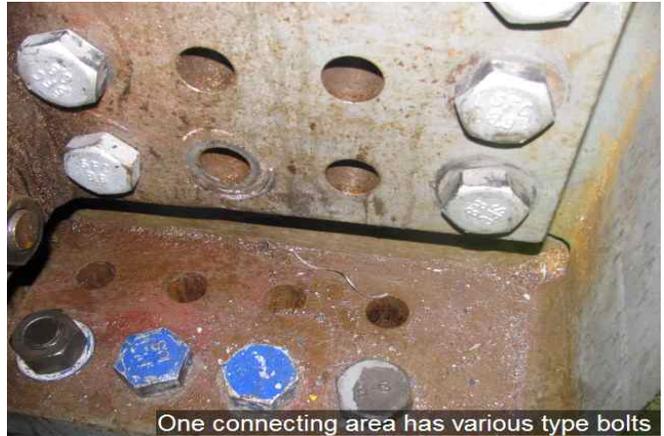
One connecting area has various type bolts

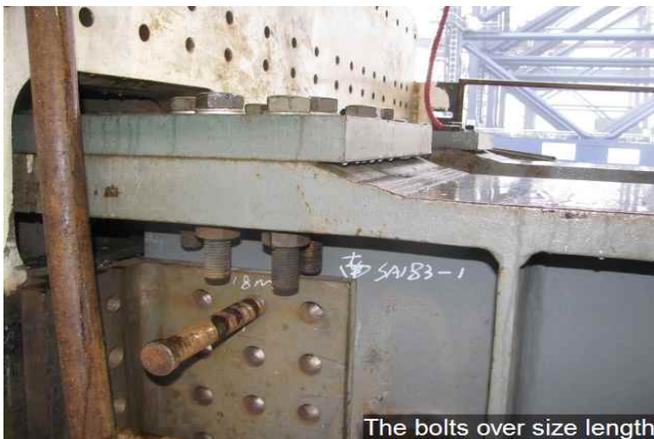
The bolts over size length

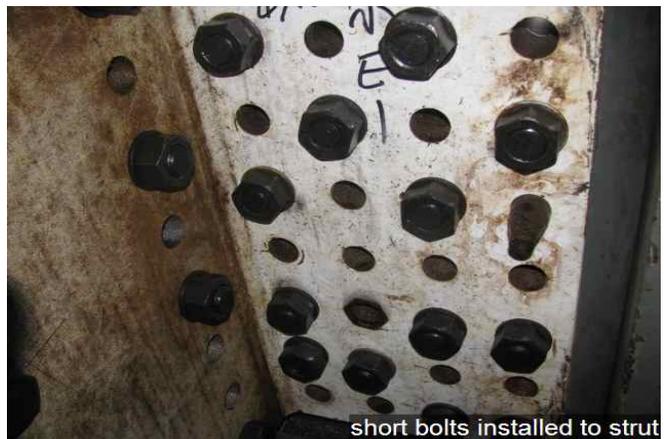
short bolts installed to strut

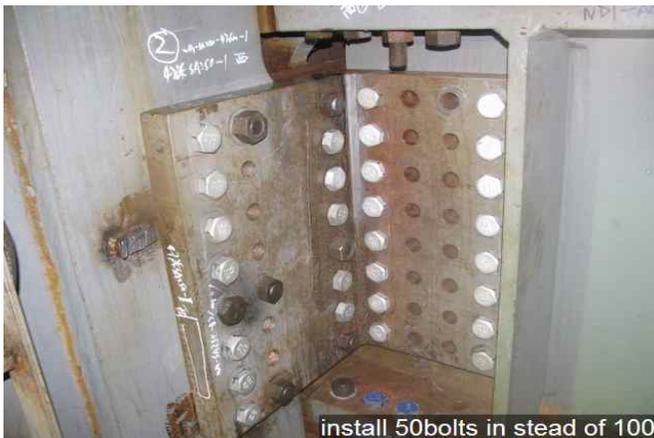
install 50bolts in stead of 100

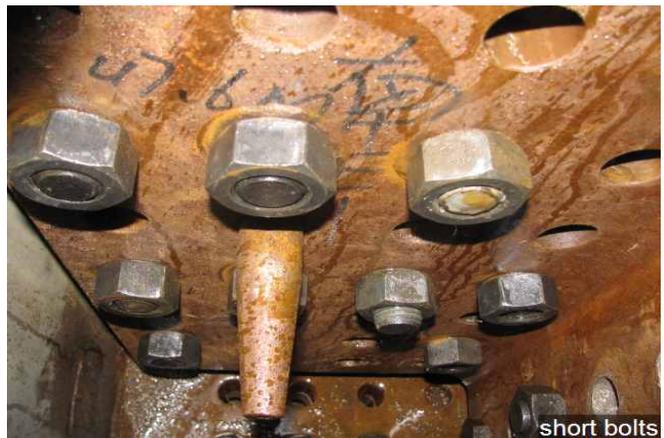
short bolts
