DEPARTMENT OF TRANSPORTATION

Contract #: 04-0120F4Cty: SF/ALA Rte: 80 PM: 13.2/13.9File #: 69.28**WELDING INSPECTION REPORT****Resident Engineer:** Pursell, Gary**Address:** 333 Burma Road**City:** Oakland, CA 94607**Report No:** WIR-013681**Date Inspected:** 16-Feb-2010**Project Name:** SAS Superstructure**OSM Arrival Time:** 700**Prime Contractor:** American Bridge/Fluor Enterprises, a JV**OSM Departure Time:** 1800**Contractor:** Zhenhua Port Machinery Company, Ltd (ZPMC), Changxing Island **Location:** Shanghai, China**CWI Name:** ZPMC and ABF**CWI Present:** Yes No**Inspected CWI report:** Yes No N/A**Rod Oven in Use:** Yes No N/A**Electrode to specification:** Yes No N/A**Weld Procedures Followed:** Yes No N/A**Qualified Welders:** Yes No N/A**Verified Joint Fit-up:** Yes No N/A**Approved Drawings:** Yes No N/A**Approved WPS:** Yes No N/A**Delayed / Cancelled:** Yes No N/A**Bridge No:** 34-0006**Component:** Tower**Summary of Items Observed:**

WELDING INSPECTION REPORT

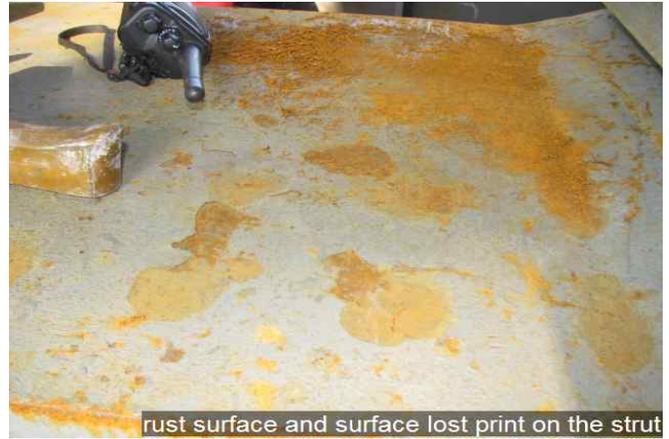
Caltrans QA inspector observed six ZPMC workers in process of temporary bolting to the struts and 90 degree angle plates which connected to tower skin plate A, B, C, D and E. The struts located at elevation 18m of north, south, east and west tower lift #1. The ZPMC will install only 25% bolts on each strut. During observation, some of temporary bolts do not have properly length after installed into the struts and 90 degree angle plates. This issue has been discovered by Caltrans QA inspector on Feb-7-10. Also, Caltrans found some of strut installed on 18m that has rust on the surface require to re-sand blast and re- print. The struts for elevation 18m have been completed installing and 25% temporary bolting.
