DEPARTMENT OF TRANSPORTATION

Contract #: 04-0120F4Cty: SF/ALA Rte: 80 PM: 13.2/13.9File #: 69.28**WELDING INSPECTION REPORT****Resident Engineer:** Pursell, Gary**Address:** 333 Burma Road**City:** Oakland, CA 94607**Report No:** WIR-013774**Date Inspected:** 13-Feb-2010**Project Name:** SAS Superstructure**OSM Arrival Time:** 700**Prime Contractor:** American Bridge/Fluor Enterprises, a JV**OSM Departure Time:** 1900**Contractor:** Zhenhua Port Machinery Company, Ltd (ZPMC), Changxing Island **Location:** Shanghai, China

WELDING INSPECTION REPORT

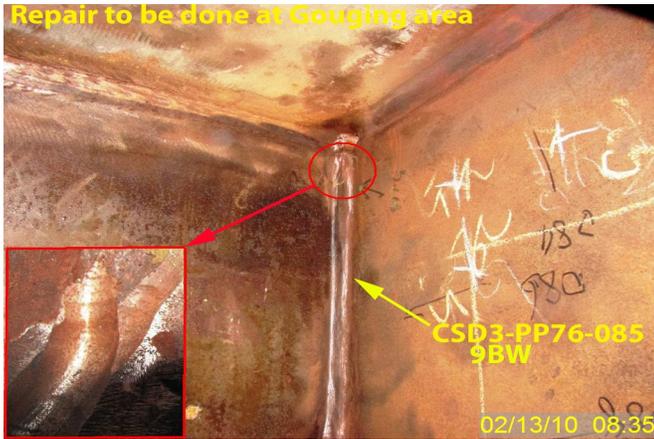
During the Quality Assurance (QA) random in-process visual inspection of Segment 9BW, this QA inspector discovered that the ZPMC welding personal is excavating on weld repair area by using Carbon Arc Gouging at Counter weight side corner weld joint joining between Deck plate to Edge plate. The weld joint is identified as CA059-004.
