Contract #: 04-0120F4Cty: SF/ALA Rte: 80 PM: 13.2/13.9File #: 1.28**WELDING INSPECTION REPORT****Resident Engineer:** Pursell, Gary**Address:** 333 Burma Road**City:** Oakland, CA 94607**Report No:** WIR-013829**Date Inspected:** 04-May-2010**Project Name:** SAS Superstructure**OSM Arrival Time:** 630**Prime Contractor:** American Bridge/Fluor Enterprises, a JV**OSM Departure Time:** 1500**Contractor:** American Bridge/Fluor Enterprises, a JV**Location:** Job Site**CWI Name:** See Below**CWI Present:** Yes No**Inspected CWI report:** Yes No N/A**Rod Oven in Use:** Yes No N/A**Electrode to specification:** Yes No N/A**Weld Procedures Followed:** Yes No N/A**Qualified Welders:** Yes No N/A**Verified Joint Fit-up:** Yes No N/A**Approved Drawings:** Yes No N/A**Approved WPS:** Yes No N/A**Delayed / Cancelled:** Yes No N/A**Bridge No:** 34-0006**Component:** Orthotropic Box Girders (OBG)**Summary of Items Observed:**

# WELDING INSPECTION REPORT

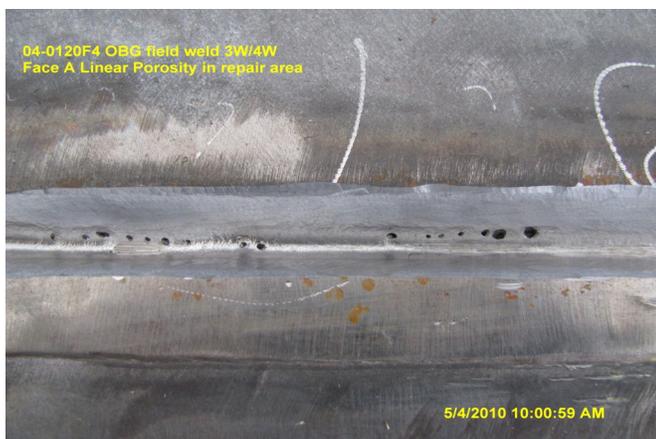
The QA inspector periodically observed QC inspectors Steve McConnell and Tom Pascaulone performing ultrasonic testing (UT) on this date for the balance of the welds designated A-5 and A-1. The QC inspectors were noted to be utilizing a zero degree transducer for lamination examination and a 70 degree transducer and wedge combination for shear wave examination. Several areas were marked for repair and later in the shift ABF welding personnel Jordan Hazalaar began the excavation process along with a helper. At this time approximately 20 areas have been marked for repair along the entire weld face designated A. At the end of the QA inspector's shift the ABF personnel had performed 10 of the excavations and shaped them for welding, however no welding was observed on this date by the QA inspector. A review of the excavation by the QA inspector revealed the majority of the rejectable areas depicted linear porosity in the weld and a digital photo is included in the body of this report for general information.
