**DEPARTMENT OF TRANSPORTATION**

Contract #: 04-0120F4Cty: SF/ALA Rte: 80 PM: 13.2/13.9File #: 1.28**WELDING INSPECTION REPORT****Resident Engineer:** Pursell, Gary**Address:** 333 Burma Road**City:** Oakland, CA 94607**Report No:** WIR-013832**Date Inspected:** 23-Apr-2010**Project Name:** SAS Superstructure**OSM Arrival Time:** 700**Prime Contractor:** American Bridge/Fluor Enterprises, a JV**OSM Departure Time:** 1530**Contractor:** American Bridge/Fluor Enterprises, a JV**Location:** Job Site**CWI Name:** See Below**CWI Present:** Yes No**Inspected CWI report:** Yes No N/A**Rod Oven in Use:** Yes No N/A**Electrode to specification:** Yes No N/A**Weld Procedures Followed:** Yes No N/A**Qualified Welders:** Yes No N/A**Verified Joint Fit-up:** Yes No N/A**Approved Drawings:** Yes No N/A**Approved WPS:** Yes No N/A**Delayed / Cancelled:** Yes No N/A**Bridge No:** 34-0006**Component:** Orthotropic Box Girders (OBG)**Summary of Items Observed:**

**Field Splice 2E/3E Face C2 (Outside)**

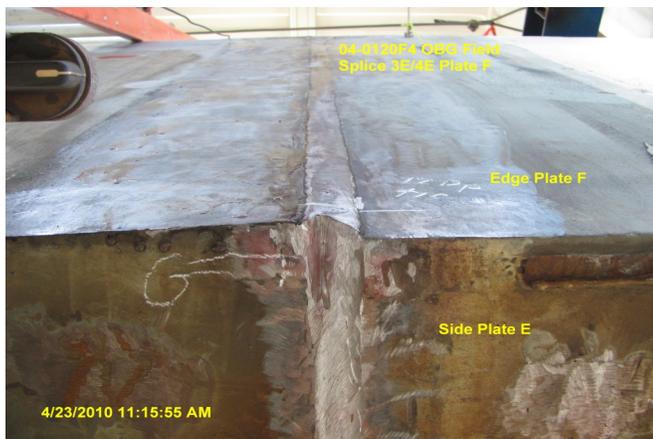
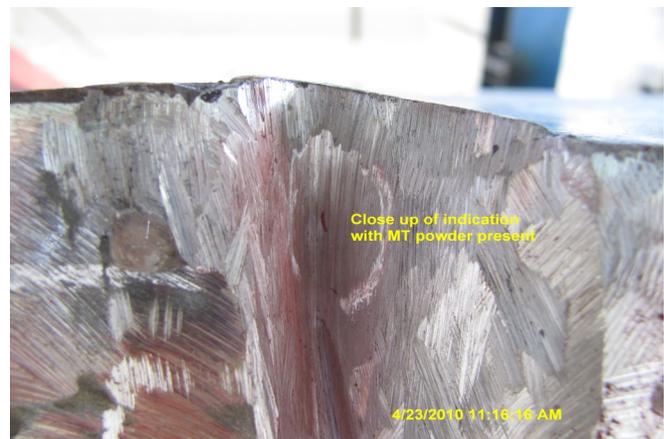
The QA inspector noted and periodically observed ABF welding operators Rory Hogan and Jeremy Dolan performing the grinding operations for face E on the second side (Outside). The welding operators continued setting the equipment up and periodically performing the operation throughout the shift. The work was not completed on this date or turned over to QC for verification to the QA inspector's knowledge but appeared to be progressing in general conformance with the contract documents.

The QA inspector periodically observed QC inspector Jessie Cayabyab performing ultrasonic testing (UT) on this date for this location. The QC inspector was noted to be utilizing a zero degree transducer for lamination examination and a 70 degree transducer and wedge combination for shear wave examination. The QC inspector relayed to the QA inspector no rejectable indications were discovered at the time of review with the exception of 1 localized area close in proximity to the intersection between the edge plate and the side plate. See digital photo included in the body of this report for clarification. The QA inspector reviewed this area visually as a portion of the weld metal has been previously removed by grinding. The QA inspector performed an initial UT review of approximately 10% of the total length for this weld with no rejectable indications noted at the time of review and relayed to QA inspectors Rick Bettencourt and Dan Reyes the repair would need to be reviewed after completion. A TL-6027 will be generated for this item for this date.
