**DEPARTMENT OF TRANSPORTATION**

Contract #: 04-0120F4Cty: SF/ALA Rte: 80 PM: 13.2/13.9File #: 1x.28**WELDING INSPECTION REPORT****Resident Engineer:** Pursell, Gary**Address:** 333 Burma Road**City:** Oakland, CA 94607**Report No:** WIR-013839**Date Inspected:** 30-Apr-2010**Project Name:** SAS Superstructure**OSM Arrival Time:** 1000**Prime Contractor:** American Bridge/Fluor Enterprises, a JV**OSM Departure Time:** 1830**Contractor:** American Bridge/Fluor Enterprises, a JV**Location:** Job Site

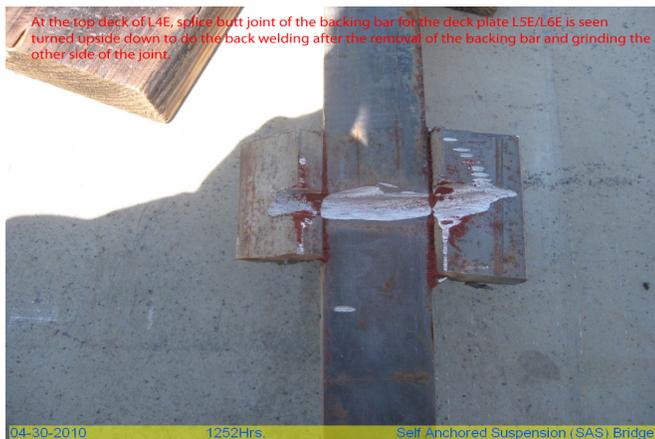
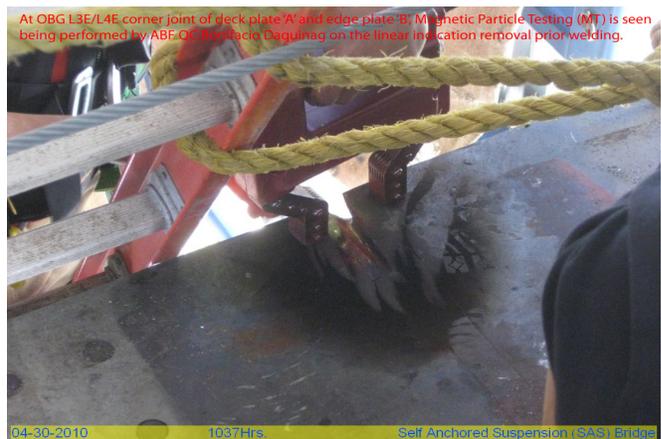
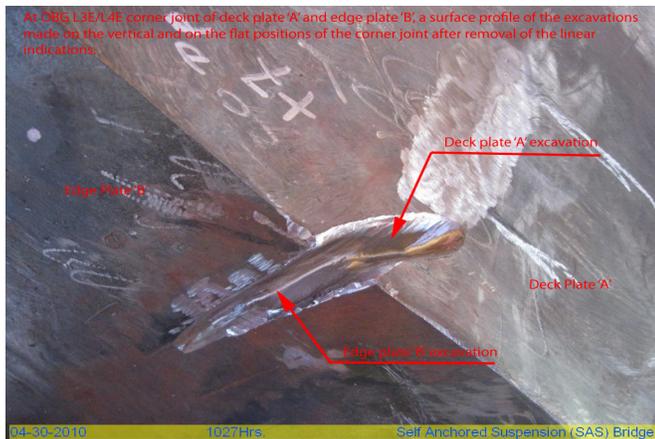
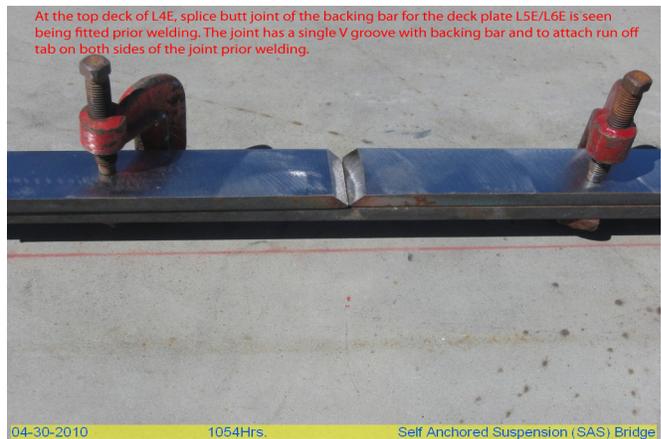
At OBG L3E/L4E top deck plate 'A' and edge plate 'B' outside, QA randomly observed ABF/JV qualified welder Jordan Hazelaar ID #2135 perform CJP groove welding repair. The welder was observed welding in the 3G (vertical) and 1G (flat) positions utilizing Shielded metal Arc Welding (SMAW) with 1/8" diameter E7018H4R electrode implementing welding procedure ABF-WPS-D15-1000-Repairs. The weld repairs were excavated to a boat shape having a dimension of 110mm long X 20mm wide X 25mm deep for plate 'A' and 55mm long X 25mm wide X 20mm deep for plate 'B'. The complete removal of the linear indications on the excavations was confirmed thru Magnetic Particle Testing (MT). Prior welding, the excavations were again tested using Magnetic Particle Testing at preheated temperature of greater than 150 degree Fahrenheit and also confirmed removal of linear indications. ABF QC Bonifacio Daquinag was noted monitoring the welder. During the shift, the welder has completed the two welding repairs and was visually accepted by ABF QC.

At top deck of OBG L4E, QA observed randomly observed ABF/JV qualified welder Rick Clayborn perform CJP groove welding on the splice butt joint of backing bar for OBG L5E/L6E top deck plate 'A' splice butt joint. The

welder was observed welding in the 1G (flat) position utilizing Shielded metal Arc Welding (SMAW) with 1/8” diameter E7018H4R electrode implementing welding procedure ABF-WPS-D15-1040C. The weld joint has a single V prep with backing bar and run off tab on both sides. After welding one side, the backing bar is turned upside down and the backing bar removed and ground/cleaned and tested with Magnetic Particle Testing (MT) and back welded. ABF QC Barry Blake was noted monitoring the welder and his welding parameters. During the shift, the welder has completed four splice butt joints into this backing bar mentioned above. ABF QC performed Visual Test (VT) and MT after the welding completion and was also Ultrasonic Tested (UT) by ABF QC Steve Mc Connell afterwards.

At OBG L2E/L3E side plate ‘E’ outside, QA randomly observed ABF/JV qualified welder Mitch Sittinger perform CJP groove welding repair. The welder was observed welding in the 4G (overhead) position utilizing Shielded metal Arc Welding (SMAW) with 1/8” diameter E7018H4R electrode implementing welding procedure ABF-WPS-D15-1000-Repairs. The weld repairs were excavated to a boat shape with one repair having a dimension of 100mm long X 19mm wide X 10mm deep. The repair excavations were preheated to more than 140 degree Fahrenheit using propane gas torch prior welding. During the shift, ABF QC William Sherwood was noted monitoring the welder. Prior welding, ABF QC William Sherwood was also observed performing Magnetic Particle Testing (MT) on the repair excavations. During the shift, the welder has completed three welding repairs outside and was noted moving inside the box to perform more repairs inside.
