**DEPARTMENT OF TRANSPORTATION**

Contract #: 04-0120F4Cty: SF/ALA Rte: 80 PM: 13.2/13.9File #: 99.28**WELDING INSPECTION REPORT****Resident Engineer:** Pursell, Gary**Address:** 333 Burma Road**City:** Oakland, CA 94607**Report No:** WIR-013914**Date Inspected:** 05-May-2010**Project Name:** SAS Superstructure**OSM Arrival Time:** 700**Prime Contractor:** American Bridge/Fluor Enterprises, a JV**OSM Departure Time:** 1900**Contractor:** Zhenhua Port Machinery Company, Ltd (ZPMC) Chanxing Island**Location:** Shanghai, China

# WELDING INSPECTION REPORT

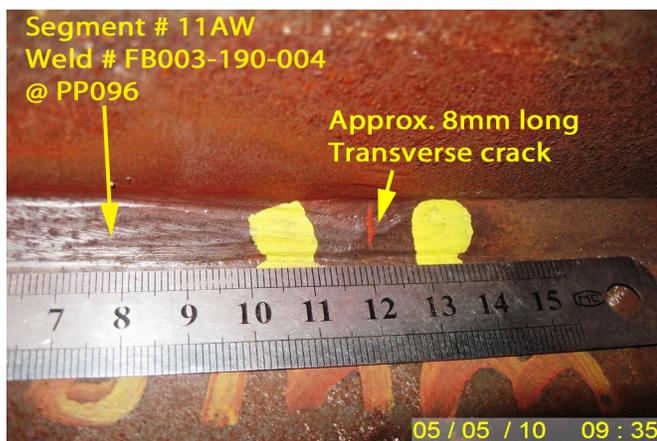
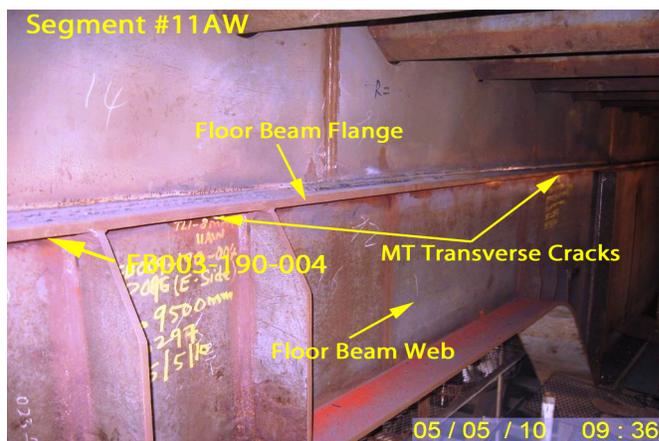
Description of Incident: During random Quality Assurance Visual review of welds located on segment 11AW, this Quality Assurance Inspector (QA) discovered three (3) Transverse linear indications measuring approximately 8 to 10mm in lengths. The indications were discovered visually and confirmed by Magnetic particle Testing (MT) by Caltrans QA. ZPMC Quality Control MT Technicians claimed that magnetic particle testing have been performed on these welds that require 25% MT. The indications are clearly marked on the material near the weld. The weld numbers are identified as FB009-038-004 and FB003-190-004. The panel point is identified as a PP096. This weld is a Fillet weld joining the Floor beam Web to Flange. The Floor Beam Flange weld is identified as Non SPCM. For further information, please see the attached pictures
