**DEPARTMENT OF TRANSPORTATION**

Contract #: 04-0120F4Cty: SF/ALA Rte: 80 PM: 13.2/13.9File #: 1.28**WELDING INSPECTION REPORT****Resident Engineer:** Pursell, Gary**Address:** 333 Burma Road**City:** Oakland, CA 94607**Report No:** WIR-013940**Date Inspected:** 07-May-2010**Project Name:** SAS Superstructure**OSM Arrival Time:** 630**Prime Contractor:** American Bridge/Fluor Enterprises, a JV**OSM Departure Time:** 1500**Contractor:** American Bridge/Fluor Enterprises, a JV**Location:** Job Site**CWI Name:** Listed below.**CWI Present:** Yes No**Inspected CWI report:** Yes No N/A**Rod Oven in Use:** Yes No N/A**Electrode to specification:** Yes No N/A**Weld Procedures Followed:** Yes No N/A**Qualified Welders:** Yes No N/A**Verified Joint Fit-up:** Yes No N/A**Approved Drawings:** Yes No N/A**Approved WPS:** Yes No N/A**Delayed / Cancelled:** Yes No N/A**Bridge No:** 34-0006**Component:** Orthotropic Box Girders**Summary of Items Observed:**

# WELDING INSPECTION REPORT

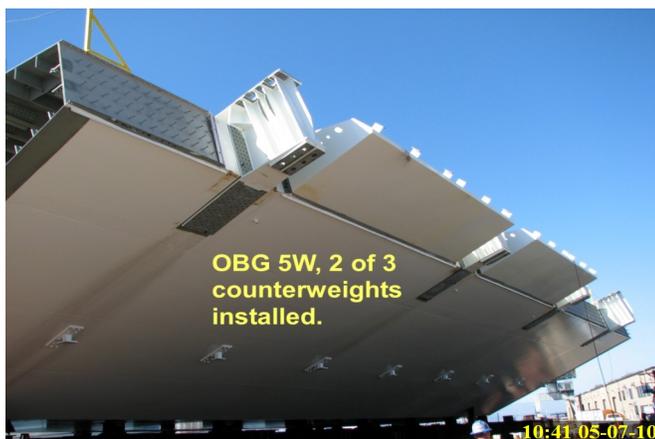
The QAI observed ABF activities at the Pier 7 location. The QAI did not observe any Quality Control (QC) Inspectors present. The QAI noted that ABF personnel are setting counterweights onto the OBG segment 5W. See the attached photo. The QAI noted that ABF personnel are welding on barges and job related equipment and assembling parts of the temporary trestle on the barges at Pier 7. The QAI did not observe any personnel welding on bridge components. The QAI noted that this work was in progress until the end of the shift. The QAI continued reviewing the contractor's submitted welding reports, submittal # 1536 Revision 4. The review was in progress at the end of this shift.
