DEPARTMENT OF TRANSPORTATION

Contract #: 04-0120F4Cty: SF/ALA Rte: 80 PM: 13.2/13.9File #: 1x.28**WELDING INSPECTION REPORT****Resident Engineer:** Pursell, Gary**Address:** 333 Burma Road**City:** Oakland, CA 94607**Report No:** WIR-013945**Date Inspected:** 04-May-2010**Project Name:** SAS Superstructure**OSM Arrival Time:** 1000**Prime Contractor:** American Bridge/Fluor Enterprises, a JV**OSM Departure Time:** 1830**Contractor:** American Bridge/Fluor Enterprises, a JV**Location:** Job Site

WELDING INSPECTION REPORT

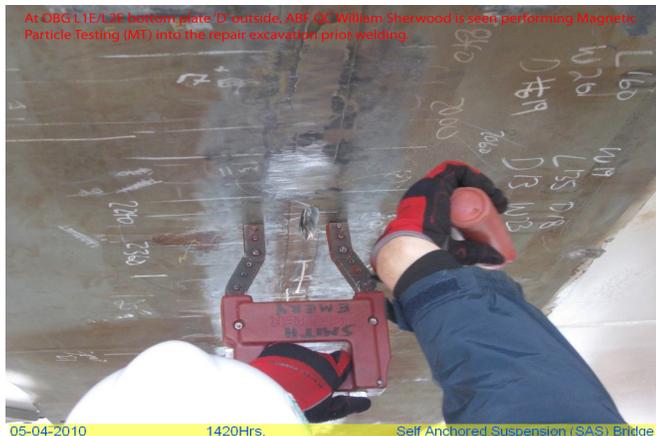
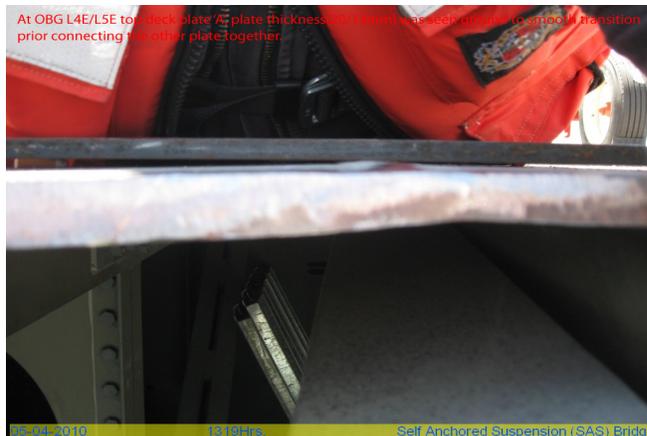
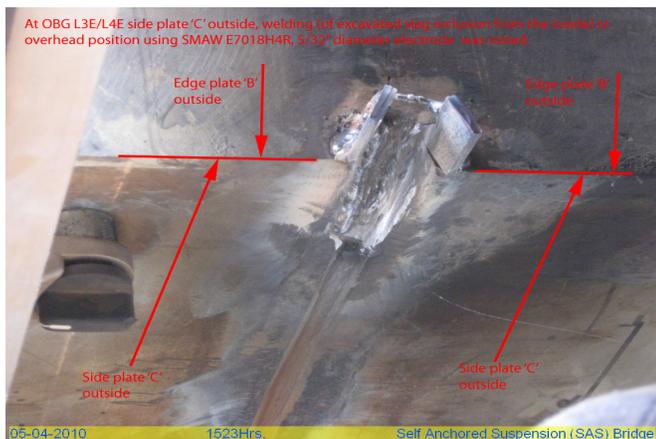
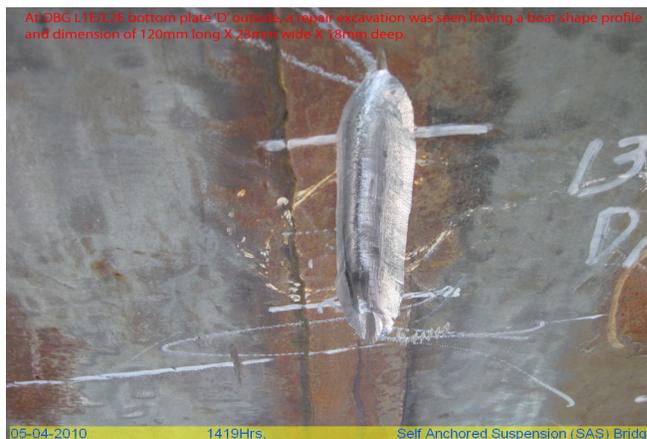
At OBG L1E/L2E bottom plate 'D' outside, QA randomly observed ABF/JV qualified welder Mitch Sittinger perform CJP groove welding repair. The welder was observed welding in the 4G (overhead) position utilizing Shielded metal Arc Welding (SMAW) with 1/8" diameter E7018H4R electrode implementing welding procedure ABF-WPS-D15-1000-Repairs. The weld repairs were excavated to a boat shape with one repair having a dimension of 120mm long X 23mm wide X 18mm deep. The repair excavations were preheated to more than 140 degree Fahrenheit using propane gas torch prior welding. During the shift, ABF QC William Sherwood was noted monitoring the welder. Prior welding, ABF QC William Sherwood was also observed performing Magnetic Particle Testing (MT) on the repair excavations. During the shift, the welder has completed three welding repair outside and was noted working on the 4th repair at the end of the shift.

At OBG L4E/L5E, ABF personnel were noted moving the OBG Lift 5E close to OBG L4E. Prior to connecting the two splice together, two ABF personnel were noted grinding the top deck transition of plate A1 (20/14mm) and A5 (14/20mm) at the bottom sides of the plates. QA also observed ABF QC Mike Johnson monitoring the grinding of the two transitions and during conversation with QC, Mike Johnson mentioned to QA about finding the transition appears acceptable.

At OBG L3E/L4E side plate 'C' outside, QA randomly observed ABF/JV qualified welder Rory Hogan ID #3186

perform welding on the excavated slag inclusion. The welder was using Shielded Metal Arc Welding (SMAW) with E7018H4R, 5/32" diameter electrode in 4G (overhead) position. During welding, ABF QC Jim Cunningham was noted monitoring the welder and his welding parameters. At the end of the shift, welding was still continuing.

While welder Rory Hogan was welding on the excavated slag inclusion at the side plate 'C', welder Jeremy Dolman was noted preparing their welding equipment in preparation for the 4G FCAW-G welding of the back welding.
