**DEPARTMENT OF TRANSPORTATION**

Contract #: 04-0120F4Cty: SF/ALA Rte: 80 PM: 13.2/13.9File #: 1x.28**WELDING INSPECTION REPORT****Resident Engineer:** Pursell, Gary**Address:** 333 Burma Road**City:** Oakland, CA 94607**Report No:** WIR-013960**Date Inspected:** 05-May-2010**Project Name:** SAS Superstructure**OSM Arrival Time:** 1000**Prime Contractor:** American Bridge/Fluor Enterprises, a JV**OSM Departure Time:** 1830**Contractor:** American Bridge/Fluor Enterprises, a JV**Location:** Job Site

# WELDING INSPECTION REPORT

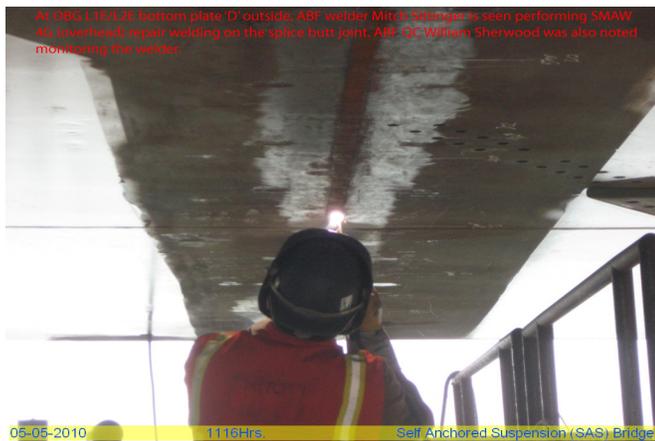
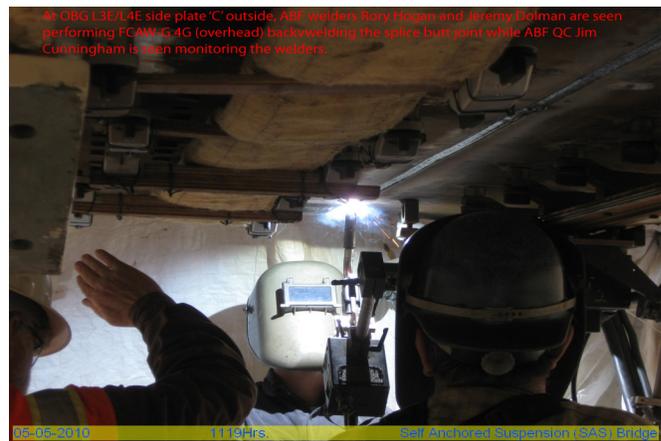
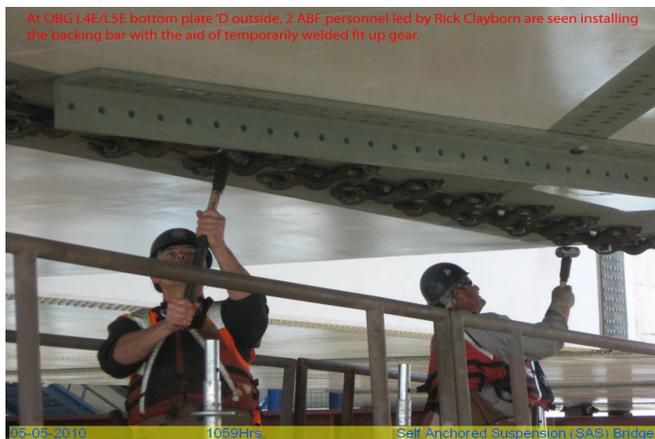
QA randomly observed ABF/JV qualified welders Rory Hogan (ID #3186) and Jeremy Dolman (ID #5042) continue perform CJP groove (splice) back welding fill to cover pass on Orthotropic Box Girder (OBG) L3E/L4E plate 'C' (0mm to 4280mm / outside). The welders were observed welding in the 4G (overhead) position utilizing a dual shield Flux Cored Arc Welding (FCAW-G) with E71T-1M, 1/16" diameter wire electrode and implementing Caltrans approved Welding Procedure Specification (WPS) ABF-WPS-D15-3110-4. The welder was using a track mounted welder holder assembly that is remotely controlled. The joint being welded has the backing bar gouged using the Esab Plasma Arc machine and was ground smooth. The gouged and ground splice butt joint was also Non Destructive Testing (NDT) tested using the Magnetic Particle Testing (MT). The splice joint was preheated and maintained to greater than 200 degree Fahrenheit using Miller Proheat 35 Induction Heating System located at the other side of the plate prior/during welding and the vicinity was properly protected from wind. During welding, ABF Quality Control (QC) Jim Cunningham was noted monitoring the welding parameters of the welder. Before the end of the shift, welding in this location was completed and the welder was noted starting welding on location 4280mm to 8555mm).

At OBG L1E/L2E bottom plate 'D' outside, QA randomly observed ABF/JV qualified welder Mitch Sittinger continue perform CJP groove welding repair. The welder was observed welding in the 4G (overhead) position utilizing Shielded metal Arc Welding (SMAW) with 1/8" diameter E7018H4R electrode implementing welding

procedure ABF-WPS-D15-1000-Repairs. The weld repairs were excavated to a boat shape. The repair excavations were preheated to more than 140 degree Fahrenheit using propane gas torch prior welding. During the shift, ABF QC William Sherwood was noted monitoring the welder. Prior welding, ABF QC William Sherwood was also observed performing Magnetic Particle Testing (MT) on the repair excavations. During the shift, the welder has completed three welding repair outside and was noted working on the weld underfills of the back weld reinforcement at the end of the shift.

At OBG L4E/L5E bottom plate 'D' outside, QA observed ABF welder Rick Clayborn install backing bar with the aid of the fit up gear. During the shift, QA noted the installation of the backing bar in this area was complete.

At L2E/L3E side plates 'C' and 'E' inside, this QA performed 10% Magnetic Particle Testing (MT) on the weld cover reinforcement of the splice butt joint. QA used a Parker Contour Probe electromagnetic yoke with red magnetic powder as detecting media. QA found no significant indications during the test.
