DEPARTMENT OF TRANSPORTATION

Quality Assurance and Source Inspection

Contract #: 04-0120F4Cty: SF/ALA Rte: 80 PM: 13.2/13.9File #: 1x.28**WELDING INSPECTION REPORT****Resident Engineer:** Pursell, Gary**Address:** 333 Burma Road**City:** Oakland, CA 94607**Report No:** WIR-013964**Date Inspected:** 11-May-2010**Project Name:** SAS Superstructure**OSM Arrival Time:** 1000**Prime Contractor:** American Bridge/Fluor Enterprises, a JV**OSM Departure Time:** 1830**Contractor:** American Bridge/Fluor Enterprises, a JV**Location:** Job Site**CWI Name:** Jim Cunningham**CWI Present:** Yes No**Inspected CWI report:** Yes No N/A**Rod Oven in Use:** Yes No N/A**Electrode to specification:** Yes No N/A**Weld Procedures Followed:** Yes No N/A**Qualified Welders:** Yes No N/A**Verified Joint Fit-up:** Yes No N/A**Approved Drawings:** Yes No N/A**Approved WPS:** Yes No N/A**Delayed / Cancelled:** Yes No N/A**Bridge No:** 34-0006**Component:** Orthotropic Box Girder**Summary of Items Observed:**

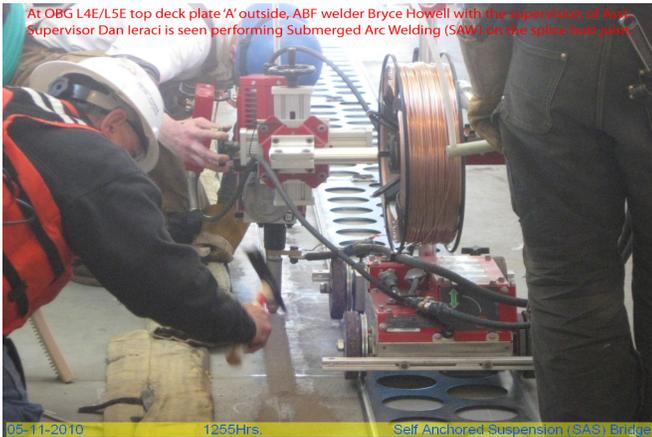
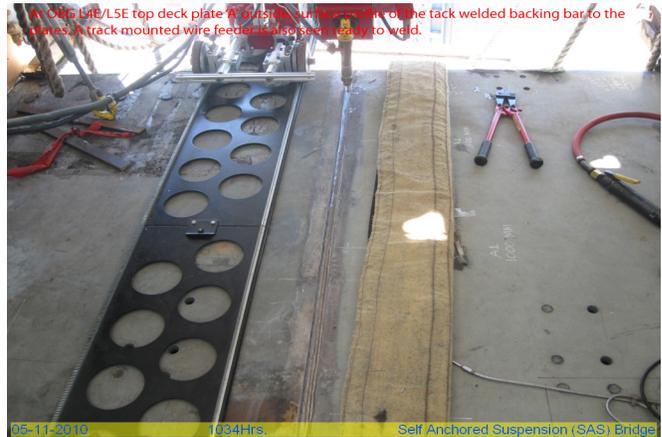
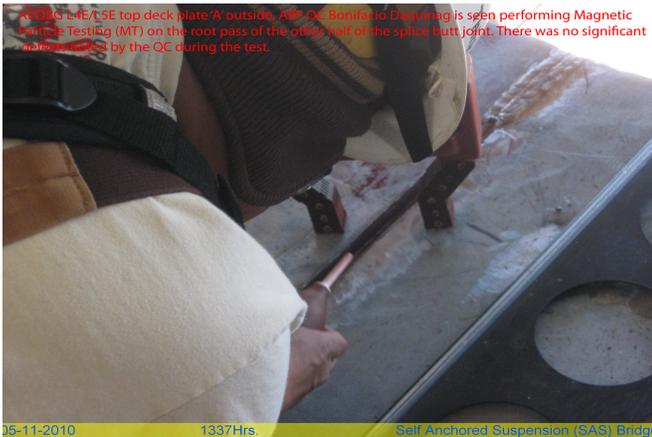
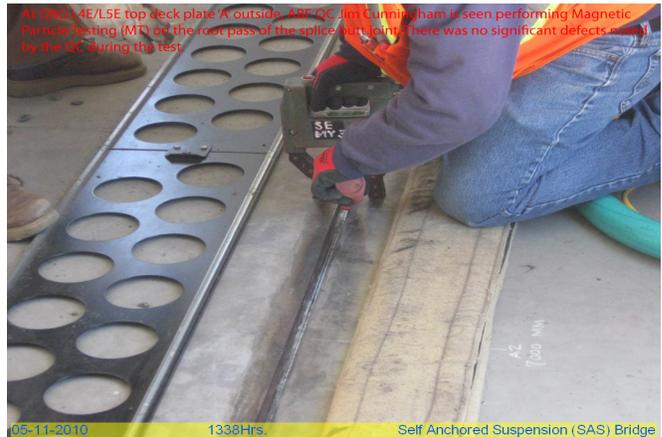
At OBG L4E/L5E plate A1 to A5, two certified ABF welders Bryce Howell ID #5591 and Jordan Hazelaar (ID #2135) were noted performing flat (1G) Submerged Arc Welding (SAW). The welders were utilizing F7A6-EM12K-H8, 3.2mm electrode with corresponding Esab OK Flux 10.62 flux and implementing Caltrans approved Welding Procedure Specification (WPS) ABF-WPS-D15-4042B-1. The two welders were welding simultaneously in two separate locations (A1 to A3 and A3 to A5) with two separate welding machines using a track mounted Lincoln Electric "Cruiser Tractor" wire feeder. The plates were preheated to >150 degree F using two Miller Proheat 35 Induction Heating System located at the other side of the plate prior/during welding.

Welding parameters were monitored by two separate ABF/QC named Bonifacio Daquinag (for Bryce Howell) and Jim Cunningham (for Jordan Hazelaar). Parameters measured by QA during welding were 580 amperes, 32.2 volts and 390mm per minute travel speed and 560 amperes, 32.0 volts and 380mm per minute travel speed respectively for the two welders. QA noted the welding parameters, the workmanship and appearance of the completed fill and cover passes satisfactory and were deemed acceptable to contract requirements.

After welding the root pass, ABF QC Bonifacio Daquinag and Jim Cunningham were observed performing 100% Magnetic Particle Testing (MT) on the root. QC Bonifacio Daquinag was noted using a Parker Contour Probe electromagnetic yoke while QC Jim Cunningham was noted using a Magnaflux electromagnetic yoke. Both QC were noted using the same red magnetic powder as detecting media. During the test, there was no significant

indications noted by the QC and so the welders resumed filling more passes into the weld splice butt joint.

At OBG L3E/L4E side plates 'C' and 'E' and bottom plate 'D' inside, this QA performed a 10% Magnetic Particle Testing (MT) using a Parker Contour Probe electromagnetic yoke with corresponding red magnetic powder as detecting media to the splice butt joints. The surface profiles of the joints were as welded and cleaned with wire brush. There were no significant defects noted during the test.
