DEPARTMENT OF TRANSPORTATION

Quality Assurance and Source Inspection

Contract #: 04-0120F4Cty: SF/ALA Rte: 80 PM: 13.2/13.9File #: 1.28**WELDING INSPECTION REPORT****Resident Engineer:** Pursell, Gary**Address:** 333 Burma Road**City:** Oakland, CA 94607**Report No:** WIR-013966**Date Inspected:** 06-May-2010**Project Name:** SAS Superstructure**OSM Arrival Time:** 630**Prime Contractor:** American Bridge/Fluor Enterprises, a JV**OSM Departure Time:** 1500**Contractor:** American Bridge/Fluor Enterprises, a JV**Location:** Job Site**CWI Name:** Bernard Docena, Steve McConnell, CWI Present**Yes** **No****Inspected CWI report:** **Yes** **No** **N/A****Rod Oven in Use:** **Yes** **No** **N/A****Electrode to specification:** **Yes** **No** **N/A****Weld Procedures Followed:** **Yes** **No** **N/A****Qualified Welders:** **Yes** **No** **N/A****Verified Joint Fit-up:** **Yes** **No** **N/A****Approved Drawings:** **Yes** **No** **N/A****Approved WPS:** **Yes** **No** **N/A****Delayed / Cancelled:** **Yes** **No** **N/A****Bridge No:** 34-0006**Component:** SAS OBG 1W/2W-C, 1W/2W-D/S, 4E/5E**Summary of Items Observed:**

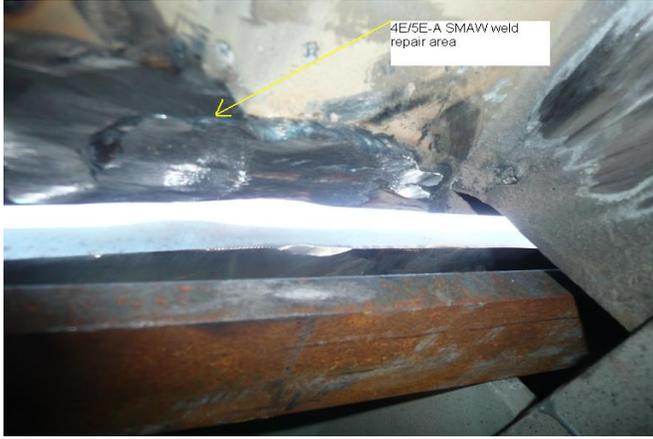
The QA Inspector randomly observed the ABF welder Chin Fai Tsui had installed round bar stock in the double V-groove opposite the side where joint restoration is being performed. The QA Inspector noted the round bar stock is placed in the groove vertically and SMAW butter passes are performed on the opposite side. The QA Inspector noted once the weld joint has been restored to the original joint configuration, the round bar stock will be removed and welding can be performed as described in the approved WPS identified as ABF-WPS-D1.5-2010-C. The QA Inspector randomly observed the above identified welder was performing SMAW butter passes on all three of the above identified weld joints during the QA Inspectors shift. The QA Inspector randomly observed the ABF welder to be utilizing 1/8" E7018 low hydrogen electrodes with 135 Amps. The QA Inspector noted the SMAW parameters appeared to be in general compliance with the contract requirements.
