DEPARTMENT OF TRANSPORTATION

Quality Assurance and Source Inspection

Contract #: 04-0120F4Cty: SF/ALA Rte: 80 PM: 13.2/13.9File #: 69.28**WELDING INSPECTION REPORT****Resident Engineer:** Pursell, Gary**Address:** 333 Burma Road**City:** Oakland, CA 94607**Report No:** WIR-013967**Date Inspected:** 14-May-2010**Project Name:** SAS Superstructure**OSM Arrival Time:** 700**Prime Contractor:** American Bridge/Fluor Enterprises, a JV**OSM Departure Time:** 1900**Contractor:** Zhenhua Port Machinery Company, Ltd (ZPMC), Changxing Island **Location:** Shanghai, China**CWI Name:** Li Yang**CWI Present:** Yes No**Inspected CWI report:** Yes No N/A**Rod Oven in Use:** Yes No N/A**Electrode to specification:** Yes No N/A**Weld Procedures Followed:** Yes No N/A**Qualified Welders:** Yes No N/A**Verified Joint Fit-up:** Yes No N/A**Approved Drawings:** Yes No N/A**Approved WPS:** Yes No N/A**Delayed / Cancelled:** Yes No N/A**Bridge No:** 34-0006**Component:** OBG**Summary of Items Observed:**

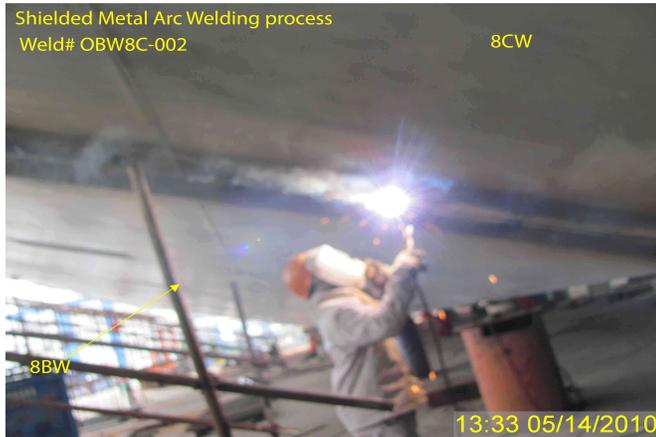
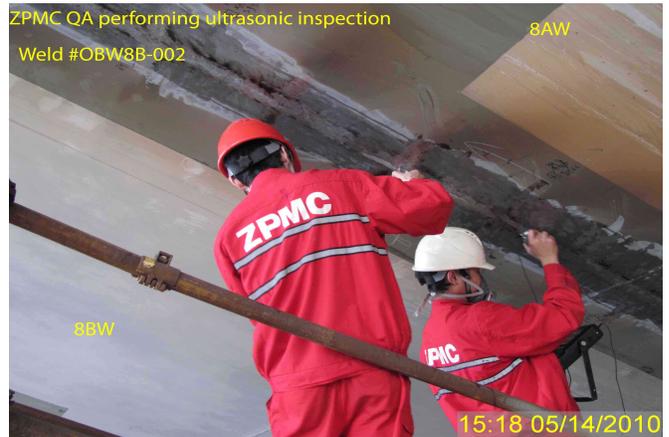
This Quality Assurance (QA) Inspector observed ZPMC QA Inspector performing ultrasonic inspection on side panel splice weld between OBG segment 8AW and 8BW (Counter weight side).

Unless otherwise noted, all work observed on this dated appeared to generally comply with applicable contract documents.
