**DEPARTMENT OF TRANSPORTATION**

Contract #: 04-0120F4Cty: SF/ALA Rte: 80 PM: 13.2/13.9File #: 1.28**WELDING INSPECTION REPORT****Resident Engineer:** Pursell, Gary**Address:** 333 Burma Road**City:** Oakland, CA 94607**Report No:** WIR-013984**Date Inspected:** 05-May-2010**Project Name:** SAS Superstructure**OSM Arrival Time:** 630**Prime Contractor:** American Bridge/Fluor Enterprises, a JV**OSM Departure Time:** 1500**Contractor:** American Bridge/Fluor Enterprises, a JV**Location:** Job Site

**Bridge No:** 34-0006**Component:** SAS OBG 1W/2W-C, 3W/4W-A, 4E/5E**Summary of Items Observed:**

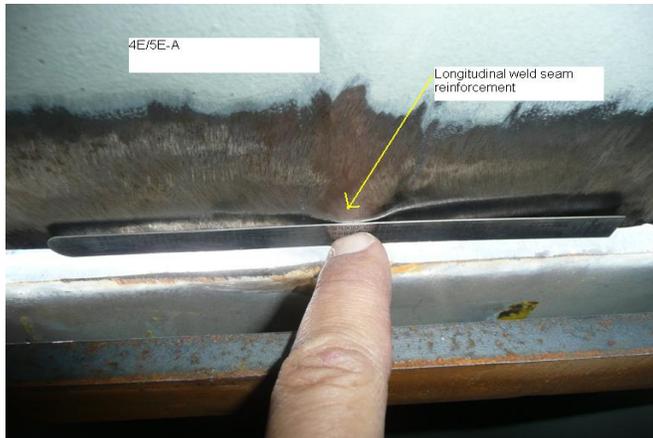
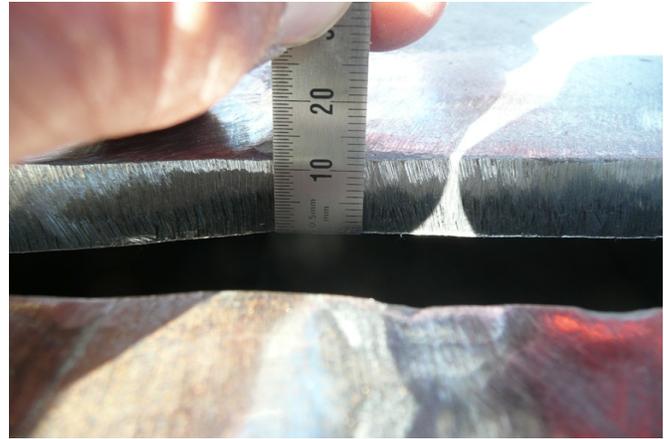
The QA Inspector randomly observed and noted the transition longitudinal weld splices on the top deck plate identified as "A" appeared to have been ground and transitioned to allow the steel backing to fit up with intimate contact. The QA Inspector observed the contractor appeared to have over ground the 20mm to 14mm transition on the North side of the top deck plate or weld segment A1. The QA Inspector noted the 14mm top deck plate appeared to have been inadvertently over ground or dished out to a point where the 14mm top deck plate had been reduced to 10mm near the edge of the bevel (pictured). In addition the QA Inspector noted the longitudinal deck welds which were welded and completed at ZPMC in China did not appear to be ground or blended in a manner which would allow the steel backing to fit up the bottom the top deck plate with intimate contact or with a gap which is less than 2mm. The QA Inspector noted some grinding did appear to have been completed, but it was noted the grinding only appeared to have removed the paint coating and not sufficient weld reinforcement to allow the steel backing to fit tightly (pictured below). The QA Inspector informed the QA Task Lead Bill Levell and ABF Welding Quality Control Manager (WQCM) Jim Bowers of the above identified issue. (see summary of conversations)

The QA Inspector Rick Bettencourt and Bill Levell had a meeting and a conversation with the WQCM Jim Bowers. Mr. Levell informed Mr. Bowers, the issues with the transition being over ground and the top deck plate being reduced to 10mm would be an easy fix at the current time to weld and grind the area. Mr. Levell went on to inform Mr. Bowers, the longitudinal butt weld reinforcement did not appear to have been ground sufficiently enough to allow the steel backing to fit up with intimate contact with the top deck plate. In addition Mr. Levell informed Mr. Bowers currently it would not be difficult to correct the issues, prior to the steel backing bar being fit up and wedged into place. Initially Mr. Bowers informed the QA Inspectors Bill Levell and Rick Bettencourt, it would be difficult to correct the above described issues and that ABF was not required to do so. In addition Mr. Bowers informed the QA Inspectors, If Caltrans METS would like those items fixed, then Caltrans would need to direct them to do so. Mr. Levell informed Mr. Bowers no such direction would be issued nor was Mr. Levell implying any direction was required. Mr. Levell reiterated that in past meetings ABF, Jim Bowers included informed Caltrans METS that ABF is and will do all that they can to allow the steel backing to fit up with a gap less than 2mm. In addition Mr. Levell informed Mr. Bowers, that by not grinding the longitudinal weld reinforcement flush and by not correcting the over ground area by welding, it did not appear ABF was doing all that they could to prevent and fit up deficiencies with the steel backing bar. Mr. Bowers responded it could not be determined at the current time whether any fit up issues would arise from the current condition of the weld joint. Mr. Levell agreed with Mr. Bowers but reiterated by correcting the issues pointed out, it would likely create insurance that the steel backing would fit up correctly and in compliance with no gaps exceeding 2mm. Mr. Bowers added again ABF was not required to perform any additional grinding or welding with out direction from Caltrans METS. In a later conversation with Mr. Bowers and Mr. Levell, Mr. Bowers agreed to make an attempt to correct the over ground area by welding and to perform additional grinding at the longitudinal weld reinforcement to ensure the steel backing fits up with intimate contact.
