DEPARTMENT OF TRANSPORTATION

Contract #: 04-0120F4Cty: SF/ALA Rte: 80 PM: 13.2/13.9File #: 1.28**WELDING INSPECTION REPORT****Resident Engineer:** Pursell, Gary**Address:** 333 Burma Road**City:** Oakland, CA 94607**Report No:** WIR-013987**Date Inspected:** 11-May-2010**Project Name:** SAS Superstructure**OSM Arrival Time:** 630**Prime Contractor:** American Bridge/Fluor Enterprises, a JV**OSM Departure Time:** 1500**Contractor:** American Bridge/Fluor Enterprises, a JV**Location:** Job Site

WELDING INSPECTION REPORT

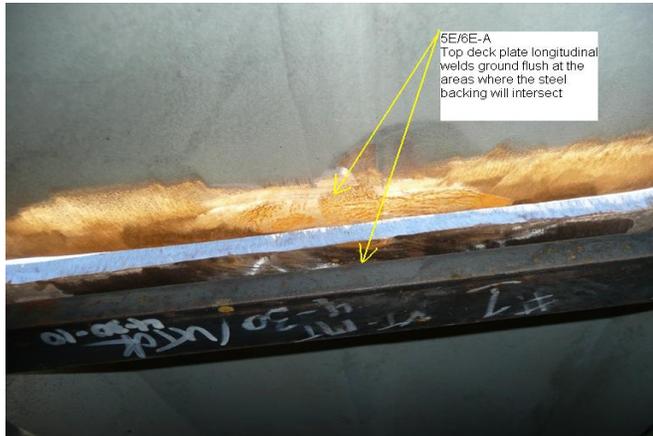
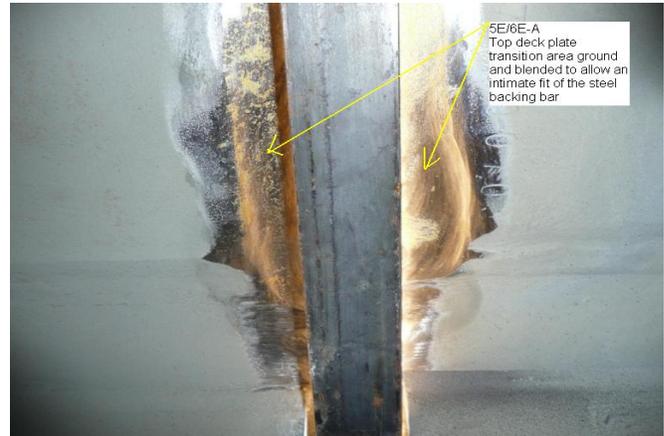
V-groove opposite the side where joint restoration is being performed. The QA Inspector noted the round bar stock is placed in the groove vertically and SMAW butter passes are performed on the opposite side. The QA Inspector noted once the weld joint has been restored to the original joint configuration, the round bar stock will be removed and welding can be performed as described in the approved WPS identified as ABF-WPS-D1.5-2010-C. The QA Inspector randomly observed the above identified welder was performing SMAW butter passes on all three of the above identified weld joints during the QA Inspectors shift. The QA Inspector randomly observed the ABF welder to be utilizing 1/8" E7018 low hydrogen electrodes with 135 Amps. The QA Inspector noted the SMAW parameters appeared to be in general compliance with the contract requirements.
