DEPARTMENT OF TRANSPORTATION

Quality Assurance and Source Inspection

Contract #: 04-0120F4Cty: SF/ALA Rte: 80 PM: 13.2/13.9File #: 1.28**WELDING INSPECTION REPORT****Resident Engineer:** Pursell, Gary**Address:** 333 Burma Road**City:** Oakland, CA 94607**Report No:** WIR-013989**Date Inspected:** 13-May-2010**Project Name:** SAS Superstructure**OSM Arrival Time:** 700**Prime Contractor:** American Bridge/Fluor Enterprises, a JV**OSM Departure Time:** 1500**Contractor:** American Bridge/Fluor Enterprises, a JV**Location:** Job Site**CWI Name:** See Below**CWI Present:** Yes No**Inspected CWI report:** Yes No N/A**Rod Oven in Use:** Yes No N/A**Electrode to specification:** Yes No N/A**Weld Procedures Followed:** Yes No N/A**Qualified Welders:** Yes No N/A**Verified Joint Fit-up:** Yes No N/A**Approved Drawings:** Yes No N/A**Approved WPS:** Yes No N/A**Delayed / Cancelled:** Yes No N/A**Bridge No:** 34-0006**Component:** Orthotropic Box Girders (OBG)**Summary of Items Observed:**

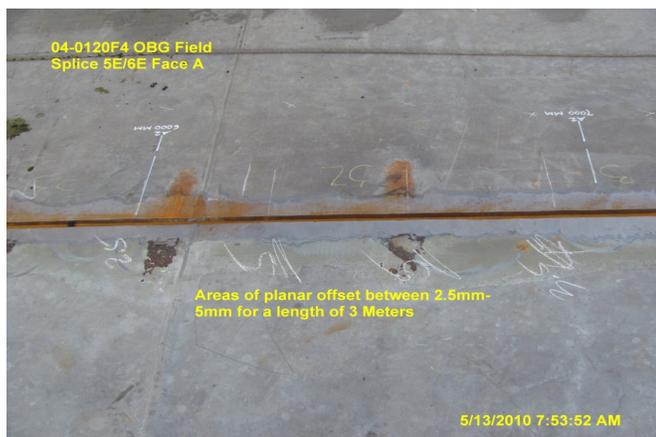
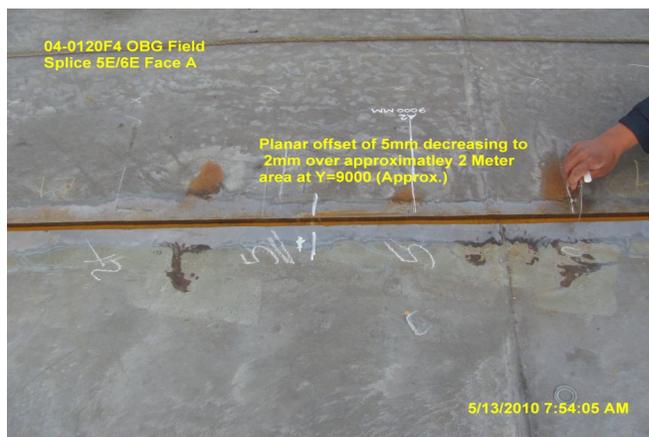
Field Splice 5E/6E Face A (Outside)

The QA inspector periodically observed ABF personnel Rick Clayborn performing SMAW in order to place temporary attachments to the deck plate for fit up purposes. QC inspector Bonafacio Daquinag was noted to be present in order to monitor the progression and adherence to the WPS designated as ABF-WPS-D1.5-1040-A. The welder was observed attempting to bring the previously identified areas of misalignment into conformance by the use of these attachments. Several areas ranging from 3-6mm for lengths of up to approximately 3 meters were identified by the QC inspector in which the welder was attempting to mitigate. The work progressed throughout the QA inspectors shift with minimal resolution in the areas and the QC inspector and the fit up welder relayed to the QA inspector it was unlikely any additional movement would be gained. The QA inspector relayed this information to QA inspector Rick Bettencourt and Dan Reyes for tracking purposes. See digital photos included in the body of this report for general information.
