DEPARTMENT OF TRANSPORTATION

Contract #: 04-0120F4Cty: SF/ALA Rte: 80 PM: 13.2/13.9File #: 1.28**WELDING INSPECTION REPORT****Resident Engineer:** Pursell, Gary**Address:** 333 Burma Road**City:** Oakland, CA 94607**Report No:** WIR-013992**Date Inspected:** 13-May-2010**Project Name:** SAS Superstructure**OSM Arrival Time:** 630**Prime Contractor:** American Bridge/Fluor Enterprises, a JV**OSM Departure Time:** 1500**Contractor:** American Bridge/Fluor Enterprises, a JV**Location:** Job Site

WELDING INSPECTION REPORT

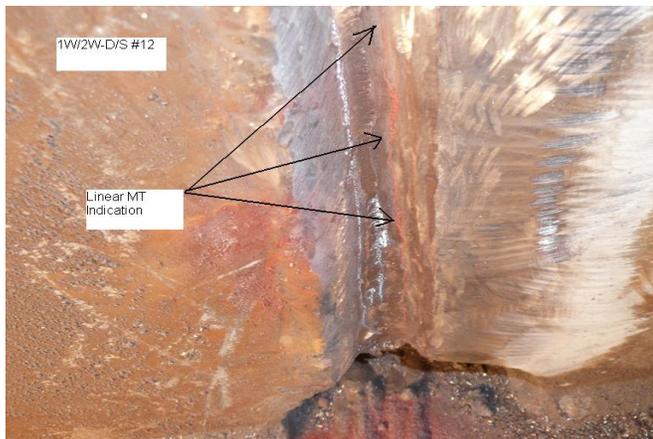
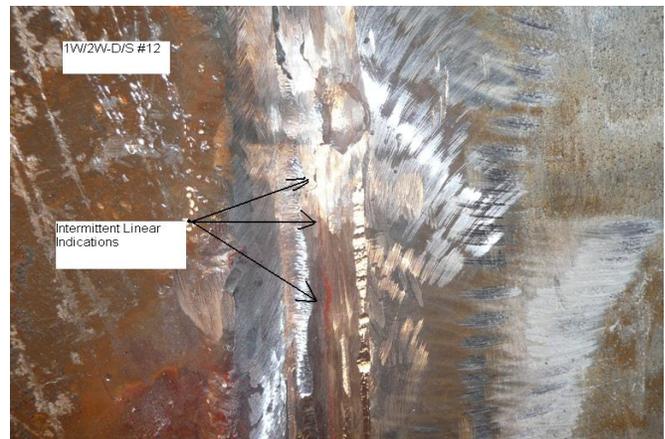
QA Inspector noted back gouged area was nearly completed. The ABF welder Rory Hogan informed the QA Inspector; during the back gouging process he located and saw many weld defects. Mr. Hogan went on to inform the QA Inspector he dug deeper and deeper in an attempt to remove all of the defects. Mr. Hogan said he would have to remove some of the remaining weld defects seen visibly with a grinder and make some SMAW repairs prior to performing the back weld.

The QA Inspector randomly observed the ABF welders Chun Fai Tsui and James performing grinding tasks of the longitudinal stiffeners. The QA Inspector noted approximately 10 of the 18 stiffener plates had been previously backed gouged and the round bar stock removed. The QA Inspector noted the ABF welders spent the majority of the QA Inspectors shift performing grinding tasks grinding and blending the back gouged weld joint to bright metal in preparation of back welding. The QA Inspector noted the SE QC Inspector Tom Pasqualone discovered and indicated intermittent linear indications in the back gouged joint of stiffener #12. The QA Inspector randomly observed the linear indications and noted the indications appeared to be indicative of lack of fusion between weld passes. The QA Inspector was informed by the QC Inspector Tom Pasqualone he did not believe the linear indications to be cracks rather lack of fusion. The QA Inspector randomly observed the QC Inspector and the ABF welder James Zhen spend the remainder of the QA Inspectors shift excavating and removing the linear MT indications. The QA Inspector noted after several attempts of grinding and MT it was observed by the QA Inspector the indications appeared to had been removed by grinding. The QA Inspector noted the SE QC Inspector Jesse Cayabayab was present and performed MT of longitudinal stiffeners #2 and #3 back gouged joint and noted no relevant indications were located at the time of the testing.
