Contract #: 04-0120F4Cty: SF/ALA Rte: 80 PM: 13.2/13.9File #: 13.28**WELDING INSPECTION REPORT****Resident Engineer:** Pursell, Gary**Address:** 333 Burma Road**City:** Oakland, CA 94607**Report No:** WIR-014003**Date Inspected:** 12-May-2010**Project Name:** SAS Superstructure**OSM Arrival Time:** 1000**Prime Contractor:** American Bridge/Fluor Enterprises, a JV**OSM Departure Time:** 1830**Contractor:** Oregon Iron Works Clackamas, Or.**Location:** Clackamas, OR

Hinge-K Pipe Beam Assembly 101A-4:

Hinge-K Pipe Beam Assembly 102A-3:

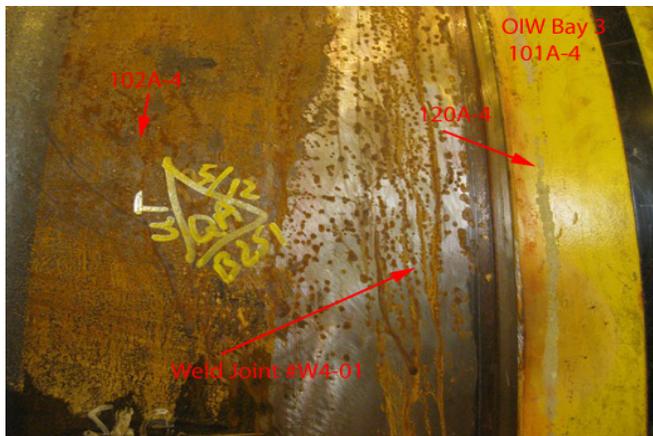
The QA Inspector performed additional Ultrasonic Testing (UT) on the weld joint, # W4-01, piece mark Fuse 120A-4 to Forging 102A-4. The QA Inspector performed this additional UT inspection on approximately 25% of the total length of the weld joint, which was previously accepted by OIW QC personell and the QA Inspector found no rejectable or recordable indications. The QA Inspector performed the shear wave inspection from Face "A", from the Forging side of the weld axis, utilizing a 60 and 70 degree testing angle attached to a 2.25 MHz transducer. Once the testing was complete from Face "A", the QA Inspector then tested the identical areas from Face "B", from both sides of the weld axis and found no rejectable indications. At this time, the QA Inspector noted that this weld joint currently has 2 non-critical weld repairs pending, which were previously discovered during the final UT. The QA Inspector notified lead QC Inspector Mike Gregson of the testing results and completed the applicable Ultrasonic Testing report (TL 6027), on this date. See Summary of Conversations and attached picture below.

Lead QA Inspector Joe Adame explained to the QA Inspector that additional Ultrasonic Testing should be performed on the weld joint, due to a missed indication by OIW Lead QC Inspector Mike Gregson. The QA Inspector had previously performed approximately 10 % UT on this WJ # W4-01 and had discovered a rejectable indication, which appeared to be slag inclusions deposited during the Submerged Arc Welding process. The QA Inspector had previously performed the 10 % inspection on an area which was inspected and accepted by QC Inspector Gregson.

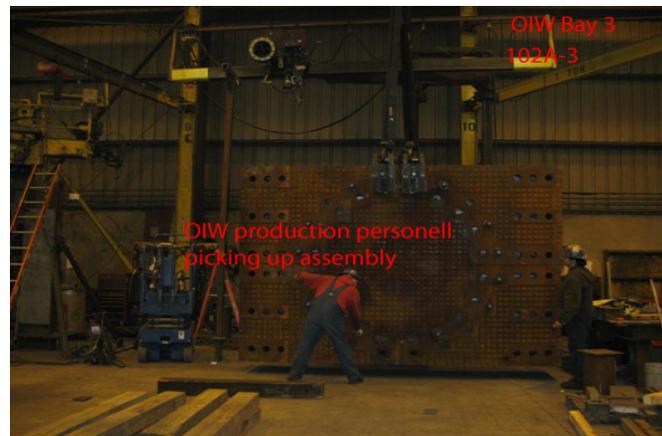
The QA Inspector observed that OIW Production personnel had previously completed the Partial Joint Penetration (PJP) weld joints # W2-01 and # W2-02 and were in process of flipping the assembly over. The QA Inspector

observed WID # B62 (Marcus Belgarde) and WID # M8 (Jim Munsey) attaching and tightening 2 previously fabricated carbon steel clamps around the a109 Cap and a110 Base plate. The QA Inspector observed that OIW Production Lead Troy Smith was present and supervising this activity and Mr. Smith explained that the assembly was being flipped to stand vertical and access the Partial Joint Penetration weld joints # W2-19 and # W2-20. The QA Inspector then observed WID # M8 placing 2 rigging shackles and slings through the above mentioned clamps. After placement of the slings, the QA Inspector observed WID # B62 utilize the hand held controls, which operate the Bay 3 Overhead Crane, to maneuver the crane hook over the assembly. Once the crane hook was placed over the assembly, the QA Inspector observed that WID # B62 lowered the hook, utilizing the hand held control and then WID # M8 placed the 2 previously attached slings on the hook. The QA Inspector then observed the assembly being lifted and placed near the Submerged Arc Welding machine, which will be utilized to perform the welding. The QA Inspector later observed WID # B62 attaching Cooperheat Ceramic blankets, to eventually start the pre-heat, prior to performing the Submerged Arc Welding. WID # B62 explained to the QA Inspector that he will continue setting up the Cooperheat for the remainder of the shift. See attached picture below.
