**DEPARTMENT OF TRANSPORTATION**

Contract #: 04-0120F4Cty: SF/ALA Rte: 80 PM: 13.2/13.9File #: 13.28**WELDING INSPECTION REPORT****Resident Engineer:** Pursell, Gary**Address:** 333 Burma Road**City:** Oakland, CA 94607**Report No:** WIR-014023**Date Inspected:** 14-May-2010**Project Name:** SAS Superstructure**OSM Arrival Time:** 1000**Prime Contractor:** American Bridge/Fluor Enterprises, a JV**OSM Departure Time:** 1830**Contractor:** Oregon Iron Works Clackamas, Or.**Location:** Clackamas, OR

## WELDING INSPECTION REPORT

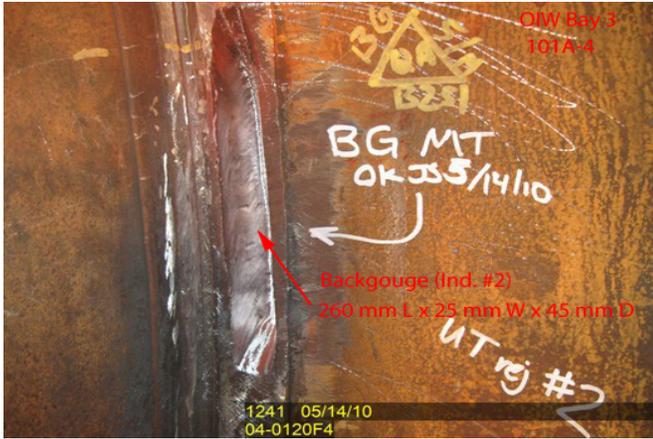
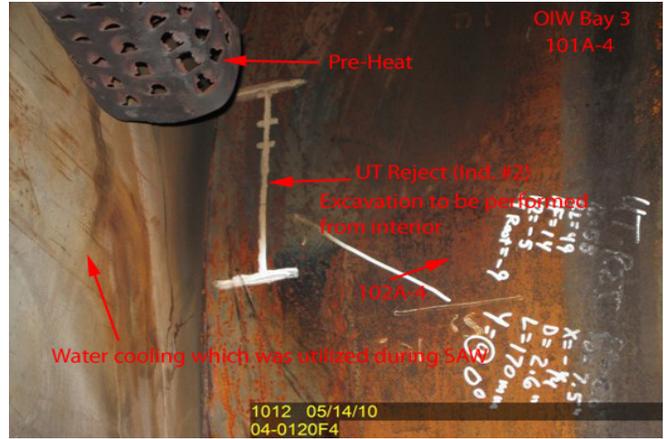
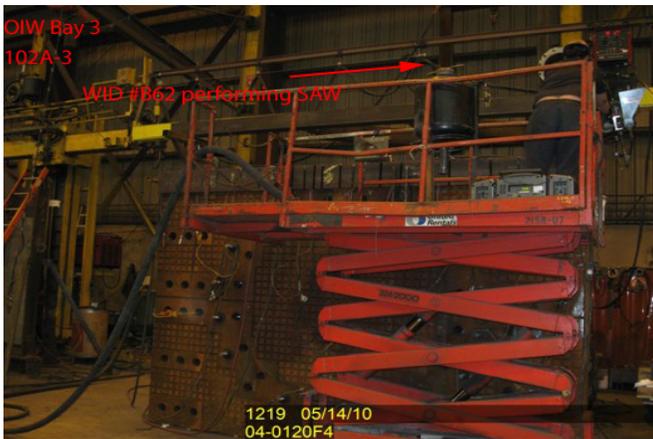
The QA Inspector observed WID # S53 (Jerry Shepherd), performing backgouging on the weld joint, designated as # W4-01. The QA Inspector noted that this weld joint was the 120A-4 Fuse to 102A-4 Forging and was designated as an AWS D1.5 B-U7-S, Complete Joint Penetration (CJP). The QA Inspector noted that the Weld Repair Report (WRR-10-03) was previously completed by OIW QC, prior to the backgouging being performed. The QA Inspector observed Mr. Shepherd was performing the backgouge in the vertical position, utilizing the Carbon Arc process and that pre-heat was intermittently applied, utilizing a previously set-up stationary torch or rosebud. The QA Inspector observed that the backgouge was being performed on the non-critical weld repair, which was previously ultrasonically tested and rejected by OIW QC Inspectors. The QA Inspector observed that Mr. Shepherd was currently performing this backgouge on "Indication #1", as recorded on OIW's Ultrasonic Examination Report (# 2244-10-UT-04) and that Mr. Shepherd was performing this, from the exterior of the weld joint. The QA Inspector spoke with Jerry Shepherd and Mr. Shepherd explained that he had previously completed the backgouge, from the interior side of the Weld Joint # W4-01. The QA Inspector noted that this was reported as "Indication # 2", on OIW's completed Ultrasonic Examination Report (# 2244-10-UT-04). Mr. Shepherd explained to the QA Inspector that during the backgouging process on # 2, he had visually discovered a slag pocket or inclusion and then a trailing slag line from this pocket, approximately 6 inches long. Mr. Shepherd

explained to the QA Inspector that he had completely removed this visible slag, utilizing Carbon arcing and then grinding to a depth of approximately 40 mm. Mr. Shepherd then explained that he will continue backgouging on the current weld repair # 1 and was currently at a depth of approximately 50 mm. Mr. Shepherd explained that at this time, no defect was visually discovered.

The QA Inspector observed that QC Inspector Jose´ Salazar was present and QC Inspector Salazar explained that the pre-heat was verified, prior to starting the Carbon Arcing on these two non-critical weld repairs. QC Inspector Salazar explained that he was currently informed that the backgouged excavation was now at a depth of approximately 50 mm. QC Inspector Salazar explained to the QA Inspector that he was aware of the 65 % maximum depth limit for a non-critical weld repair and he will closely monitor the depth on the excavation and that it will not exceed 58 mm deep. The QA Inspector noted that 58 mm is 65 % of the weld depth and that the minimum temperature required, prior to carbon arcing, is 150 degrees Fahrenheit. QC Inspector Salazar explained that the Flux Core Arc welding (FCAW) will probably start on 5/17/10 and OIW approved Welding Procedure Specification (WPS) 3048 will be utilized, for the two repairs. The QA Inspector noted that the above mentioned in process backgouging on the two non-critical repairs, appears to be in compliance with AWS D1.5.

The QA Inspector later observed that QC Inspector Salazar had completed the VT/MT on the previously excavated weld repair # 2 and found no rejectable indications, as noted next to the area by QC Inspector Salazar. The QA Inspector then performed VT/MT on the excavation and found no rejectable indications. The QA Inspector measured the excavation utilizing a 150 mm long pocket steel ruler and recorded the measurements as follows: 260 mm Long x 25 mm Wide x 45 mm Deep, including the approximate 3 mm weld reinforcement on the depth. The QA Inspector then completed an applicable Magnetic Testing report (TL 6028), on this date. See attached pictures below.
