**DEPARTMENT OF TRANSPORTATION**

Contract #: 04-0120F4Cty: SF/ALA Rte: 80 PM: 13.2/13.9File #: 1.28**WELDING INSPECTION REPORT****Resident Engineer:** Pursell, Gary**Address:** 333 Burma Road**City:** Oakland, CA 94607**Report No:** WIR-014027**Date Inspected:** 15-May-2010**Project Name:** SAS Superstructure**OSM Arrival Time:** 600**Prime Contractor:** American Bridge/Fluor Enterprises, a JV**OSM Departure Time:** 1400**Contractor:** American Bridge/Fluor Enterprises, a JV**Location:** Job Site**CWI Name:** See Below**CWI Present:** Yes No**Inspected CWI report:** Yes No N/A**Rod Oven in Use:** Yes No N/A**Electrode to specification:** Yes No N/A**Weld Procedures Followed:** Yes No N/A**Qualified Welders:** Yes No N/A**Verified Joint Fit-up:** Yes No N/A**Approved Drawings:** Yes No N/A**Approved WPS:** Yes No N/A**Delayed / Cancelled:** Yes No N/A**Bridge No:** 34-0006**Component:** Orthotropic Box Girders (OBG)**Summary of Items Observed:**

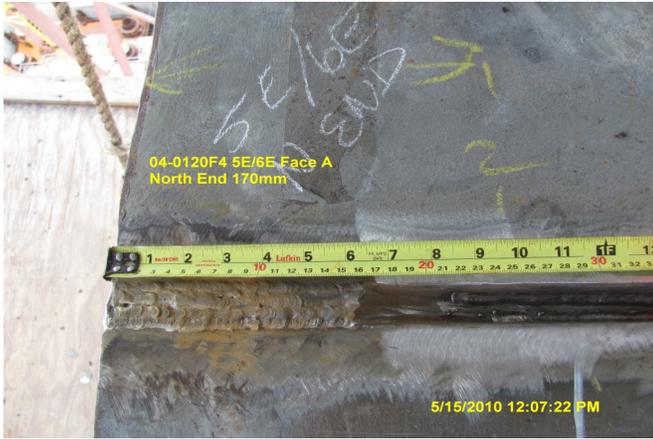
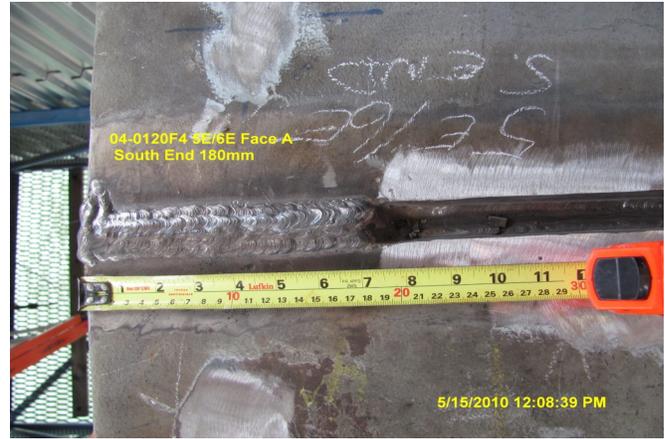
The QA inspector received a phone call from Structure Materials Representative Pat Lowry inquiring about the planar misalignment measured, documented and submitted late in the shift the previous day. It was relayed to Mr. Lowry the edges of the deck plate and edge plates were welded almost to the flush condition for approximately 160mm, the high strength bolted connection for the U-ribs appeared to be tensioned and the full length tack welds were 90% completed at this time. The QA inspector reviewed the areas and sent Mr. Lowry digital photos of the welded edges. The total area of planar misalignment was calculated to be approximately 22% located primarily in the traffic portion of the deck plate and this information would need to be discussed further with other personnel for disposition. See digital photos included in the body of this report for general information.
